ASSESSMENT OF MAIN CONTRIBUTING FACTORS LEADING TO THREE MAJOR PEATLAND FAILURES IN LEITRIM, KERRY AND DONEGAL

PROJECT SUMMARY REPORT

Prepared by Fehily Timoney and Company on behalf of Geological Survey Ireland (Department of the Environment, Climate and Communications and National Parks and Wildlife Service (Department of Housing, Local Government and Heritage).

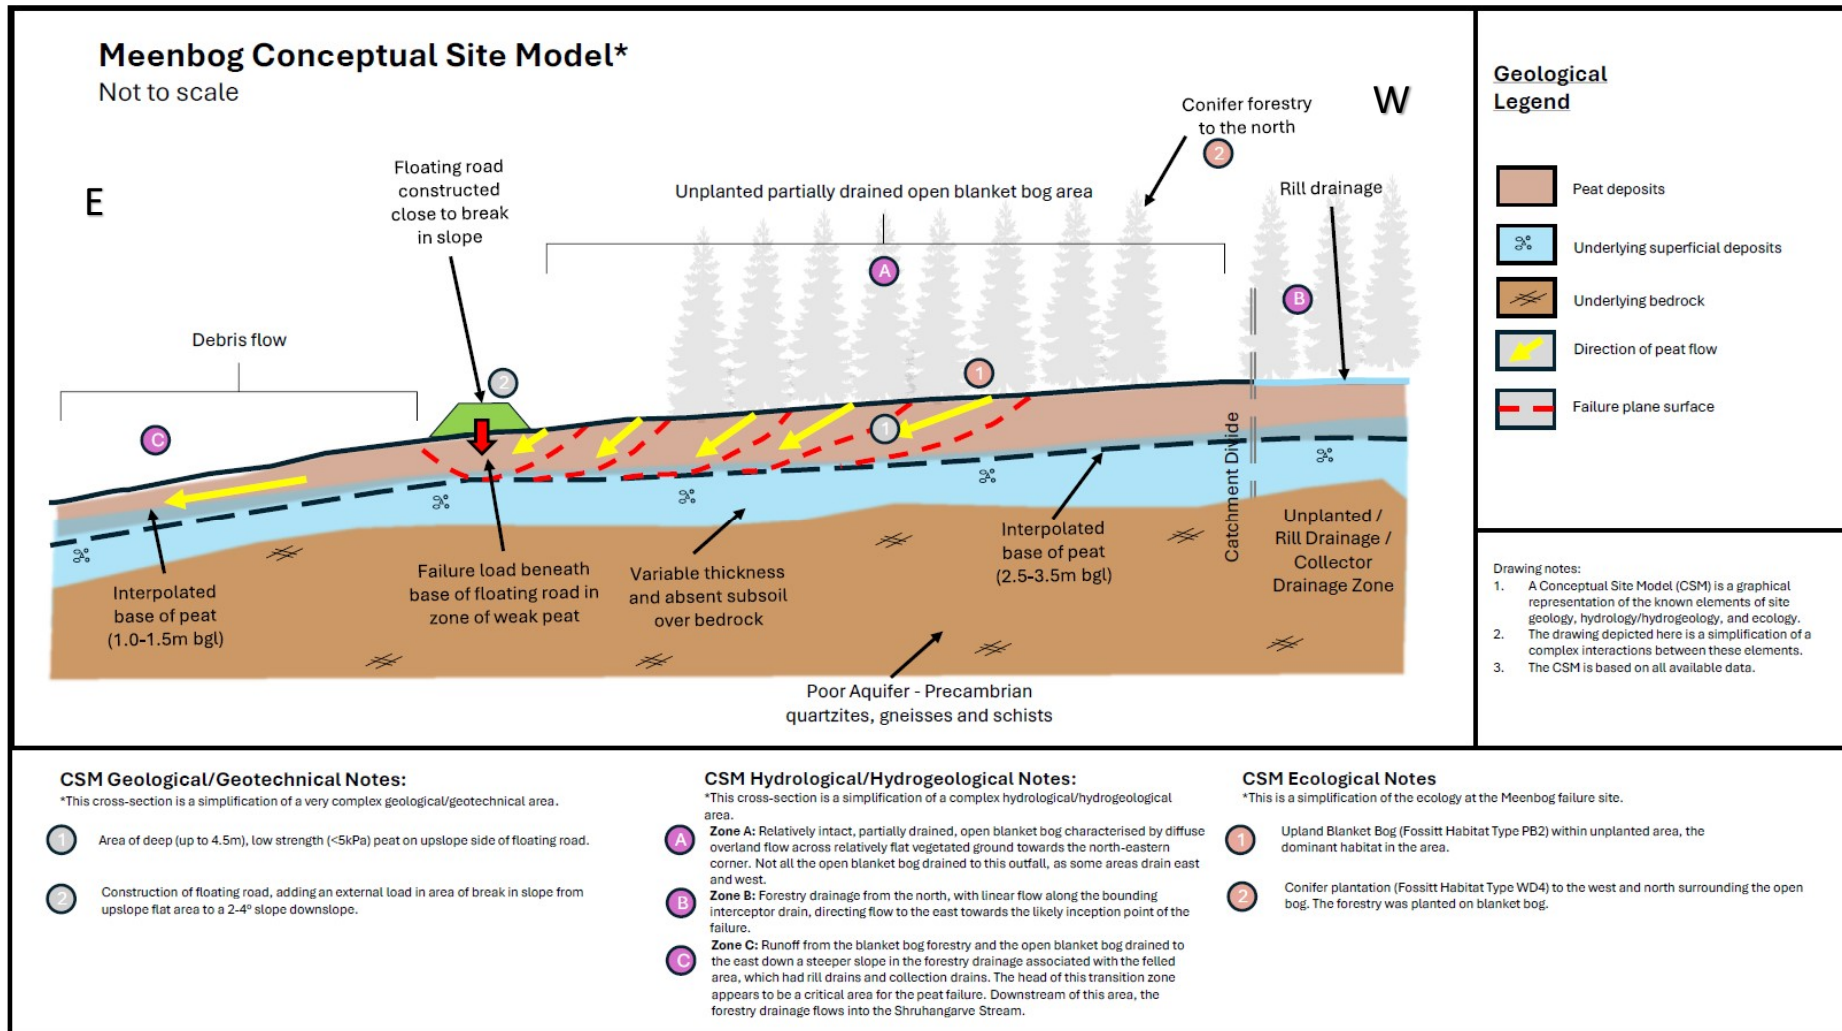
Figure 6.1: Meenbog Conceptual Site Model

The LiDAR data available for this site allows for refined slope analysis to be carried out. The approximate failure point for the Meenbog failure occurred close to a convex break in slope between an almost flat area to the west/southwest and a shallow (2-4 degree) slope to the east. This change in slope is considered to be a conditioning factor in the failure, even though the slopes would be considered to be shallow in general terms.

Within the site there are numerous man-made drains, mostly installed prior to the planting of the forestry but drains are also present within the open area of blanket bog upslope of the failure location. Based on the EIAR (2017), the forestry plantations at the site are generally drained by a network of mound drains which typically run perpendicular to the topographic contours of the site and feed into collector drains, which discharge to interceptor drains down-gradient of the plantations. The forestry drainage pattern is influenced by the local topography, ground conditions, layout of the forestry plantations and existing access roads, as would be typical of upland forestry plantation on peatlands in Ireland.

The catchment area upslope (south) of the failure is divided, with the western side draining to an interceptor or collector drain on the western edge of the open peatland, and from there draining to the Bunadaowen River and the eastern side draining to a collector drain that runs south-north, following the edge of the felled forestry, at a break in slope. This drains outfalls to the east towards the Shruhingarve stream at several locations, the most prominent of which is at a topographical low point some 80m to the south of the failure.

Due to the low permeability nature of the Precambrian bedrock aquifer underlying the site, groundwater flowpaths are likely to be short (30 – 300m), with groundwater discharging to nearby streams and small springs. This means there is a low potential for groundwater dispersion and movement within the aquifer. There is a lack of mapped springs and flush areas at the site, and this suggests that groundwater has a limited local influence at this site. Bedrock aquifer properties can be considered a conditioning factor since the relative impermeability of the underlying rock will not facilitate drainage of surface water and, is instead more likely to cause flow at the base of the peat where it lies directly on bedrock.
