MONAGHAN - COUNTY GEOLOGICAL SITE REPORT

NAME OF SITE	Tassan
Other names used for site	
IGH THEME	IGH15 Economic Geology
TOWNLAND(S)	Tassan
NEAREST TOWN/VILLAGE	Annayalla
SIX INCH MAP NUMBER	14
ITM CO-ORDINATES	679122E 826134N
1:50,000 O.S. SHEET NUMBER	28
GSI BEDROCK 1:100,000 SHEET NO.	8/9

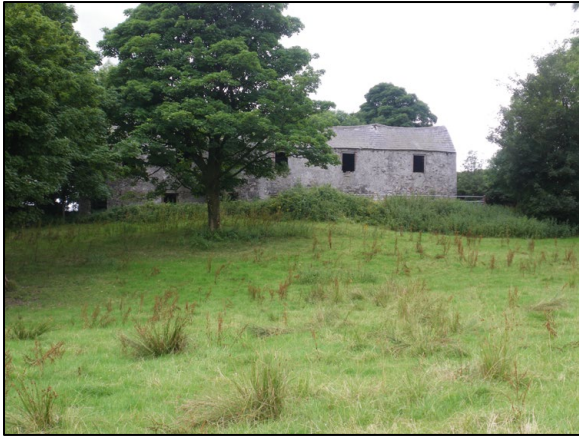
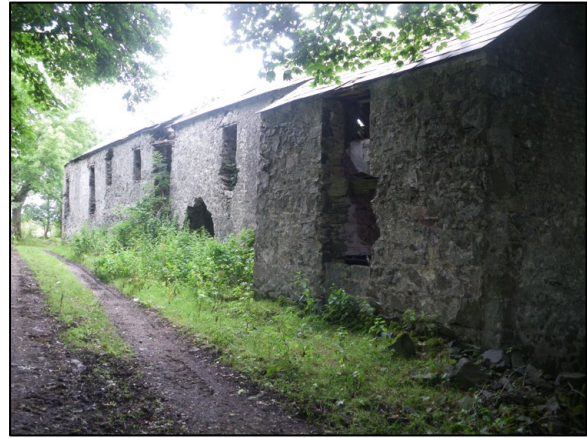
Today, the site contains more visible features than any of the other mine sites in the district. The site is largely grassed over apart from a large solid waste heap that marks the eastern boundary of the site on the west shore of Tassan Lough. Immediately west of this is a sloping field that was once the dressing floor. A low masonry wall below an overgrown mound marks the site of the combined engine and crusher house. Of five shafts marked on the 1857 OS 6-inch map there is no trace. A water-filled depression, resembling a sink-hole, beside the spoil heap near the lake appears to mark the site of a shaft even if it does not correspond to the location of any shaft marked on the OS maps. The most substantial mine feature is the old office and workshops building. This was in use as a family home until the 1940s but of late has been used as a farm out-building and is in a state of disrepair, with collapsed walls and sagging roof.

Looking west toward mine office/workshop with grassed-over dressing floor in foreground (left) and mine office/workshop (western side).

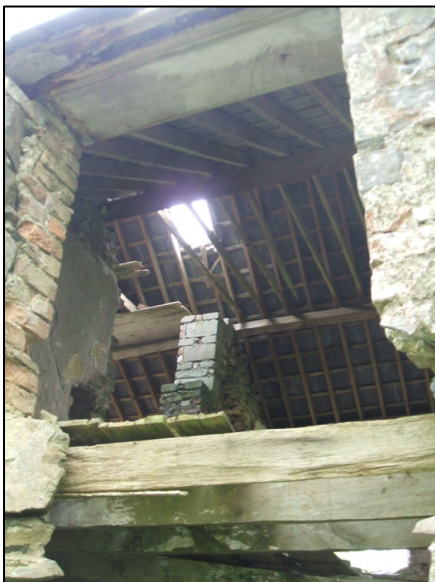
The site is on private land used for pasture. The mine office/workshop building has fallen further into disrepair in the last five years. The lack of any clear trace of shafts marked on old 1:10,560 (six-inch) sheets suggests a need for caution regarding visits given the potential for future shaft collapse.

Interior of mine office/workshop showing damage to roof (left) and remains of engine and crusher house (right).

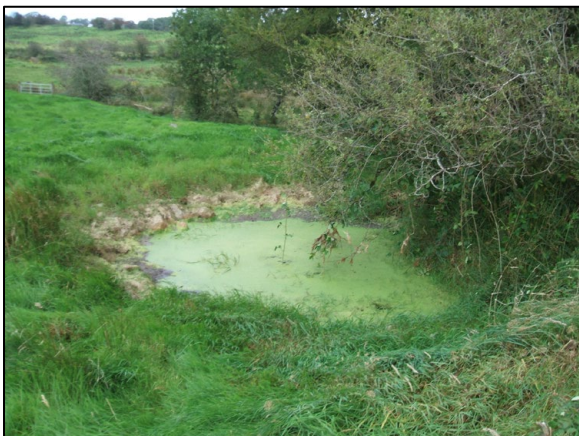
Possible site of shaft (left) and view eastwards of mine waste heaps and lake (left)
