TIPPERARY - COUNTY GEOLOGICAL SITE REPORT

NAME OF SITE	Hollyford Mines
Other names used for site	Holyford Mines, Holyford Copper Mines
IGH THEME	IGH15 Economic Geology
TOWNLAND(S)	Reafadda
NEAREST TOWN/VILLAGE	Hollyford
SIX INCH MAP NUMBER	45
ITM CO-ORDINATES	593338E 654050N (centre of site)
1:50,000 O.S. SHEET NUMBER 66	GSI BEDROCK 1:100,000 SHEET NO. 18

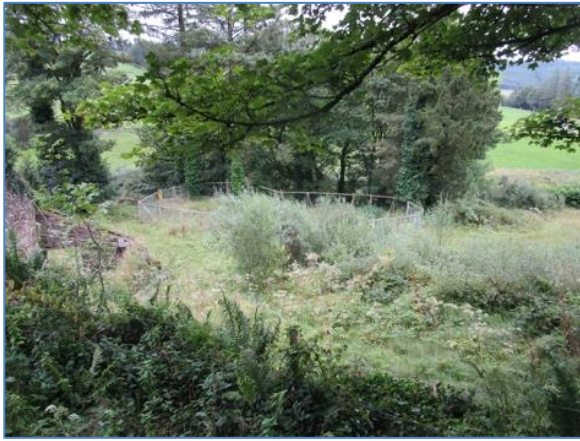
The site is on private land and there is no access without permission. The open shaft is fenced off but has previously been capped twice and subsequently collapsed twice, as in any former mining area, caution must be exercised in case of any unknown or obscured dangers. The upstanding mine chimney is also a risk in that possible lightning strikes have perhaps damaged the upper portions which could collapse. Ideally, a conservation project should be initiated to make the chimney secure from weather damage and to install a lightning conductor inside the chimney if none exists.

A view of the fenced off shaft.

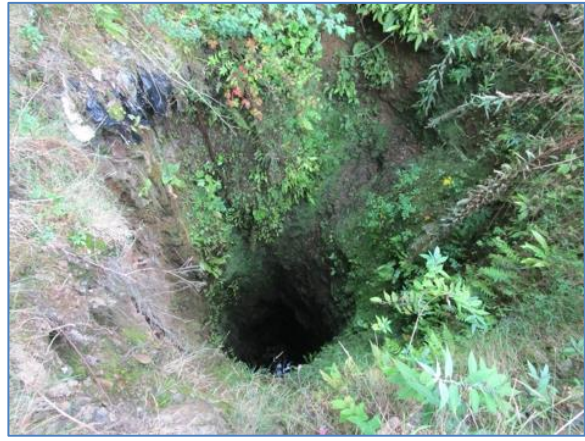
A view into the deep, open mine shaft.

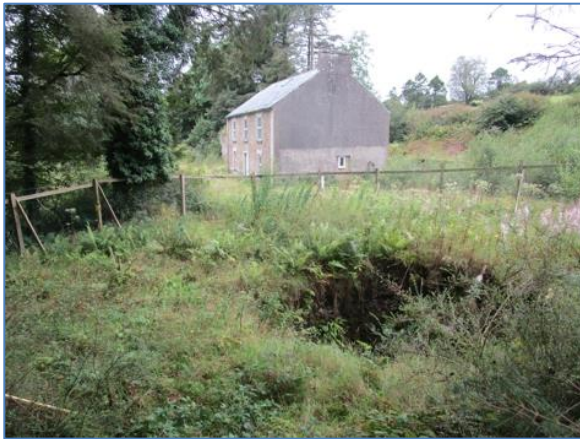
The Mine Captain's House viewed across the fenced off open shaft.

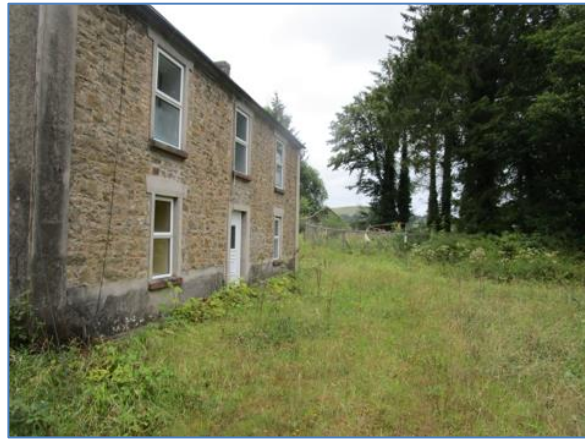
The Mine Captain's House.

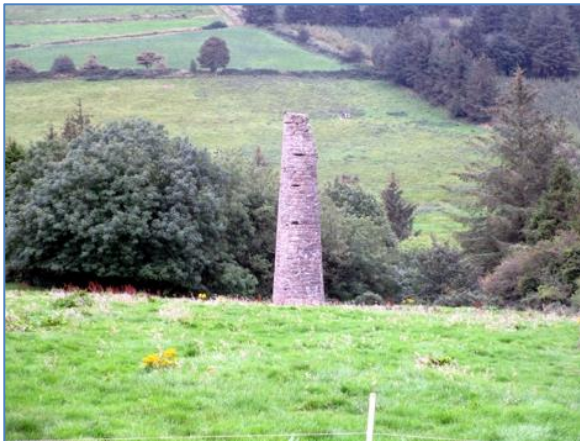
The extant engine house chimney.

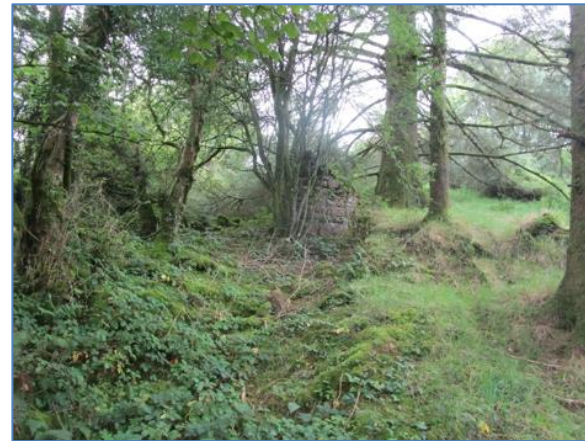
The base of the other engine house chimney.
