## WATERFORD - COUNTY GEOLOGICAL SITE REPORT

<b>NAME OF SITE</b>	<b>Ross Slate Quarry</b>
Other names used for site	
<b>IGH THEME</b>	<b>IGH15 Economic Geology, IGH 4 Cambrian-Silurian</b>
<b>TOWNLAND(S)</b>	<b>Ross</b>
<b>NEAREST TOWN</b>	<b>Kilmacthomas</b>
<b>SIX INCH MAP NUMBER</b>	<b>Waterford 16</b>
<b>NATIONAL GRID REFERENCE</b>	<b>245655 108668</b>
<b>1:50,000 O.S. SHEET NUMBER</b>	<b>82                      1/2 inch Sheet No.    22</b>

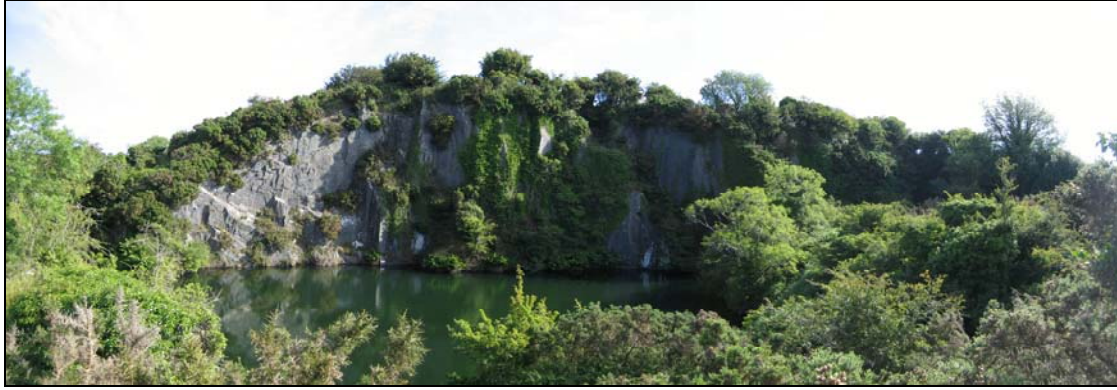
The Ross Slate Quarry main face, viewed from the west.

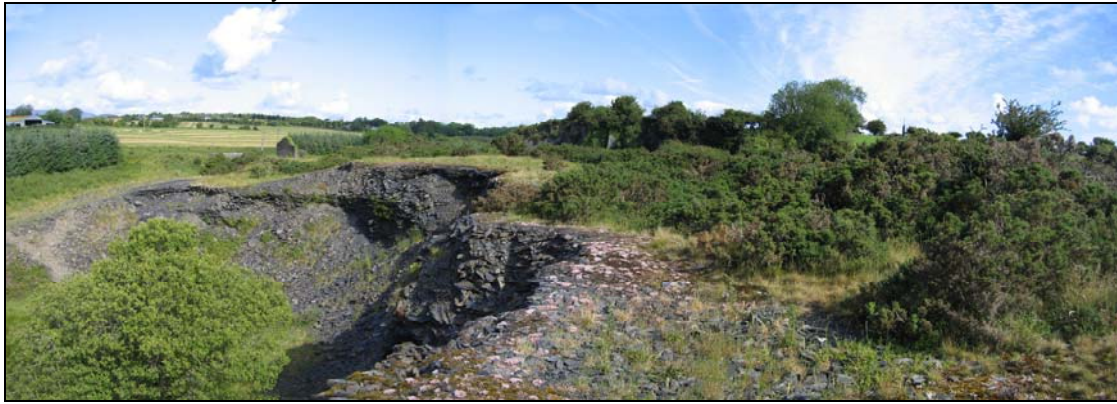
This site is not suitable for public promotion due to being on private property (landowner is unknown to audit) and also has safety concerns. Loose rock faces in the spoil heaps show signs of being dug out occasionally and they are steep and potentially dangerous. The main quarry is flooded, is probably very deep, and difficult to exit from if anyone fell in. The mill building is still largely intact, but shows some signs of risk of damage, especially in the wall opening facing the west.

View north across one of the spoil heaps (showing more recent excavation).

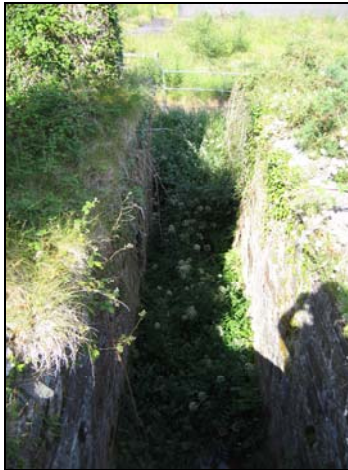
The wheelpit.

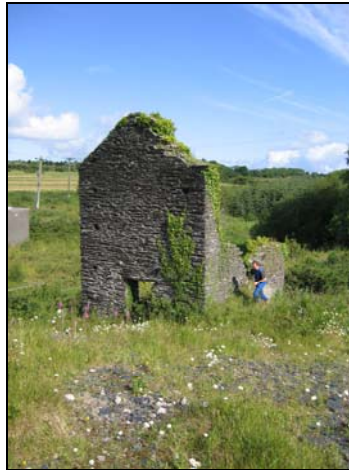
The water mill from the south.

Remedial conservation works to stabilise this building would be desirable if funds and owner agreement can be found. No leats (constructed wooden or stone channels to bring water to the wheel) or other evidence was seen as to whether this was an undershot or overshot water wheel, but the carrying out of a more expert assessment is also advisable, e.g. by the Mining Heritage Trust of Ireland or the Mills and Millers Association.

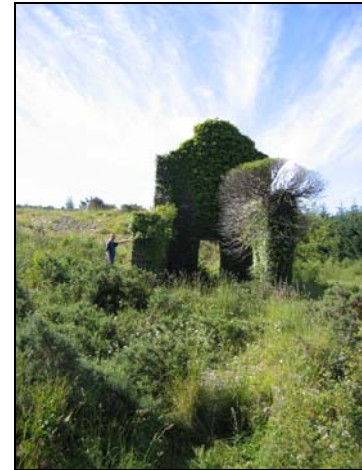
The water mill from the north.
