Environmental Protection Agency

Establishment of Groundwater Source Protection Zones

Kilcoran Group Water Scheme

November 2010

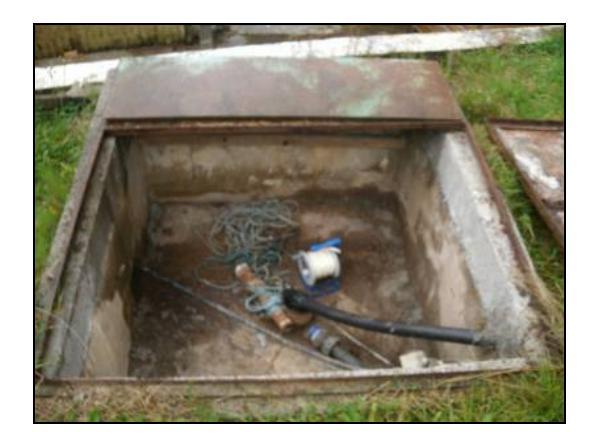
Photo 1: Well Head Chamber

The base of the chamber is 1 m below the ground surface and is not sealed. Because the chamber is set at ground level, surface run-off from the lands to the west can enter the chamber (Photograph 1). The steel borehole casing rises 5 cm above the bottom of the chamber, which should decrease the risk of surface run off or spills from entering the well head directly. However, there is no information (e.g. a borehole or well construction log) to establish whether or not the borehole is adequately sealed to prevent shallow subsurface inflow or to determine the precise location of inflow to the well at depth.

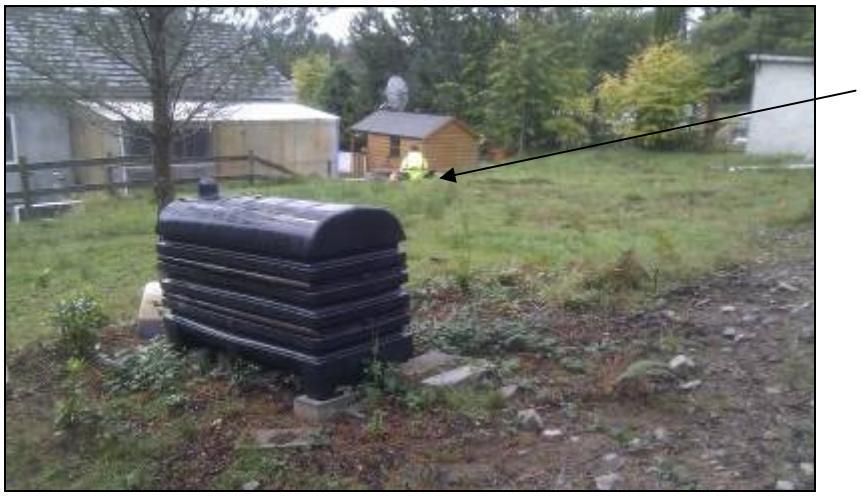
Photographs 2 and 3: Oil Storage Tank

A heating oil fuel storage tank for the adjacent private dwelling is located 10 meters up hydraulic gradient of the borehole (Photograph 2). While the tank is in good repair and constructed of polyethylene, the fuel line runs under ground to the dwelling. During the site inspection it was noted that line had been disconnected and kerosene was observed in a 25 litre plastic container beside the tank (Photograph 3). It is assumed that this was used to collect kerosene from the line when it was being disconnected. The disconnected fuel line and storage of kerosene in a non-secure container presents a serious risk of contamination of the water supply.

- That the oil fuel storage tank be moved to a location down hydraulic gradient of the well and that the fuel line from this tank run above ground to the dwelling to minimise the risk of hydrocarbon contamination of the well.
- That the pump house and the concrete manhole cover of the well should be upgraded as recommended in the Paul Murphy Report (Appendix1).

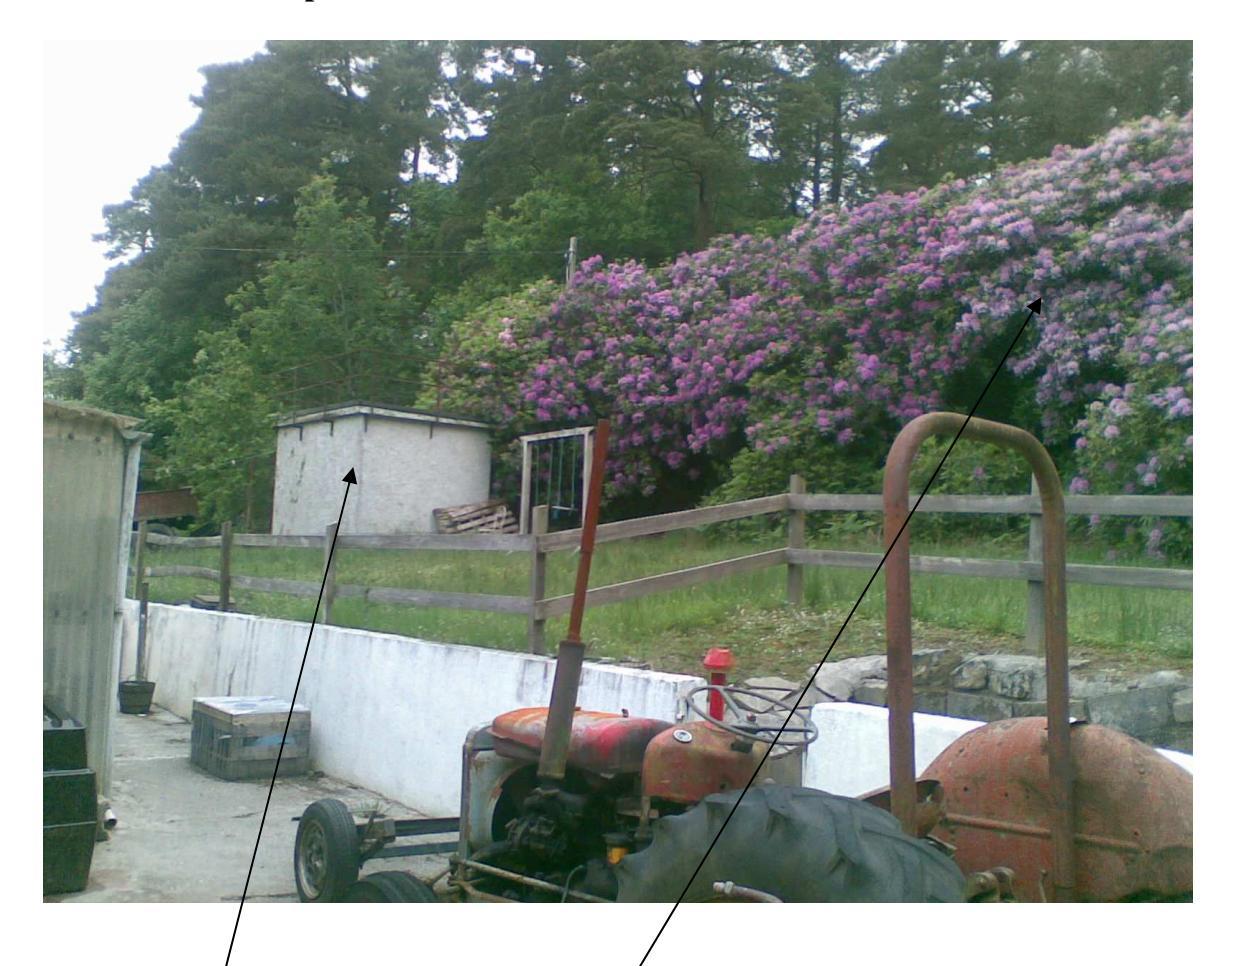
Location of pump house and borehole in foreground near dwelling house boundary wall

- Existing trees being retained but area behind pump house has to be deforested to allow construction of reservoir
- Timber post and rail boundary fences are required on house side of the site and peripheral boundary fence to be refurbished and made good

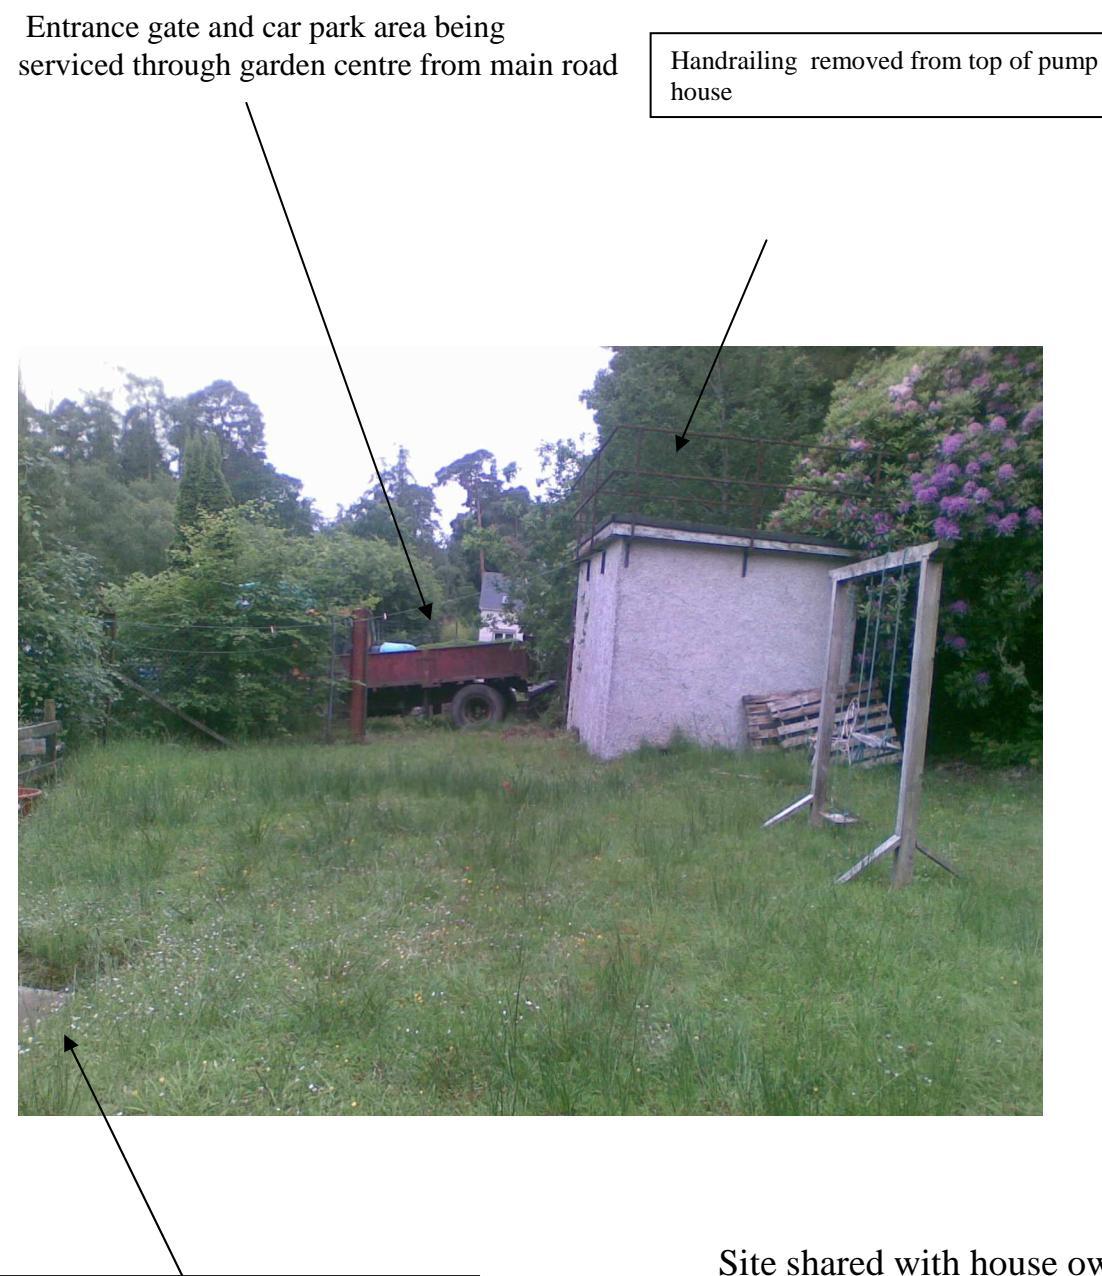
The well and pumping facility is located on the side of a shallow sloped forested hillside over a dwelling house and garden centre complex. The borehole finishes below finished ground level to the rear of a dwelling house and could be subject to being polluted by hillside surface water. It would be recommended that the area around the borehole should be elevated circa 200mm above finished ground level and sealed with concrete to prevent infiltration into the well from surface water.

Borehole cover
