# ASSESSMENT OF MAIN CONTRIBUTING FACTORS LEADING TO THREE MAJOR PEATLAND FAILURES IN LEITRIM, KERRY AND DONEGAL

## LITERATURE REVIEW OF CONDITIONING AND TRIGGERING FACTORS IN PEAT FAILURES

Prepared by Fehily Timoney and Company on behalf of Geological Survey Ireland (Department of the Environment, Climate and Communications and National Parks and Wildlife Service (Department of Housing, Local Government and Heritage).

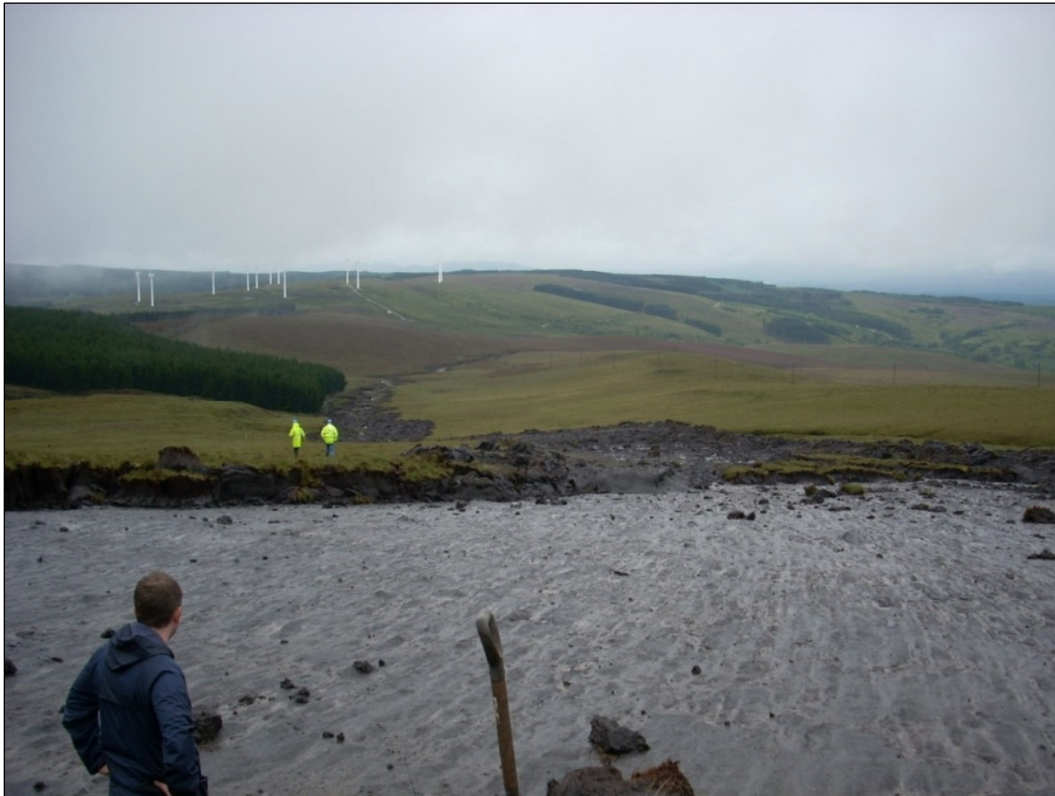
**Figure 4.1: Example of failure (peat slide) in blanket bog at Corry Mountain, Co. Sligo**  
(photo courtesy of Dr Paul Jennings, from Dykes and Jennings, 2011)

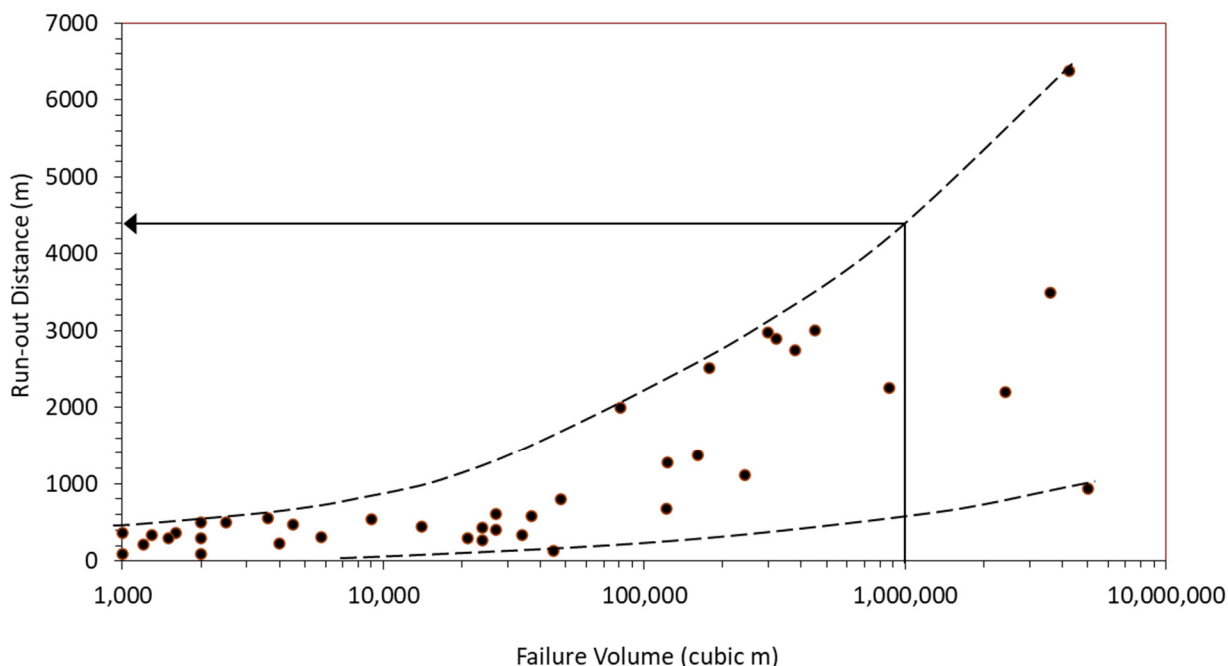
Run-out distance versus failure volume for a total of 44 reported peat failures is shown in Figure 4.3 (from Boylan, Jennings & Long, 2008). Run-out distance is defined as the horizontal distance from the downslope edge of the failure scar to the downslope limit of failure debris. As peat debris is notably mobile and can be relatively easily transported in water it is difficult, in many peat failures, to determine exactly where the downslope limit of peat debris is.

There is a general trend showing that run-out distance increases with failure volume, though there is a large scatter of results at larger failure volumes. The scatter may be attributable to many factors, such as degree of topographic confinement, presence of entrapped water in failure mass and the wash-out of debris along river courses (Boylan, Jennings & Long, 2008).

Figure 4.3: Failure volume versus run-out distance (reproduced from Boylan et al, 2008)

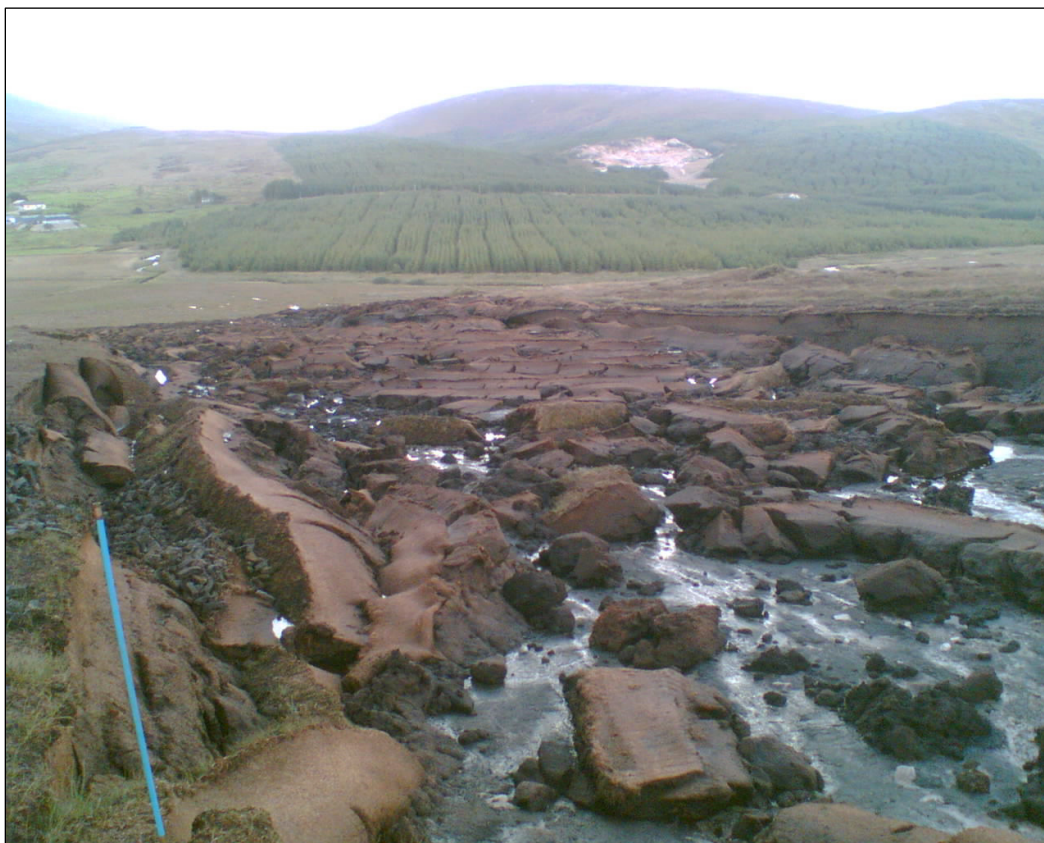
**Figure 4.4: Peat failure, Glencolumcille, Co. Donegal showing a peat failure within a machine cut area of peat.**  
(Photo courtesy of Dr Paul Jennings)

Peat extraction at the edge of a peat deposit typically results in an open unsupported peat face. This, over time, acts as a drain for the edge of the peat, drying the edge of the peat. Peat cutting may also increase the risk of peat mass movements such as bog slides because the peat bank constitutes a break in the fibrous vegetation mat which binds the bog system securely on a slope. Drainage offers the potential for cracks to develop in the peat, thus permitting heavy rainfall to reach and lubricate the junction between the peat and the mineral sub-soil (Lindsay, 2014). The failure at Knocknageeha in 1896 is considered to have been the result of cutting a relatively deep peat face, exposing the lower, softer, more humified peat which then failed.

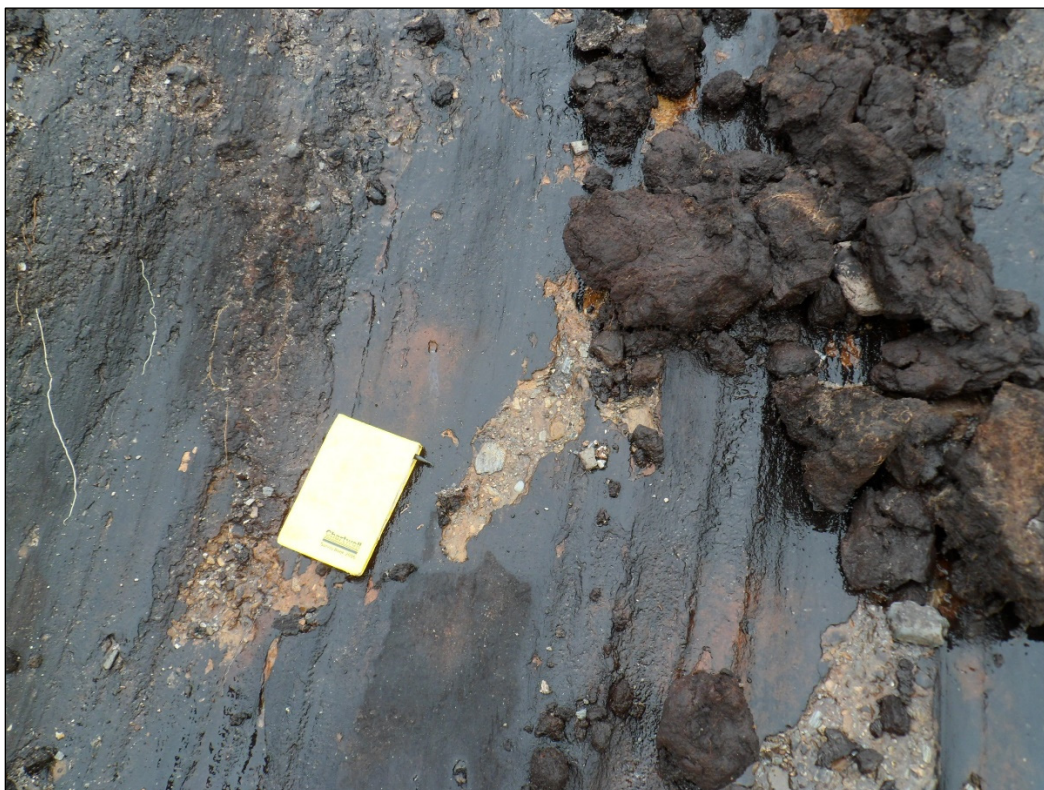
**Figure 4.5: Base of Peat failure, Flughland, Co. Donegal, 2017.**  
(Photo courtesy of Dr Paul Jennings)

In the context of steeper hillslope peat failures, (iron) hard pan deposits forming hydrological barriers and potentially weak failure surfaces have been identified beneath thin blanket peat (Dykes and Warburton, 2007). The presence of an impermeable layer, such as a soft clay layer or iron pan, directly beneath peat can be a conditioning and triggering factor for the onset of a Peaty-debris slide (Warburton et al, 2007), but also applies to other failure types. This impermeable layer provides a sliding surface for the failure, with the peat often remaining relatively intact as it is transported. The impermeable layer also effects the water pressure within the peat deposits, especially following intense rainfall events.

Examples are noted in Alexander et al (1986), describing a failure near Geevagh, Co. Sligo, for a series of failures on Dooncarton Mountain, Co. Mayo in September 2003 (Dykes and Warburton, 2007), as well as at Flugland, Co. Donegal (Figure 4.5) (Jennings & Kane, 2019).
