GALWAY - COUNTY GEOLOGICAL SITE REPORT

NAME OF SITE	Boyounagh Turlough
Other names used for site	
IGH THEME	IGH1 Karst, IGH16 Hydrogeology
TOWNLAND(S)	Cashel, Patch
NEAREST TOWN/VILLAGE	Glenamaddy
SIX INCH MAP NUMBER	18
ITM CO-ORDINATES	559800E 763000N (centre of feature)
1:50,000 O.S. SHEET NO. 39	GS1 BEDROCK 1:100,000 SHEET NO. 11

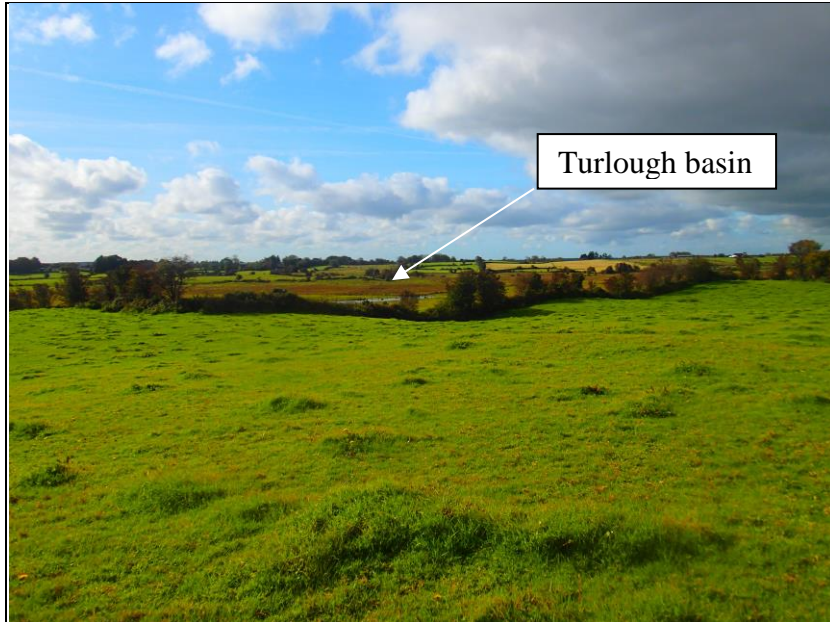
Boyounagh Turlough, viewed from the north, September 2018.

The landscape surrounding Boyounagh Turlough is comprised of low hills, but the floor of the turlough is relatively flat except for a rise in the eastern half. The basin is confined by slopes on the north and part of the south but is more open to the west. The northern shore is more steeply sloping with a good zonation from wet to drier grassland, while wetland herbs predominate in wetter areas.

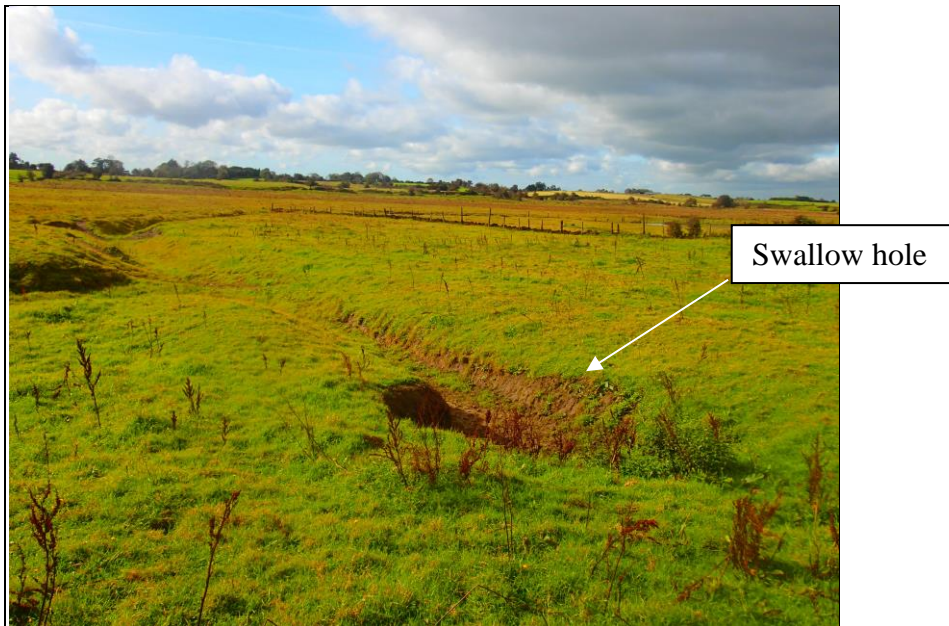
The channel leading from the turlough to the swallow hole at its northeastern end.

Water enters the basin from the eastern end *via* an excavated drain from Lough Nahask. This continues through to a central marshy pond where drainage has resulted in some drying. A swallow hole occurs at the northeastern end of the feature, connected to the turlough *via* a partially-excavated drainage channel.

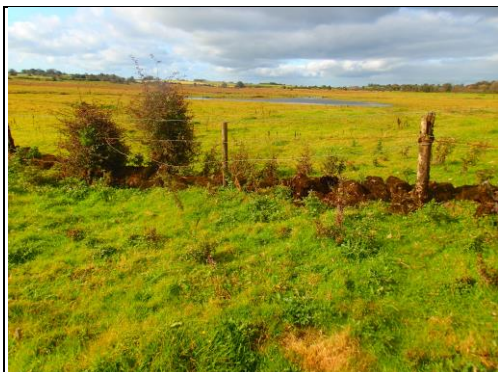
Moss-covered cobbles in a stone wall within the turlough feature; the extent of the moss shows flooded water levels in the basin.

The feature reflects the interaction of the groundwater table with the land surface, and is a seasonal lake. There are many erratics of pure limestone around the base of the turlough, many of which are moss covered up to a certain elevation. Such moss provides a watermark which allows an approximation of the high-water level when the turlough is in flood.

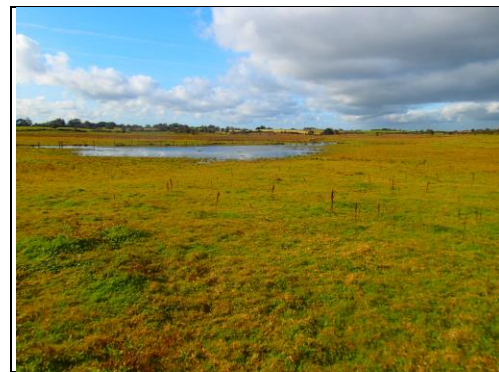
Small pond in the centre of the turlough, September 2018.
