# GALWAY - COUNTY GEOLOGICAL SITE REPORT

<b>NAME OF SITE</b>	<b>Kilkerrin Turlough</b>
Other names used for site	Lehinch Turlough
<b>IGH THEME</b>	<b>IGH1 Karst, IGH16 Hydrogeology</b>
<b>TOWNLAND(S)</b>	<b>Lehinch, Rockfield West</b>
<b>NEAREST TOWN/VILLAGE</b>	<b>Kilkerrin</b>
<b>SIX INCH MAP NUMBER</b>	<b>31</b>
<b>ITM CO-ORDINATES</b>	<b>563200E 756200N (centre of feature)</b>
<b>1:50,000 O.S. SHEET No. 39</b>	<b>GSi BEDROCK 1:100,000 SHEET NO. 12</b>

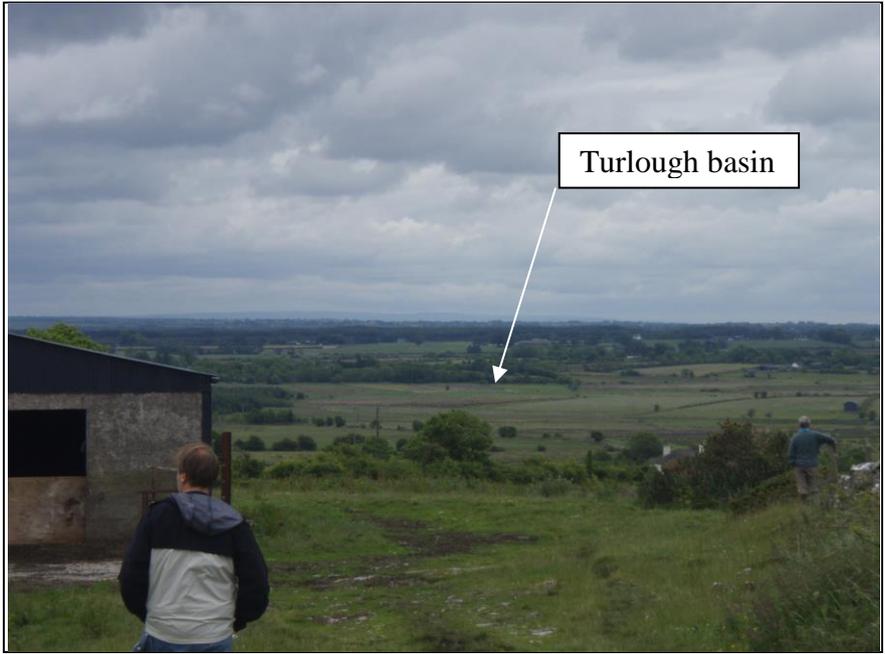
Kilkerrin Turlough, viewed from Rockfield Hill at the east.

The turlough basin site lies within a deep valley of glacial till, with bedrock outcrop common at the southwestern side as well as at the eastern side of the basin. There is one small stream inflow feeding surface water into the feature, from the northeast, and a surface outflow at the southwestern corner, which is hewn into the bedrock. Kilkerrin Turlough is a 'dry' turlough, which empties early in the year.

The turlough is crossed by a road on the northern side which divides it roughly into two halves. Both halves extend southwards in a crescent shape, with the western arm leading to the deep trench cut through the bedrock. At least five individual swallow holes occur at the base of the feature, and a cave has also been recorded historically.

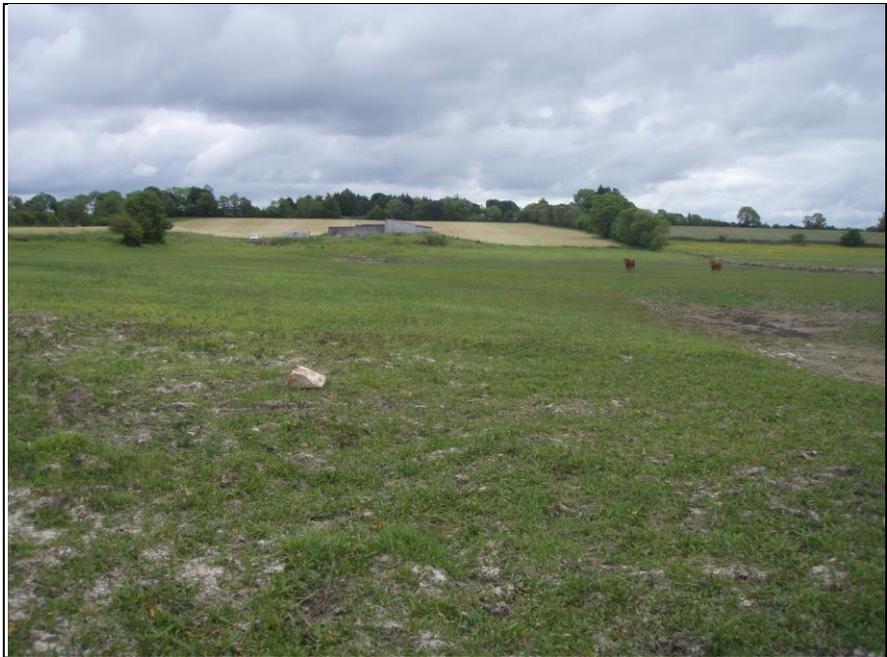
The undulating surface at the base of Kilkerrin Turlough.

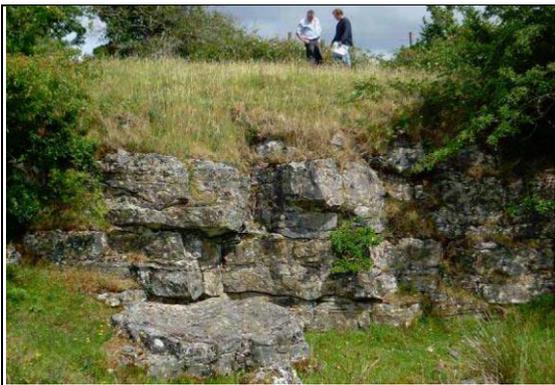
Bedded limestone at the eastern end of the turlough.

The bedrock under the site is pure bedded, Lower Carboniferous limestone, but the turlough feature itself is post-glacial, formed in the last 11,000 years.

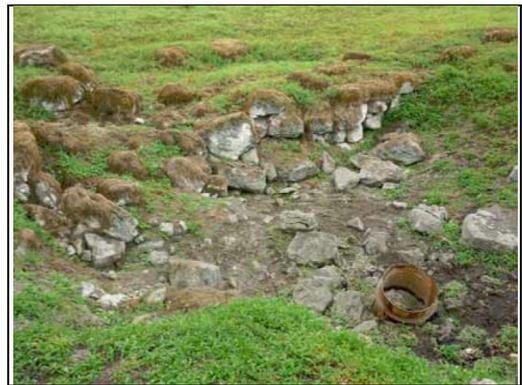
Detail of swallow hole at the base of Kilkerrin Turlough.

Water flowing into swallow holes at the base of Kilkerrin Turlough, as well as in the bedrock outcrop on top of Rockfield Hill, southeast of Kilkerrin, has been previously dye-traced and the water emerged from both traces at Marganure Spring, which is 2.5 km to the southeast of the Kilkerrin Turlough site. This proves that subsurface, groundwater flow from the Kilkerrin Turlough locality is southeastwards, *via* conduits underground.
