GALWAY - COUNTY GEOLOGICAL SITE REPORT

NAME OF SITE	Kiltullagh Lough
Other names used for site	
IGH THEME	IGH1 Karst, IGH7 Quaternary
TOWNLAND(S)	Creggaun, Shannagh Beg, Kiltullagh, Lehurick, Monagormley
NEAREST TOWN/VILLAGE	Glenamaddy
SIX INCH MAP NUMBER	18
ITM CO-ORDINATES	561100E 759350N (centre of lake)
1:50,000 O.S. SHEET No. 39	GS1 BEDROCK 1:100,000 SHEET NO. 11

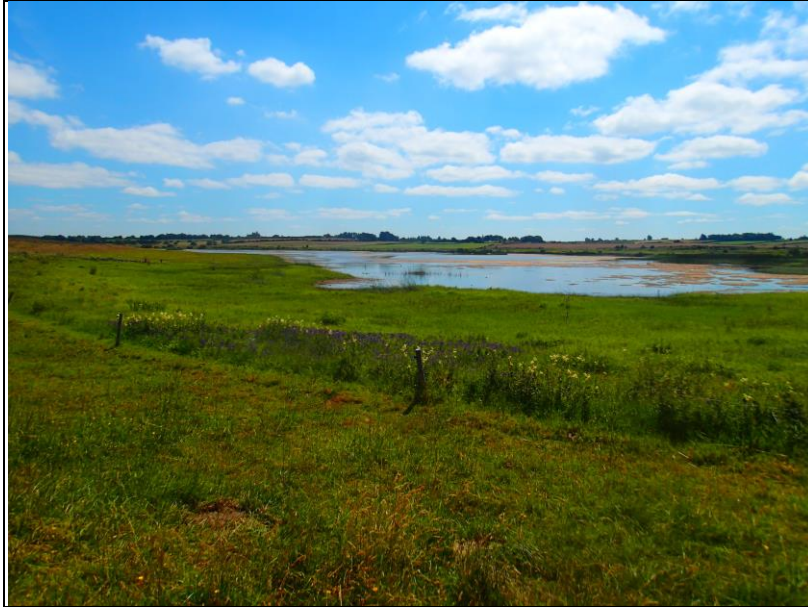
The half-empty Kiltullagh Lough, July 2018. Viewed from the north.

This site comprises a lake which is actually a turlough feature, but which empties only every few years, and not on an annual basis.

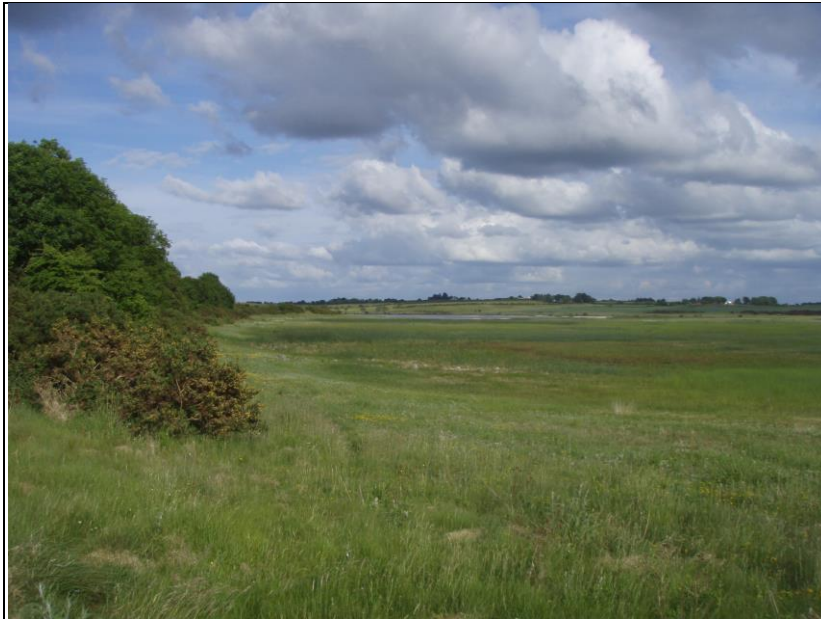
The lake almost fully dry in June 2010, again viewed from the north.

This was only discovered by the scientific community as a turlough in 2010, when the lake emptied fully and the large swallow hole at its base was exposed.

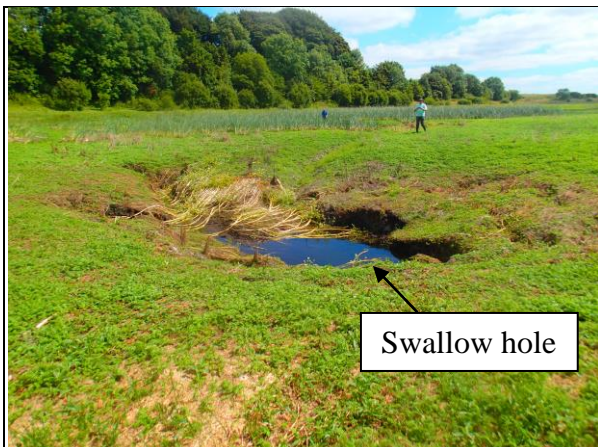
The swallow hole in the floor of the lake basin, July 2018.

The water sinking into this swallow hole was dye-traced that summer, and the water emerged at Gortgarrow Spring, 4 km to the west. The lake fully emptied again in summer of 2018.

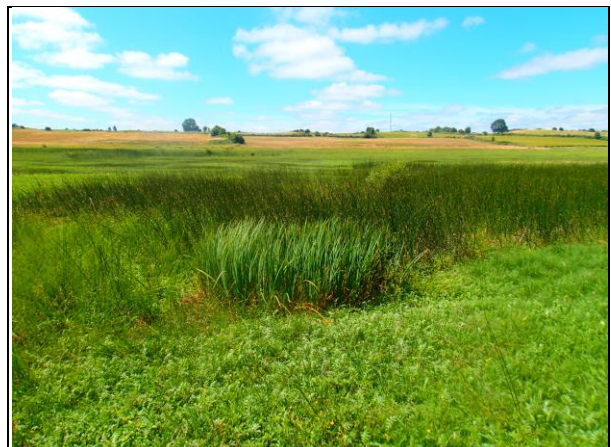
Species-rich wet grassland exposed in the dry floor of the lake basin, July 2018.
