GALWAY - COUNTY GEOLOGICAL SITE REPORT

NAME OF SITE	Summerville Lough
Other names used for site	Lake Summerville
IGH THEME	IGH1 Karst, IGH16 Hydrogeology
TOWNLAND(S)	Mountsilk, Templemoyle, Creggauns, Summerville, Moylough, Moylough More
NEAREST TOWN/VILLAGE	Moylough
SIX INCH MAP NUMBER	45
ITM CO-ORDINATES	560400E 750000N (centre of lake)
1:50,000 O.S. SHEET NOS. 39, 46	GS1 BEDROCK 1:100,000 SHEET NO. 11

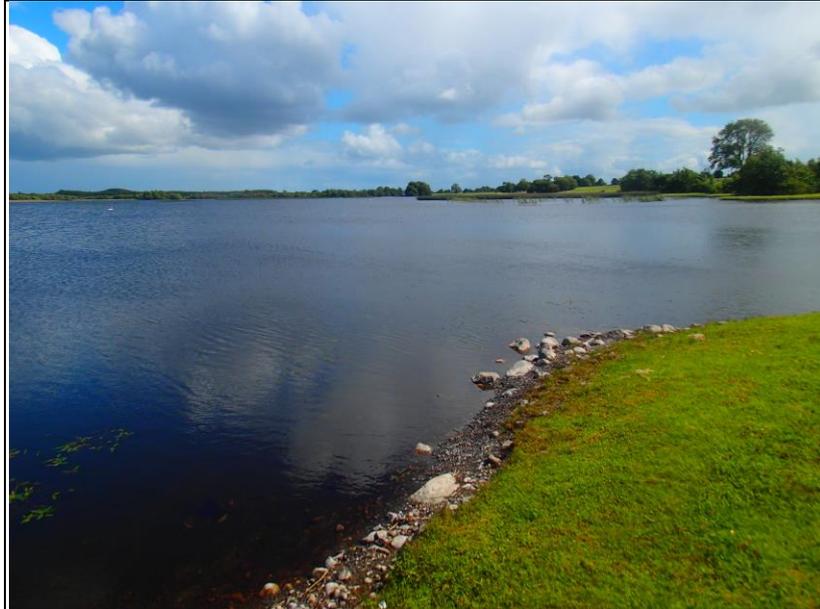
Summerville Lough, August 2018. Viewed from the west.

Summerville Lough is quite shallow, with extensive patches of rush near the centre and on the margins. The lake is flanked at the northwest and north by an esker and sands and gravels, at the east by an expanse of raised peat, and at the south by a ridge of glacial till.

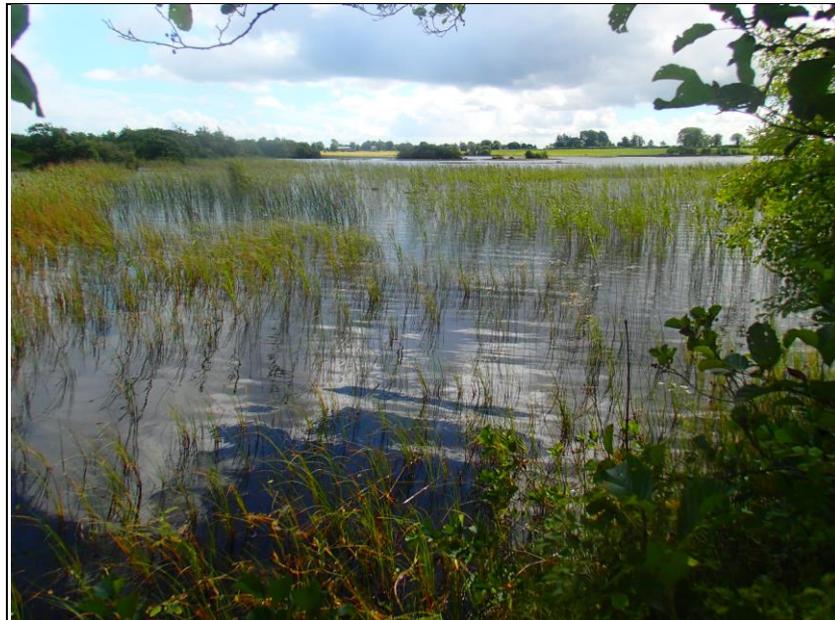
Patches of common club rush (also known as lakeshore bulrush) along the northwestern edge of Summerville Lough.

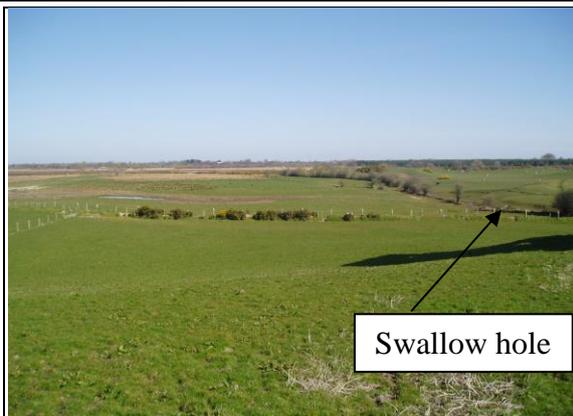
The dry, peaty basin at the eastern end of Summerville Lough, November 2011.

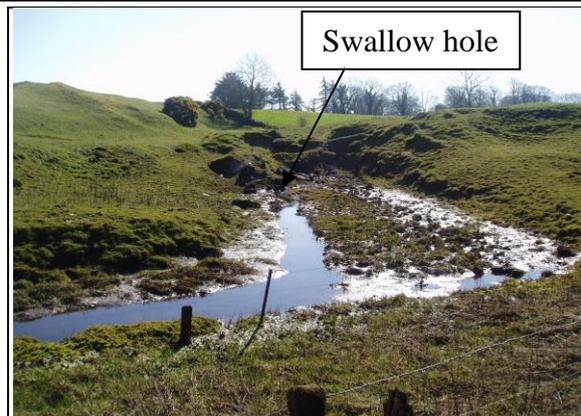
Detail of the swallow hole east of the lake basin, November 2011.

A swallow hole occurs at the southeastern edge of the peat flanking the lake basin, just north of Moylough Castle. The water sinking into this swallow hole was dye-traced in 2011, and the water emerged at public water supply springs at Barnaderg and (adjacent) 'mid-Galway' springs, almost 10 km to the southwest, in Derreen Townland. The lake therefore drains at high water levels into this swallow hole and subsurface, and *via* conduits, to the distant southwest.
