GALWAY - COUNTY GEOLOGICAL SITE REPORT

NAME OF SITE	Williamstown Turloughs
Other names used for site	Polleagh Lough, Curragh Lough, Gortduff Lough (individually)
IGH THEME	IGH1 Karst, IGH16 Hydrogeology
TOWNLAND(S)	Polleagh North, Gortduff, Polleagh South, Beagh, Cloonmaghaura, Coothagh, Curragh West
NEAREST TOWN/VILLAGE	Williamstown
SIX INCH MAP NUMBER	5, 6
ITM CO-ORDINATES	557200E 768340N (centre of Polleagh Lough)
1:50,000 O.S. SHEET No. 39	GS1 BEDROCK 1:100,000 SHEET NO. 12

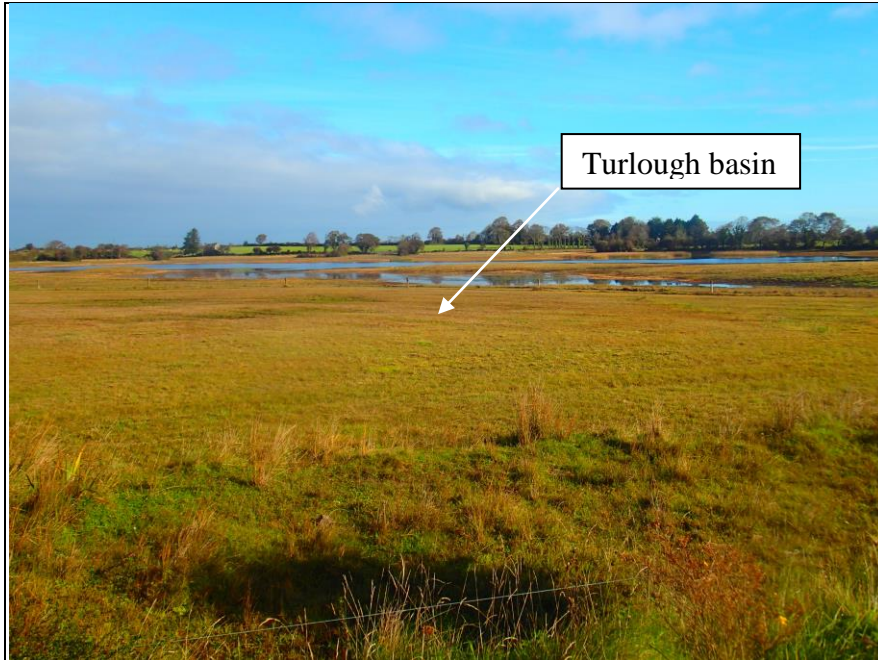
Polleagh Lough, with very low levels of water within, viewed from the southwest, September 2018.

Polleagh Lough is an oligotrophic turlough. It has a permanent very shallow lake which is probably dependent for its existence in summer on a perched water-table fed only by water from its surrounding small catchment area flowing onto peat and marl. This catchment area includes a significant area to the east of the Regional R360 road. Polleagh Lough is joined to Polleagh West at times of high flood, completely surrounding a low hill of glacial till. In summer, Polleagh West almost dries out.

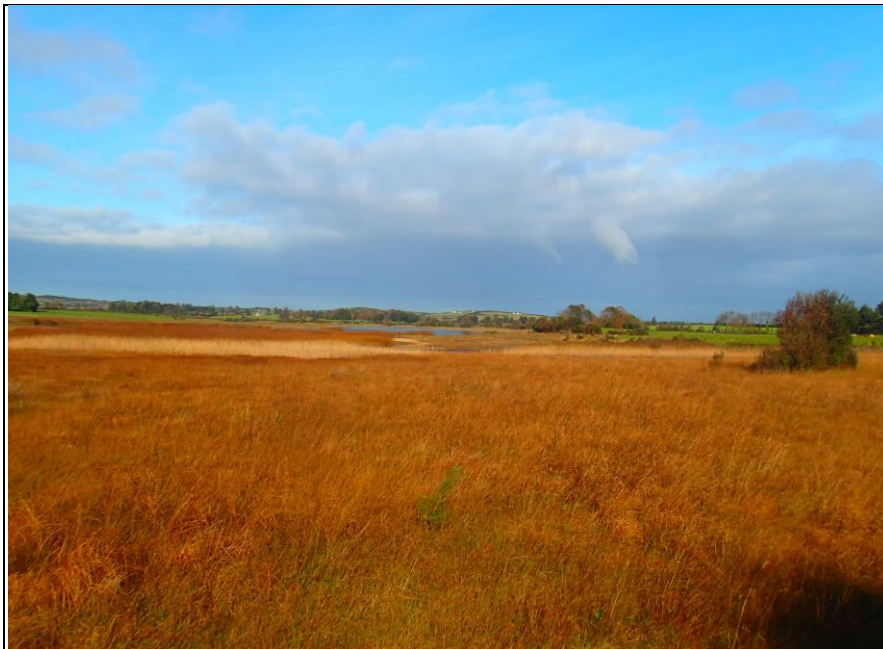
Raised peat in the main turlough depression, at the southeastern end of the turlough site.

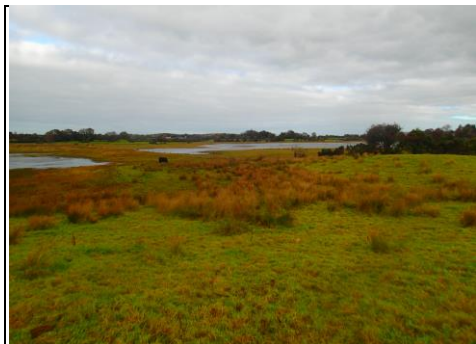
Curragh Lough, almost dry, September 2018.

Curragh Lough is similar in many ways and is in hydraulic continuity with Polleagh.

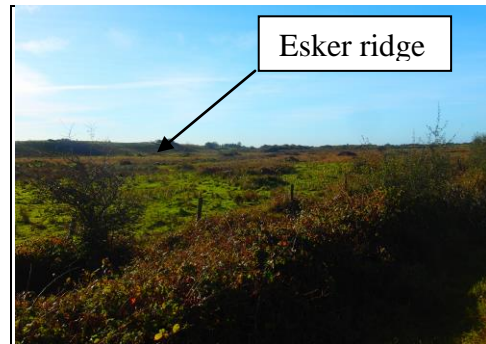
The esker at the eastern edge of the R360.

The turloughs site lies within a complex of low hills of glacial till, esker ridges and raised and valley peats, close to the Shannon - Corrib watershed. There are a number of small streams feeding surface water into the features, but no surface outflows.
