## TIPPERARY - COUNTY GEOLOGICAL SITE REPORT

NAME OF SITE	Tincurry Sink
Other names used for site	
IGH THEME	IGH1 Karst, IGH16 Hydrogeology
TOWNLAND(S)	Garrycloher
NEAREST TOWN/VILLAGE	Caher
SIX INCH MAP NUMBER	81
ITM CO-ORDINATES	602448E 622199N
1:50,000 O.S. SHEET NUMBER 74	GSI BEDROCK 1:100,000 SHEET NO. 22

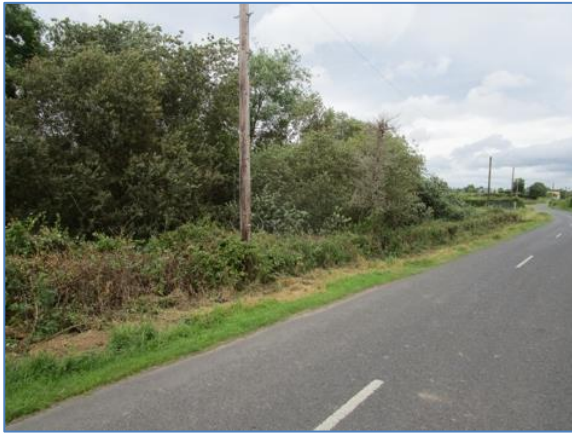
The main sink is in the trees.

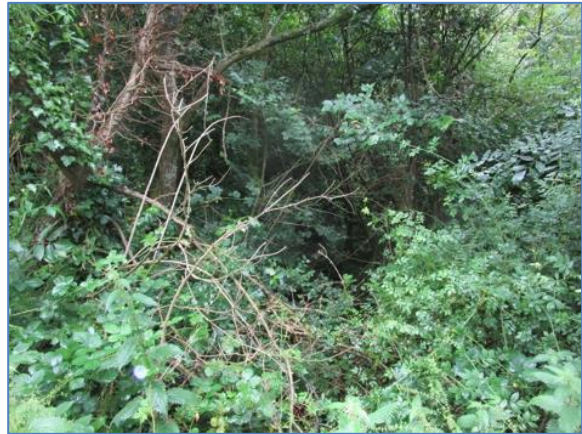
The main sink viewed from the roadside.

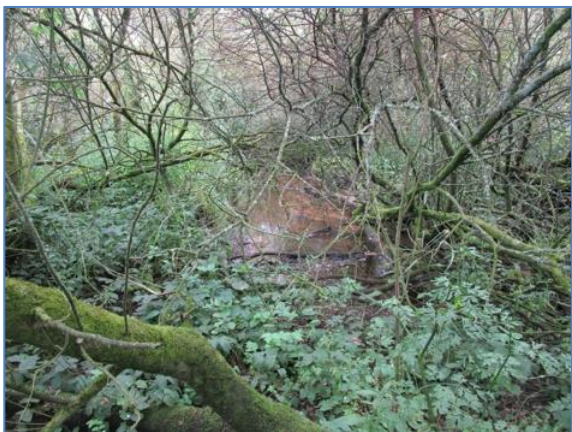
The main sink is spread along a stretch.

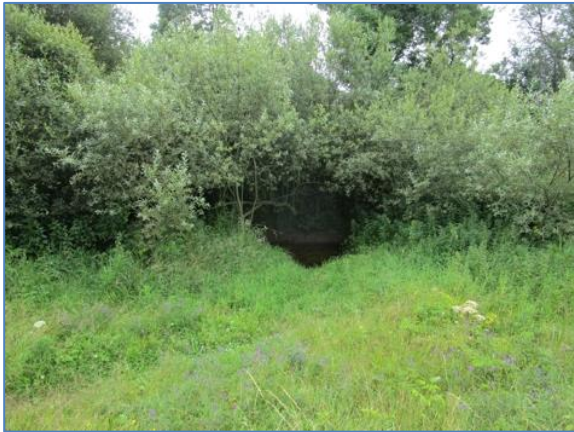
The stream bank at the northern part.

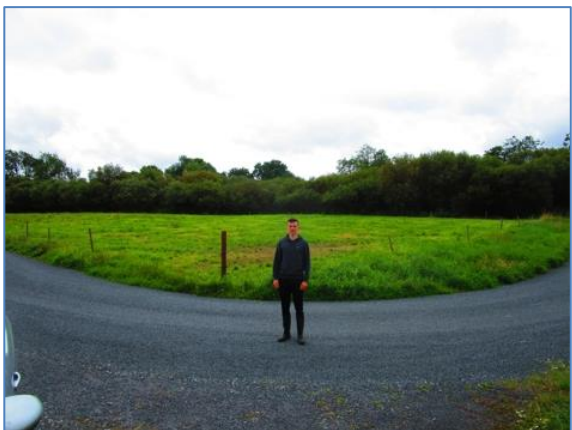
The sink stretch is along the visible trees.

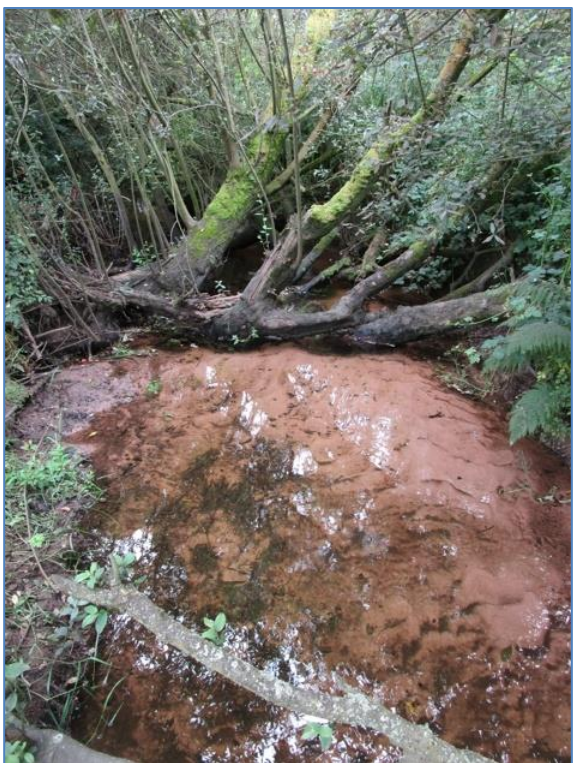
The sinking stream is heavily overgrown.
