# WESTMEATH - COUNTY GEOLOGICAL SITE REPORT

<b>NAME OF SITE</b>	<b>Dún na Sí Amenity and Heritage Park</b>
Other names used for site	Moate Cowpark, The Cow Park
<b>IGH THEME</b>	<b>IGH1 Karst, IGH7 Quaternary, IGH16 Hydrogeology</b>
<b>TOWNLAND(S)</b>	<b>Knockdomny, Tullaghnageeragh</b>
<b>NEAREST TOWN/VILLAGE</b>	<b>Moate</b>
<b>SIX INCH MAP NUMBER</b>	<b>30</b>
<b>ITM CO-ORDINATES</b>	<b>617415E 738810N (centre of turlough feature)</b>
<b>1:50,000 O.S. SHEET NUMBER</b>	<b>48 GSI BEDROCK 1:100,000 SHEET NO. 15</b>

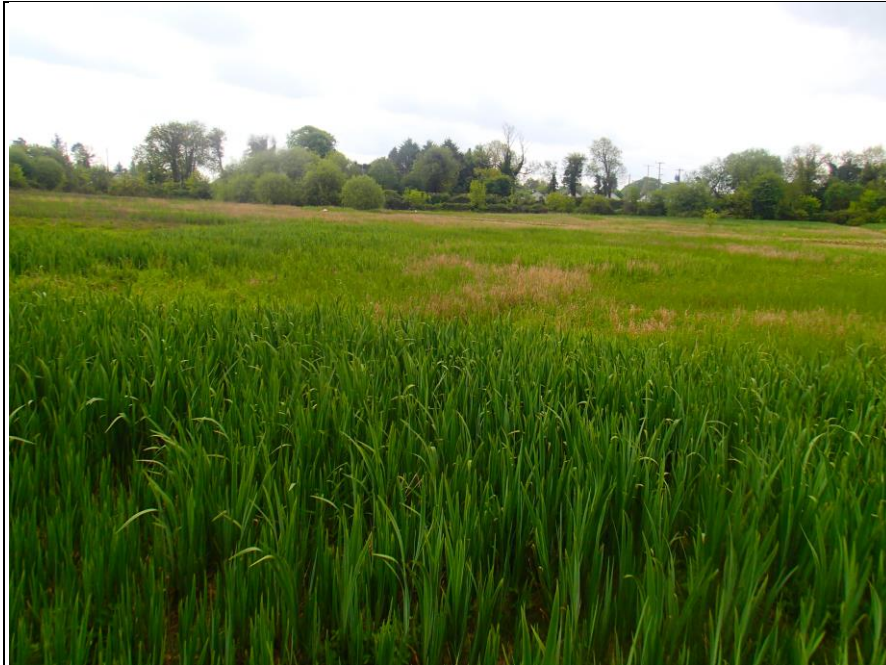
The turlough at Dún na Sí Amenity and Heritage Park, viewed from the northeast (dry, May 2018).

The turlough reflects the interaction of the groundwater table with the land surface, and is a seasonal lake. There is a well-defined estavelle feature at the centre of the turlough, where water emerges as a spring when the basin is beginning to fill, and where it disappears into a swallow hole when the basin is almost fully empty. There is no sign of bedrock outcrop exposed anywhere across the basin.

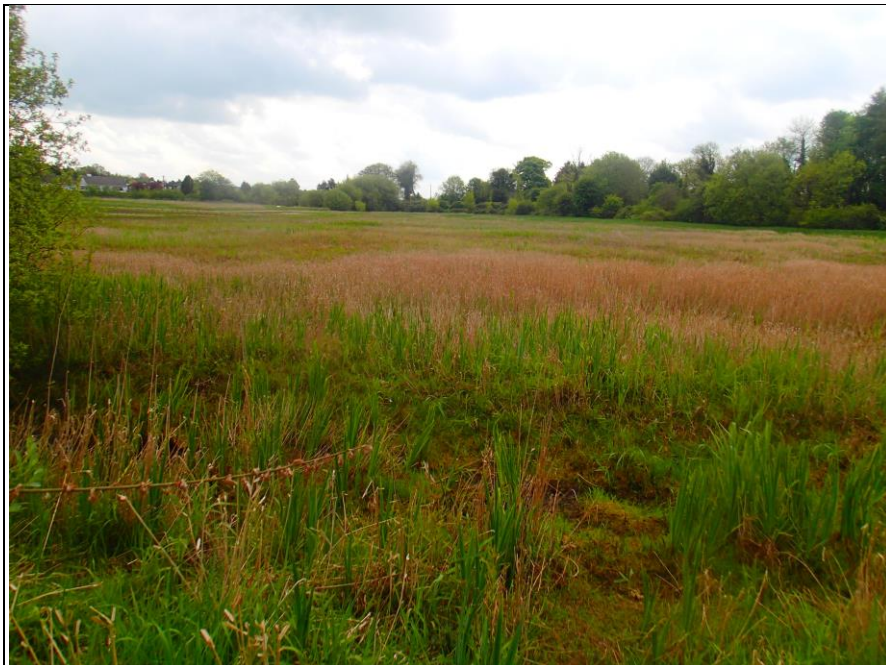
Looking southwards from where the springs emerge to fill the turlough (dry, May 2018).

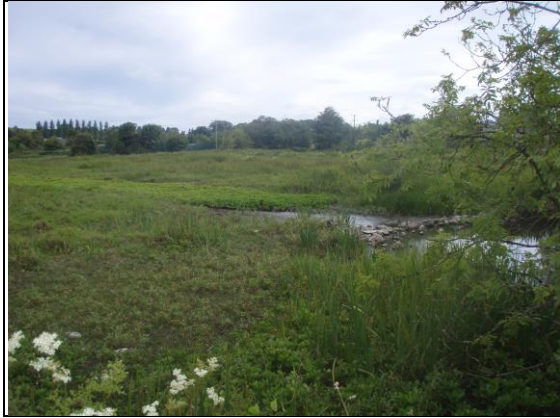
The turlough partially flooded, August 2010.
