WESTMEATH - COUNTY GEOLOGICAL SITE REPORT

NAME OF SITE	Lough Lom
Other names used for site	Lough Lum
IGH THEME	IGH1 Karst, IGH16 Hydrogeology
TOWNLAND(S)	Kilbalraherd, Mabrista, Benalbit and Derryroe
NEAREST TOWN/VILLAGE	Castletown Geoghegan
SIX INCH MAP NUMBER	32
ITM CO-ORDINATES	633950E 741290N (centre of feature)
1:50,000 O.S. SHEET NUMBER	48 GSI BEDROCK 1:100,000 SHEET NO. 15

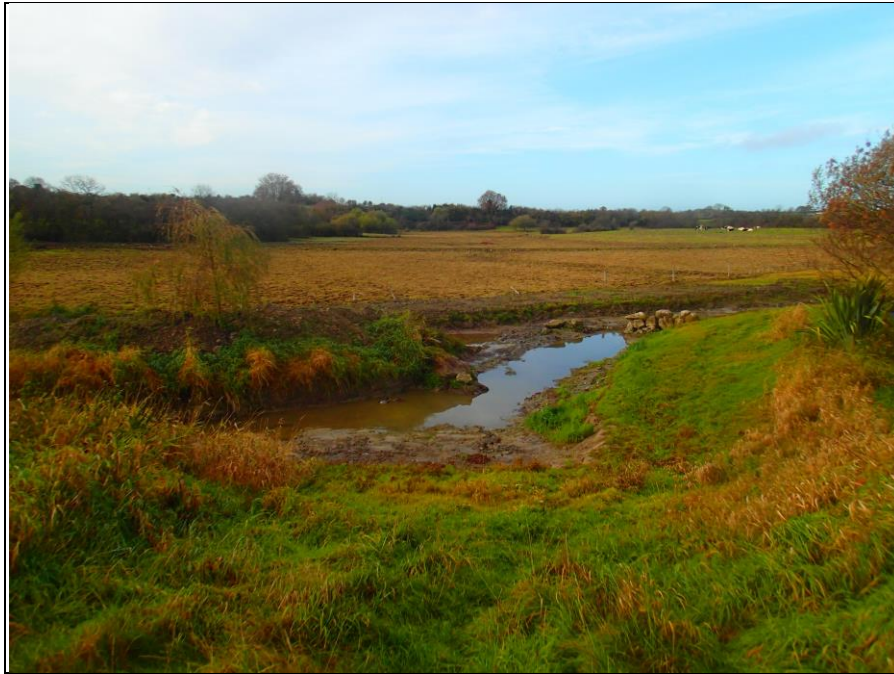
The (dry) turlough at Lough Lom, November 2018. Some recent drainage works have been completed, in the foreground.

Issues such as cattle encroachment and soil disturbance of the margins, and agricultural drainage attempts may also cause problems. The hollows around the turlough site should not be used as dumping grounds, as this may affect the hydrology of the locality and mean that flood levels get higher as climate change ensues.

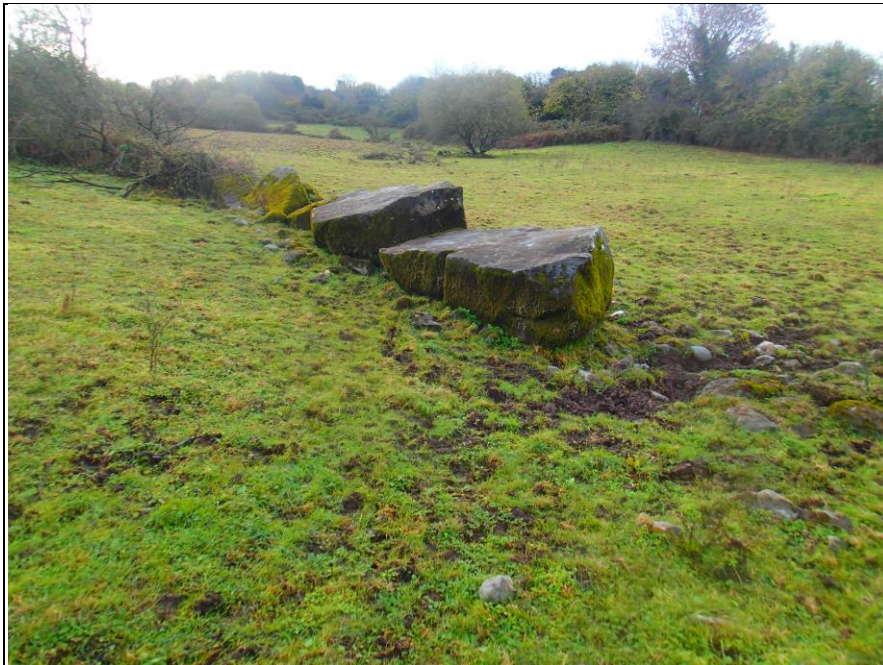
Large, moss covered boulders at the western end of the feature, with moss showing the flooded water level.

The feature reflects the interaction of the groundwater table with the land surface, and is a seasonal lake. There are many erratics of pure limestone around the base of the turlough, many of which are moss covered up to a certain elevation. Such moss provides a watermark which allows an approximation of the high water level when the turlough is in flood to be gleaned.

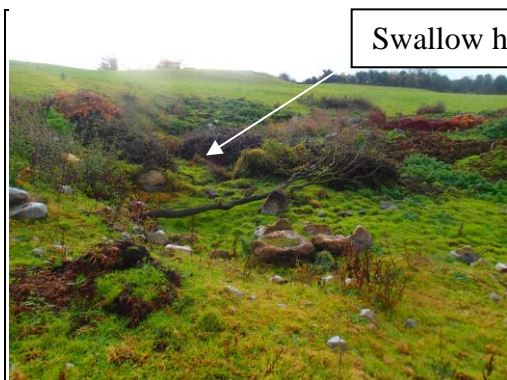
Swallow hole

The swallow hole at the southern end of the feature.

A marked swallow hole occurs at the southern end of the feature, and the hollow may also fill from this locality, but the exact process of empty and fill of the turlough feature remains to be observed and documented fully.

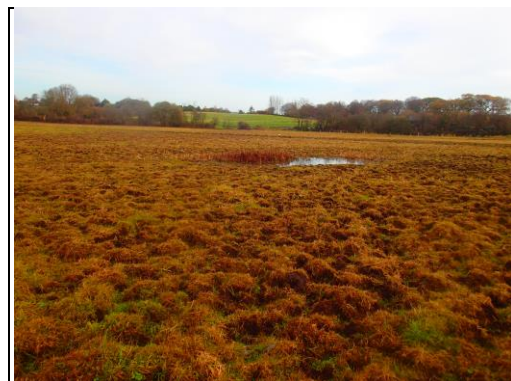
Small pond in the centre of the turlough.
