## WICKLOW - COUNTY GEOLOGICAL SITE REPORT

<b>NAME OF SITE</b>	<b>Sroughmore</b>		
Other names used for site			
<b>IGH THEME</b>	<b>IGH15 Economic Geology</b>		
<b>TOWNLAND(S)</b>	<b>Sroughmore</b>		
<b>NEAREST TOWN/VILLAGE</b>	<b>Avoca</b>		
<b>SIX INCH MAP NUMBER</b>	<b>35</b>		
<b>NATIONAL GRID REFERENCE</b>	<b>720658E 684158N</b>		
<b>1:50,000 O.S. SHEET NUMBER</b>	<b>62</b>	<b>GSI Bedrock 1:100,000 Sheet No.</b>	<b>16</b>

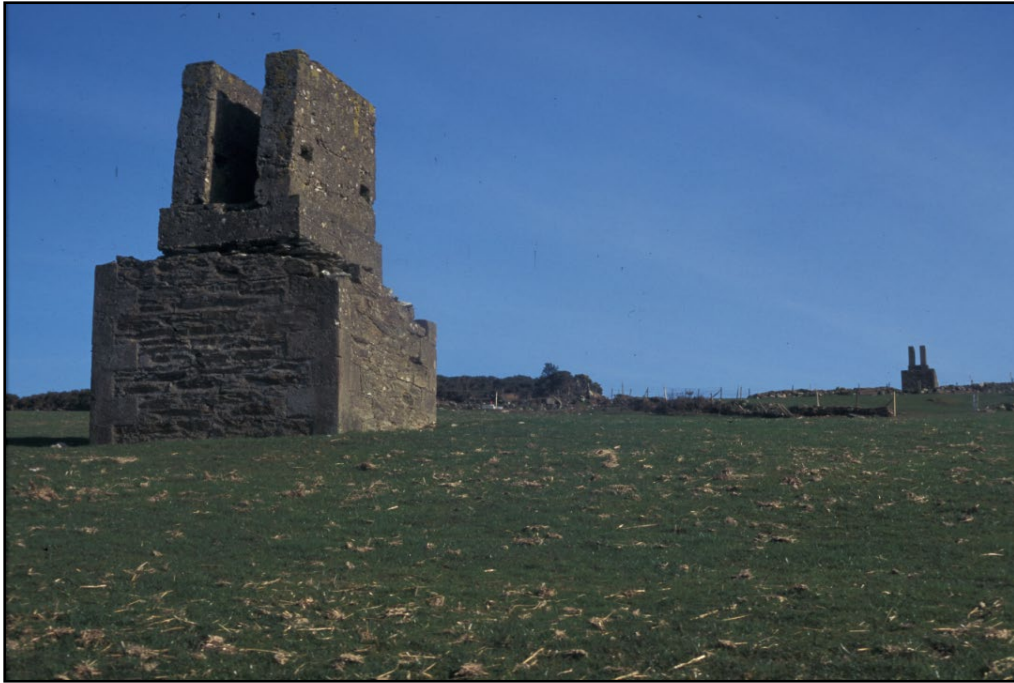
Ropeway support at Sroughmore. Second structure visible in background. View to east.

Sroughmore contains two concrete structures that are the remains of a 19<sup>th</sup>-century aerial ropeway constructed to pump water from Connary mine. A third structure, overturned and damaged, is located inside the Connary site itself. The ropeway was apparently powered by a turbine at Sroughmore old glebe house and ran c. 1.5 km to Connary engine shaft. As a pumping mechanism however, the ropeway was a failure. Similar pylon-type structures were used in Tigroney to transmit power via cables linked to water wheels on the Avoca River but there are no remains of these. For this reason, the structures at Sroughmore are valuable evidence for various mine engineering approaches in the 18<sup>th</sup> and 19<sup>th</sup> centuries.

The ropeway support structures are of interest because they help demonstrate the variety of mine engineering approaches adopted at Avoca.
