# WICKLOW - COUNTY GEOLOGICAL SITE REPORT

<b>NAME OF SITE</b>	<b>Glendasan - Ruplagh</b>		
Other names used for site			
<b>IGH THEME</b>	<b>IGH15 Economic Geology</b>		
<b>TOWNLAND(S)</b>	<b>Brockagh, Sevenchurches or Camaderry</b>		
<b>NEAREST TOWN/VILLAGE</b>	<b>Laragh</b>		
<b>SIX INCH MAP NUMBER</b>	<b>17</b>		
<b>NATIONAL GRID REFERENCE</b>	<b>709213E 699473N</b>		
<b>1:50,000 O.S. SHEET NUMBER</b>	<b>56</b>	<b>GSI Bedrock 1:100,000 Sheet No.</b>	<b>16</b>

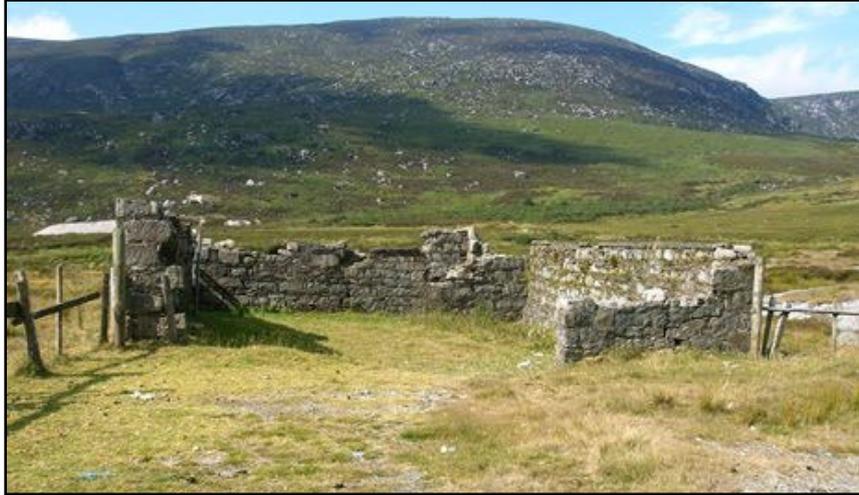
Mine building at Ruplagh.

The Ruplagh site is most remarkable for an abundance of extant if collapsed shafts and adits. Among several ruined mine buildings the most impressive of them appears to be an engine-house ruin, now consisting of exterior and interior stone walls and a well preserved wheel pit. The highest wall is 2.5 m high. This building is now part of a farm enclosure and is used as a sheep shelter. Solid waste on the site is typical of the district but is not very extensive - in part this reflects the fact that most of the material produced at Ruplagh was processed at the Old Hero Processing site further down the valley.

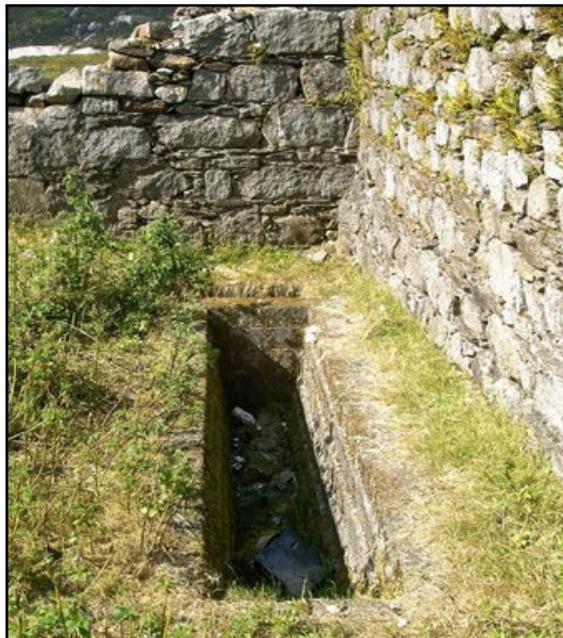
Wheel pit in mine building at Ruplagh..

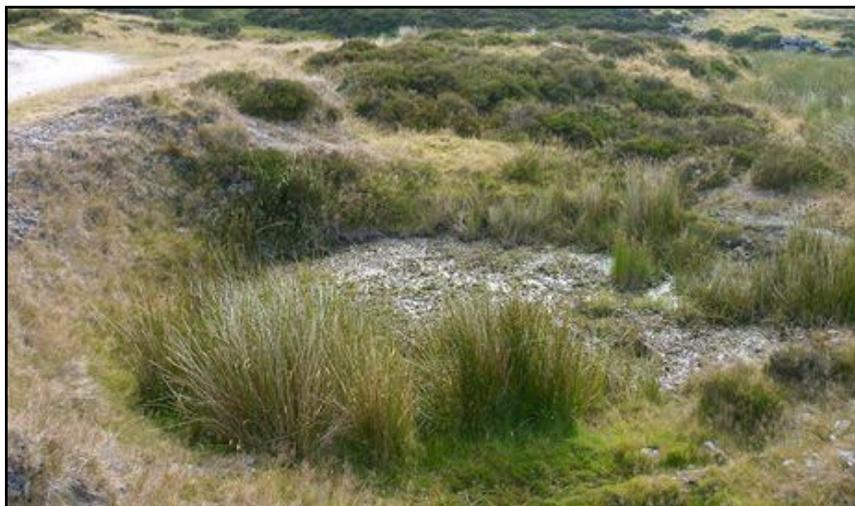
New Engine Shaft at Ruplagh.

The site is less well known than others in the district owing to its remoteness. Numerous unfenced shafts and adits are potential safety issues in the context of promotion of the site to the general public.
