## WICKLOW - COUNTY GEOLOGICAL SITE REPORT

<b>NAME OF SITE</b>	<b>Tober Demesne</b>
Other names used for site	The Fish Pond, Gormanstown Group Water Scheme
<b>IGH THEME</b>	<b>IGH16 Hydrogeology</b>
<b>TOWNLAND(S)</b>	<b>Tober Demesne</b>
<b>NEAREST TOWN/VILLAGE</b>	<b>Dunlavin</b>
<b>SIX INCH MAP NUMBER</b>	<b>15</b>
<b>NATIONAL GRID REFERENCE</b>	<b>688527E 703350N (centre of 'fish pond')</b>
<b>1:50,000 O.S. SHEET NUMBER</b>	<b>56 GSI Bedrock 1:100,000 Sheet No.</b>

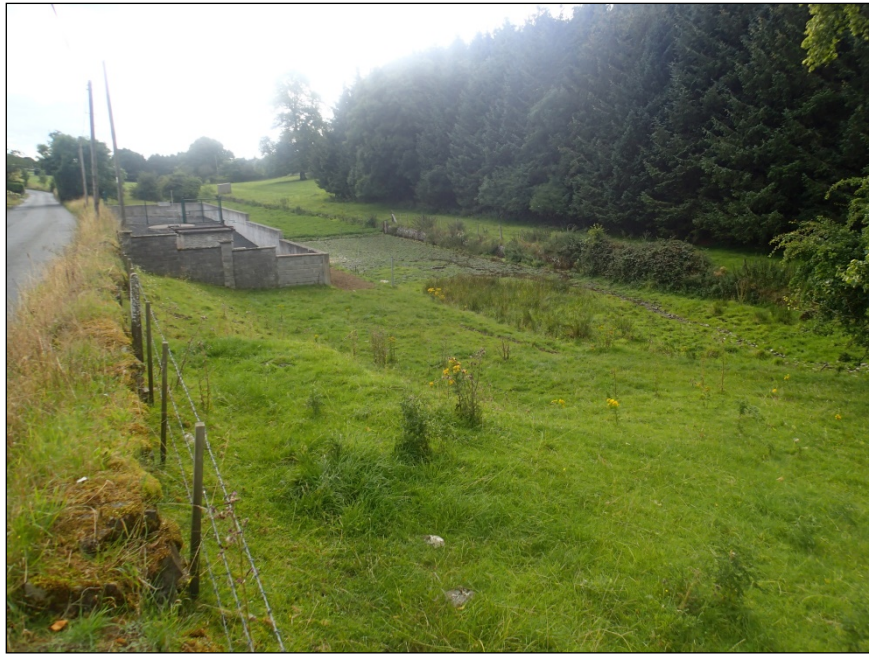
The 'fish pond', viewed from the road at the northeast.

The site is securely fenced off within its own compound, and the 'fish pond' is surrounded by a concrete chamber. Being a secure water supply vulnerable to contamination the general promotion of the locality is not recommended. General education about the vulnerability of 'spring' groundwater supplies to pollution from septic tanks and agricultural slurry spills and bad spreading practices is highly advisable.

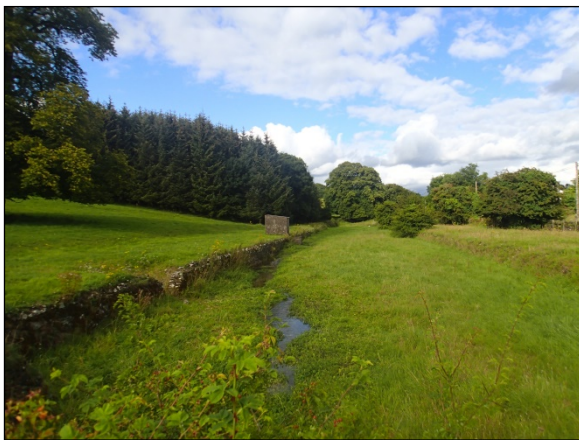
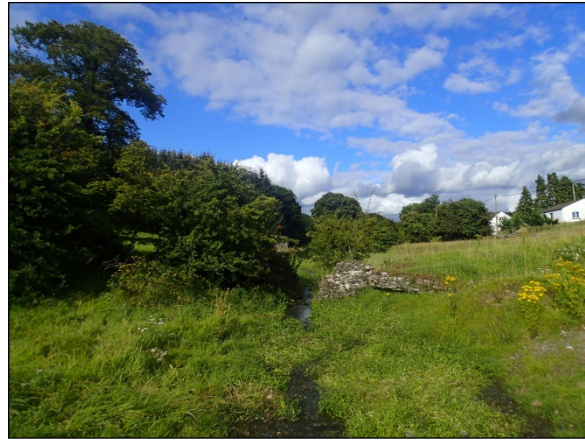
The water emerging through the fish pond (left), and flowing past the ruined church (right).

At Tober Demesne a spring emerges from deep glaciofluvial gravels and flows into a man-made 'fish pond' feature, before flowing away from the site as a fast-flowing stream. The water supply for much of the area inside the Kildare county boundary to the northwest of the site (the 'Gormanstown Usk' group scheme groundwater supply), is extracted from a shallow borehole at the site, which is adjacent to the spring.

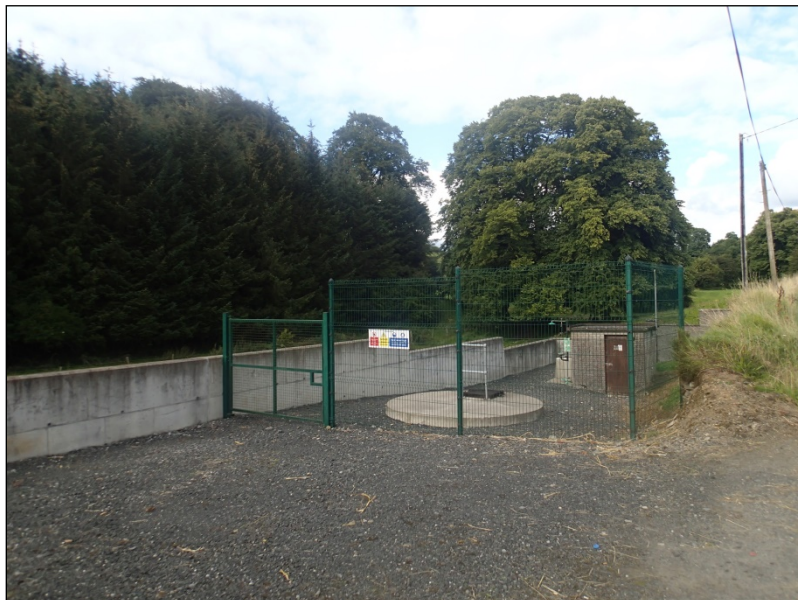
Overview of the Gormanstown Usk Group Water Scheme, viewed from the adjacent road.

The Gormanstown Group Water Scheme abstracts 300 m<sup>3</sup> per day (66,000 gallons per day) from a borehole located beside a high yielding spring. The spring (and borehole) is fed by a locally important sand and gravel aquifer. Almost 3,000 m<sup>3</sup> of water per day has been measured to flow out of the spring.
