HERBERSTOWN PUBLIC SUPPLY
GROUNDWATER SOURCE PROTECTION ZONES

Jenny Deakin
Groundwater Section
Geological Survey of Ireland

December 1995

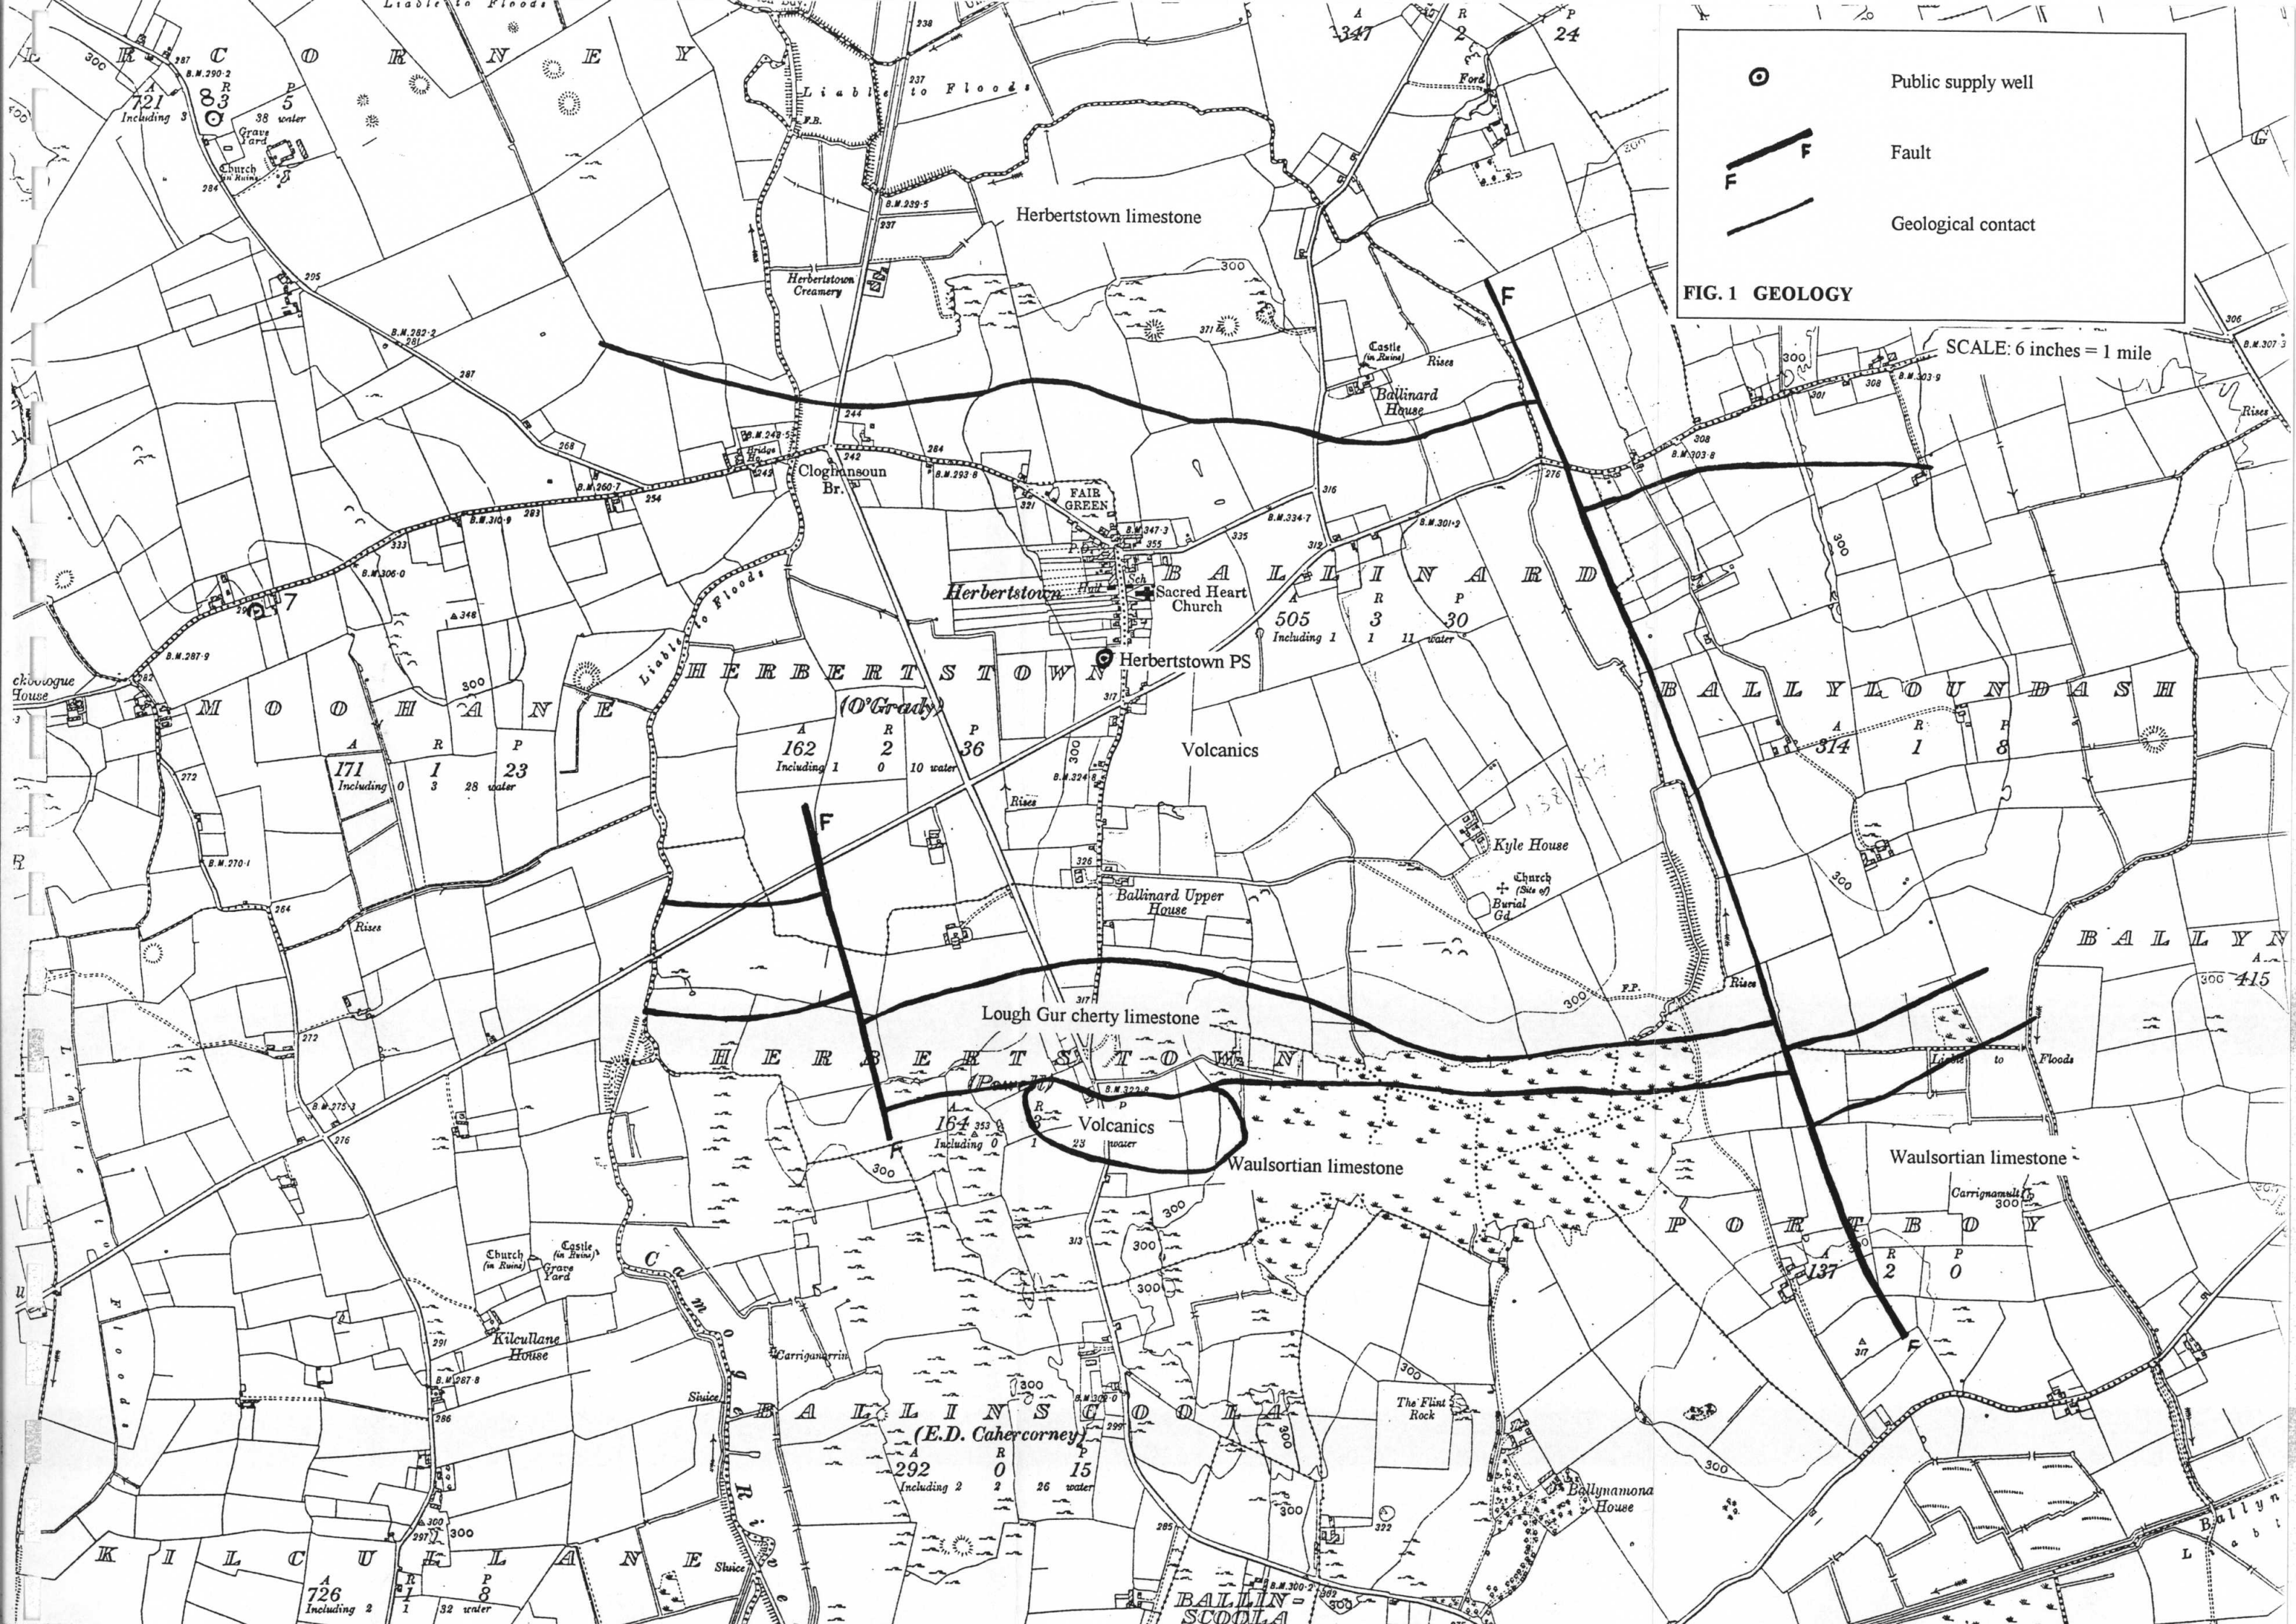
FIG. 1 GEOLOGY

The area has been mapped in detail by a number of geologists and as there is good bedrock exposure (Fig. 1) there is a high level of confidence inherent in the geology map. Herbertstown village lies within an east-west trending band of intermediate felsic volcanic rocks, which are the oldest volcanics cropping out in the Limerick Syncline. The rocks comprise purple-grey, brown-grey and grey lavas, tuffs and volcanoclastics. To the south, the underlying typically blue-grey, massive Waulsortian bank limestones crop out. The upper beds of these limestones are more cherty than the typical bank limestones and they have been mapped out separately by some geologists as a separate formation; they are referred to here as the Lough Gur cherty limestones. The rocks to the north of the volcanics, known as the Herbertstown Limestones, are younger, and are oolitic shelf limestones with some shale and chert in places. The sequence is orientated east-west and dips to the north at 5–45°. A NNE-SSW fault trends through the small stream valley to the east of the source and there may be associated fracture sets with it. Jointing is common, predominantly vertical, in a north-south trend while there is also a weaker east-west subvertical set.

Based on the depth of the well and simple trigonometry it would appear that the well only penetrates the volcanic sequence. The area is faulted and fractured however, and there may therefore be limestones either faulted in or interbedded with the volcanics at depth.

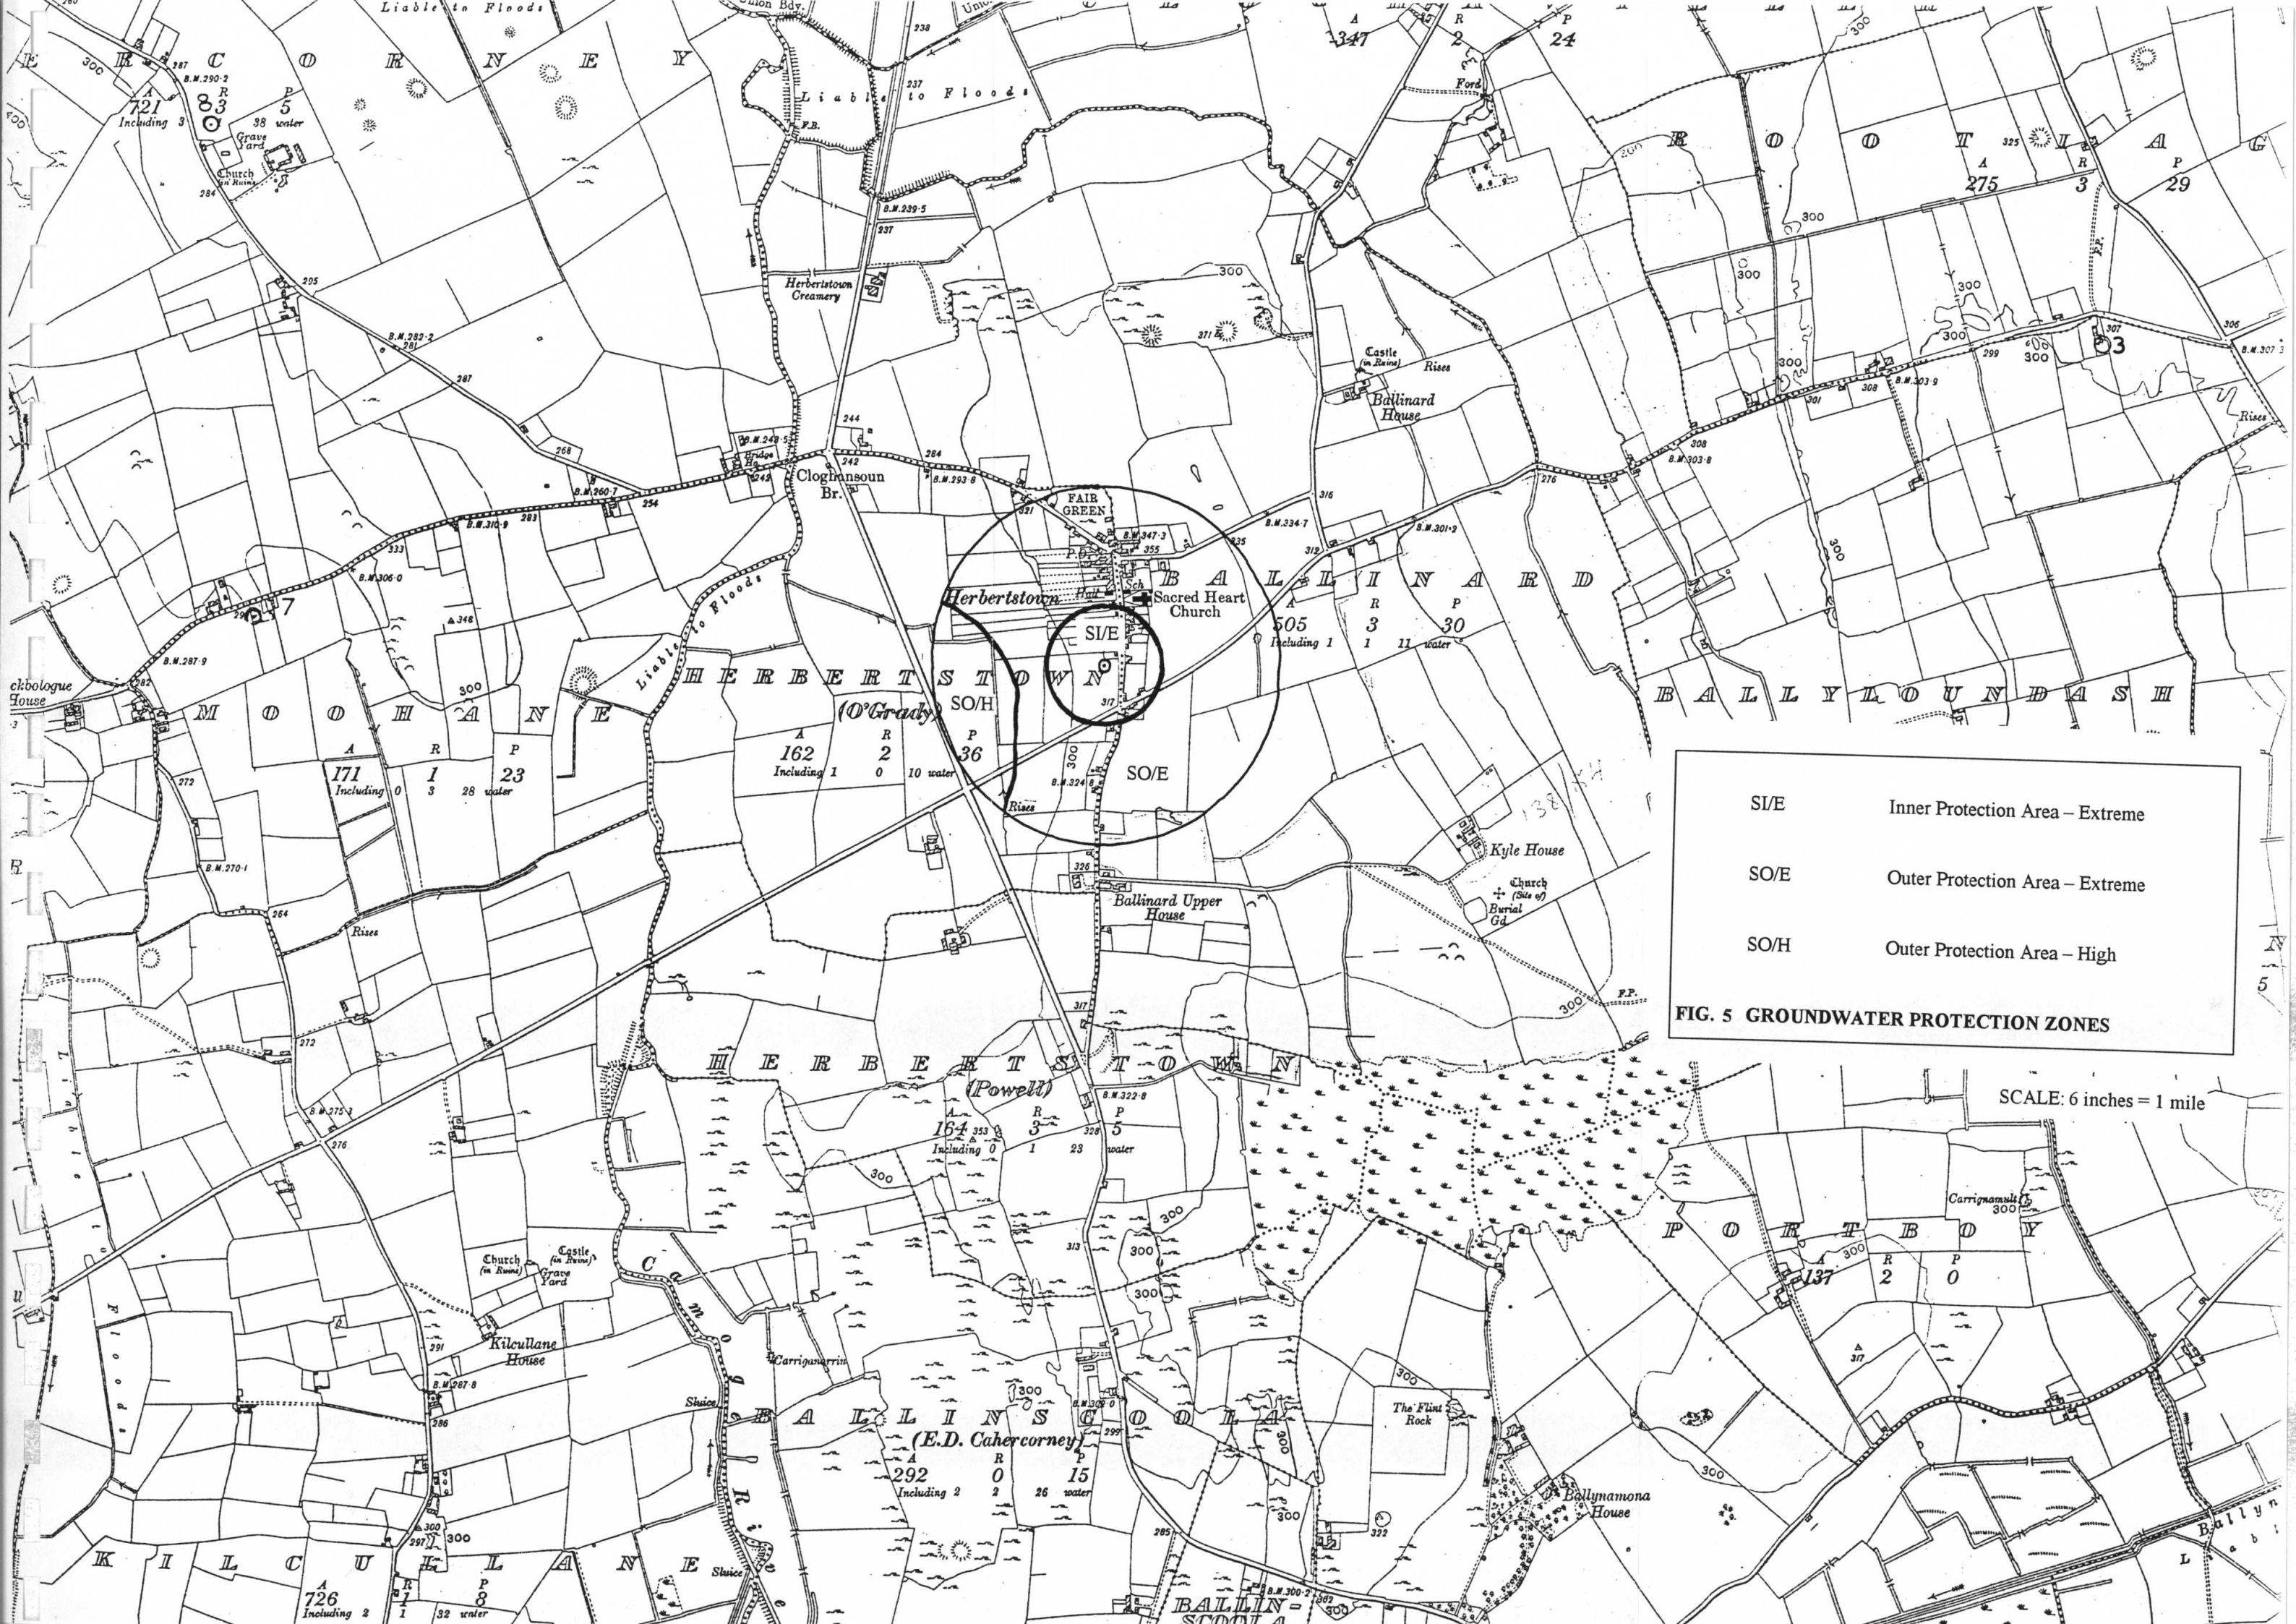
Combining the Source Protection Areas, as described above, with the vulnerability ratings, delineates a total of four groundwater source protection zones for the Herbertstown source. These are listed here in order of decreasing degree of protection required and are shown in Figure 6 (with the exception of the Source Site):

- Source Site / Extreme (SS/E)
- Inner Protection Area / Extreme (SI/E)
- Outer Protection Area / Extreme (SO/E)
- Outer Protection Area / High (SO/H)
