Pyrrhotite-bearing concrete investigation, Co. Donegal

Laboratory Analysis Services in support of Geological Survey
Ireland's "Irish Construction Materials" Project: Concrete
Products

Phase 1 Report

1283831-01 (02)

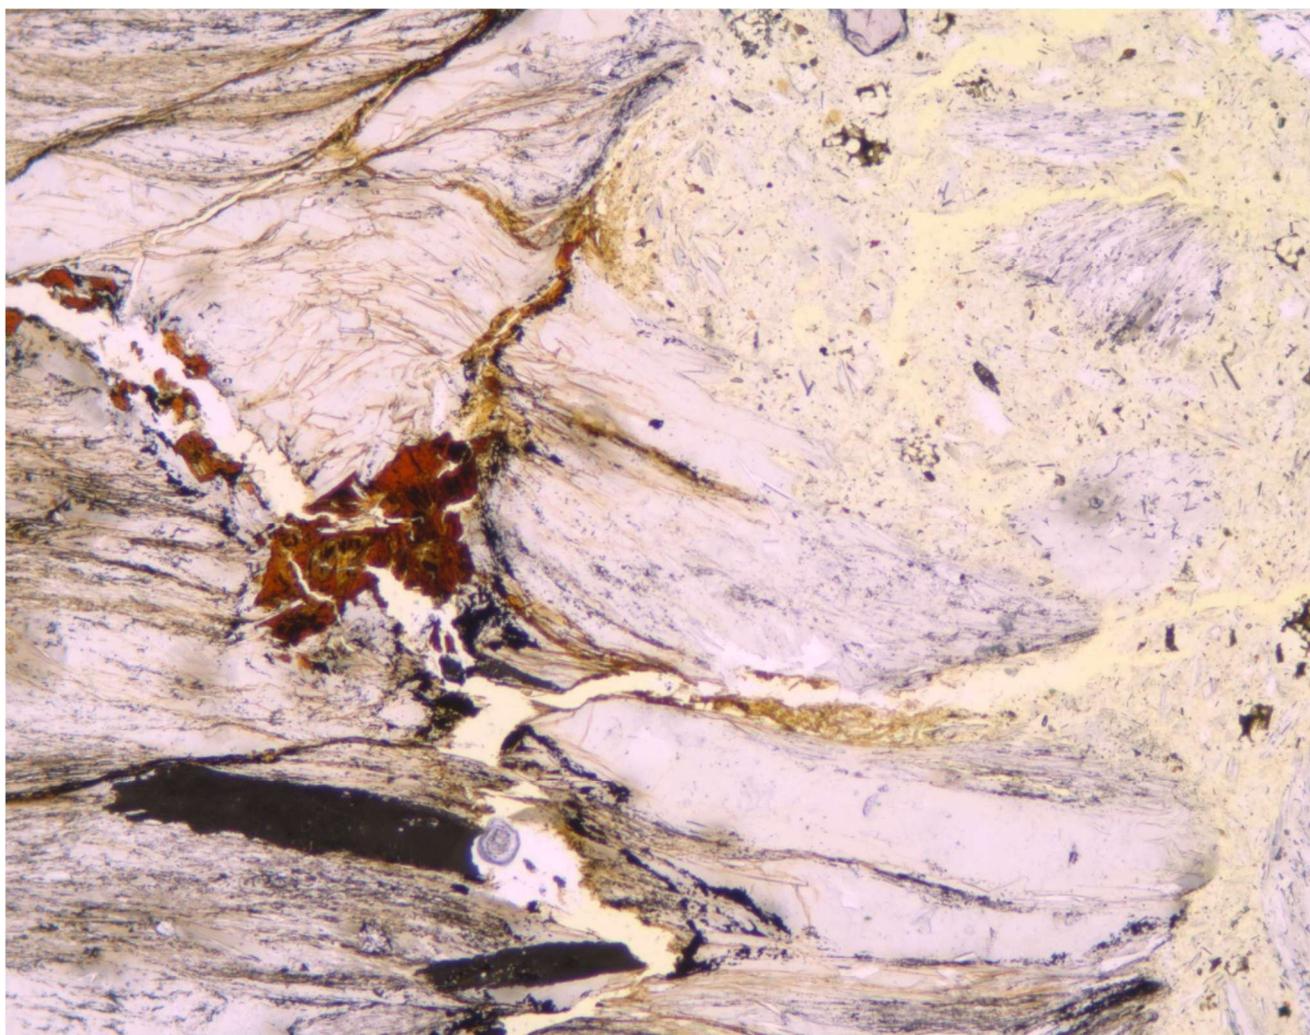
Sample 20511/B11 Polished thin section showing oxidation of sulfides and evidence of expansion caused by internal sulfate attack.

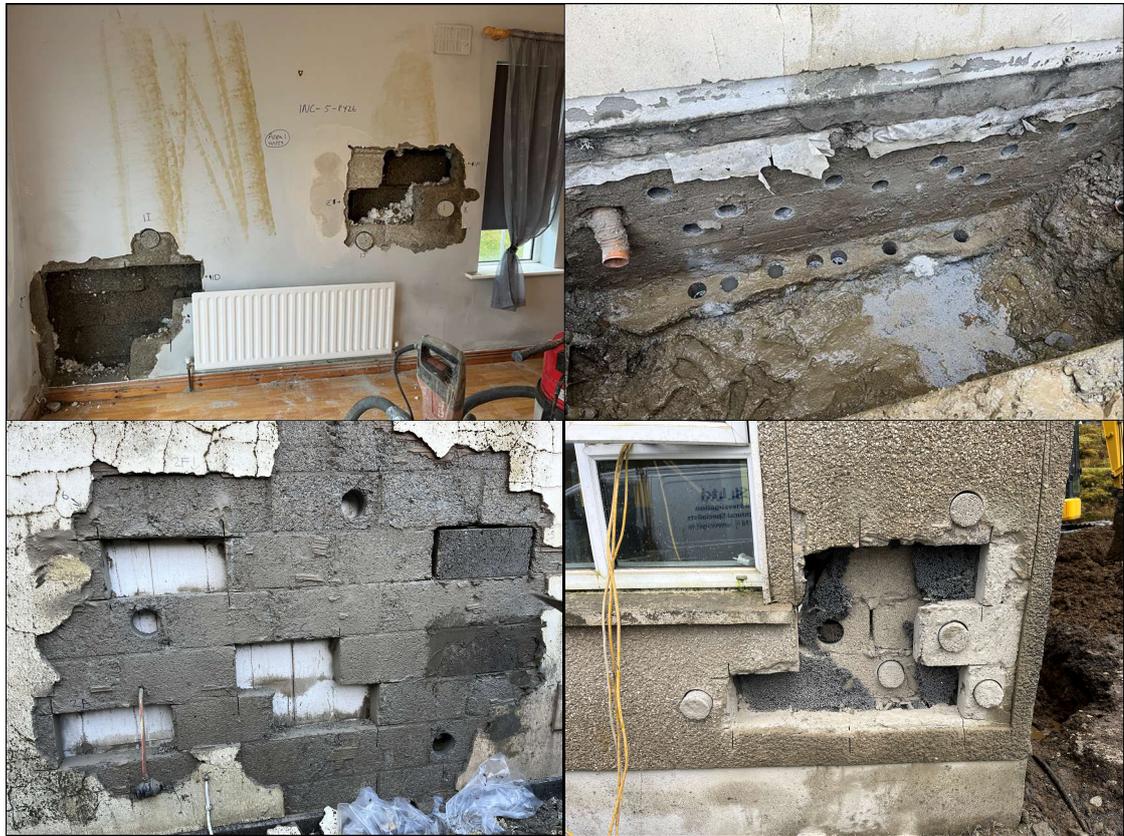
Figure 2-1 Examples of sampling areas

1st Row Left – 7MV inner leaf sampling location. 1st Row Right – 21GD rising wall and foundation sampling location. 2nd Row Left – 28AW An outer leaf sampling location. 2nd Row Right – C outer leaf sampling location. Photos taken from IGSL Sampling Reports. Source IGSL.

A selection of blocks and cores were extracted from the inner leaf, outer leaf, rising wall (where possible) and strip foundation building elements. Core samples were taken by coring rigs using approximately 100 mm inner diameter barrels. Trial pits were excavated with a digger to expose the foundations and rising walls (see **Figure 2-1**). More details of the sampling can be found in the sampling report and **Appendix B**.¹³

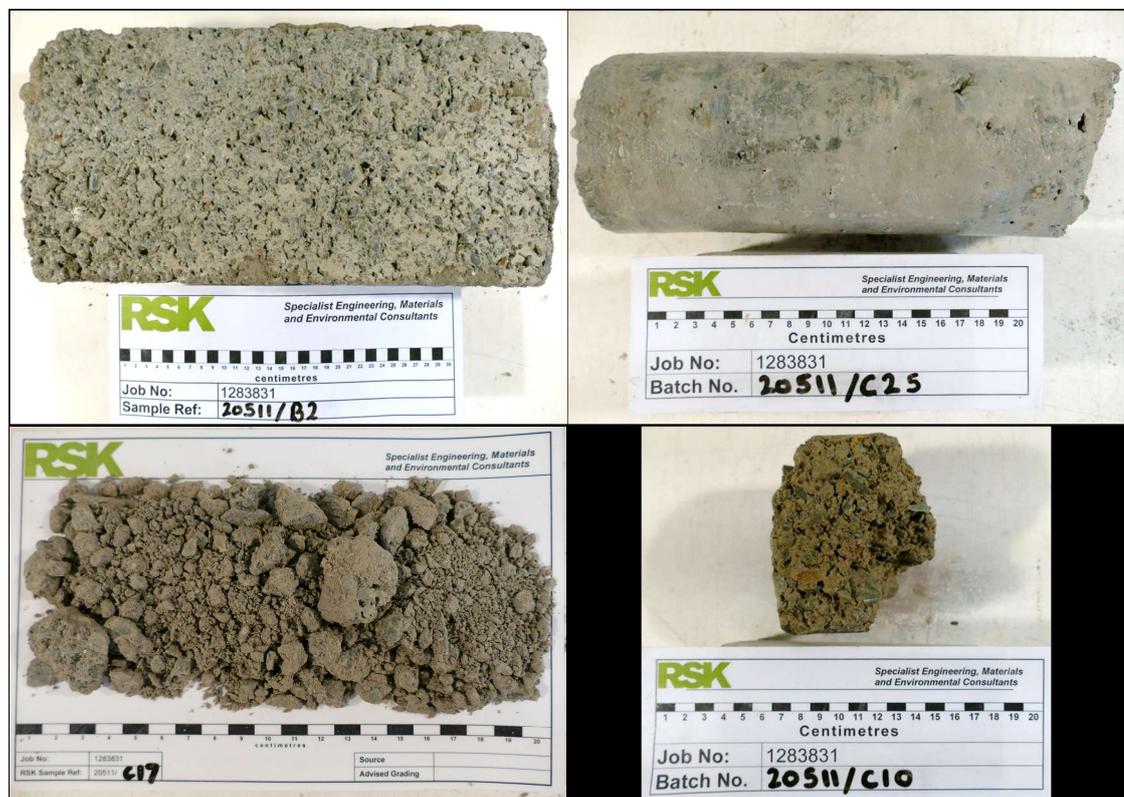
Figure 3-1 Examples of as-received samples

PHOTOS of a variety of as-received sample types and conditions from across all four properties. 1st Row Left, 7MV IL intact. 1st Row Right, 21GD RW intact. 2nd Row Left, 28AW OL disintegrated. 2nd Row Right, C F fragmented. For references see Table 3-1.
