Environmental Protection Agency

Establishment of Groundwater Source Protection Zones

Kilcoran Group Water Scheme

November 2010

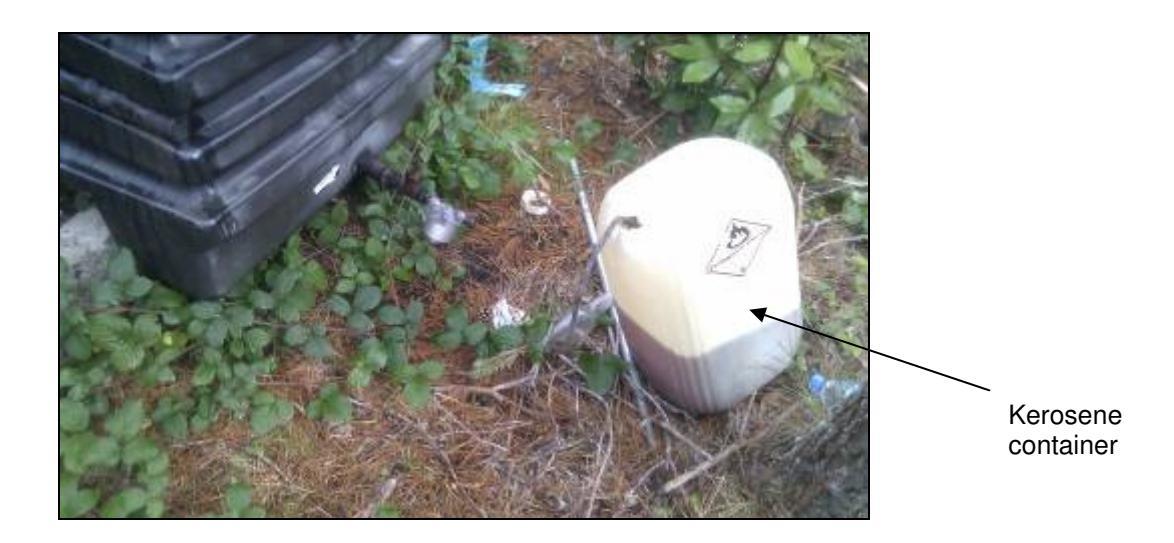
A heating oil fuel storage tank for the adjacent private dwelling is located 10 meters up hydraulic gradient of the borehole (Photograph 2). While the tank is in good repair and constructed of polyethylene, the fuel line runs under ground to the dwelling. During the site inspection it was noted that line had been disconnected and kerosene was observed in a 25 litre plastic container beside the tank (Photograph 3). It is assumed that this was used to collect kerosene from the line when it was being disconnected. The disconnected fuel line and storage of kerosene in a non-secure container presents a serious risk of contamination of the water supply.

Borehole
