# **BALLINSPITTLE / GARRETTSTOWN WATER SUPPLY SCHEME**

## **GROUNDWATER SOURCE PROTECTION ZONES**

**Denise Kelly & Geoff Wright**  
**Groundwater Vulnerability Mapping by Una Leader**  
**Groundwater Section**  
**Geological Survey of Ireland**

**Revised May 2002**

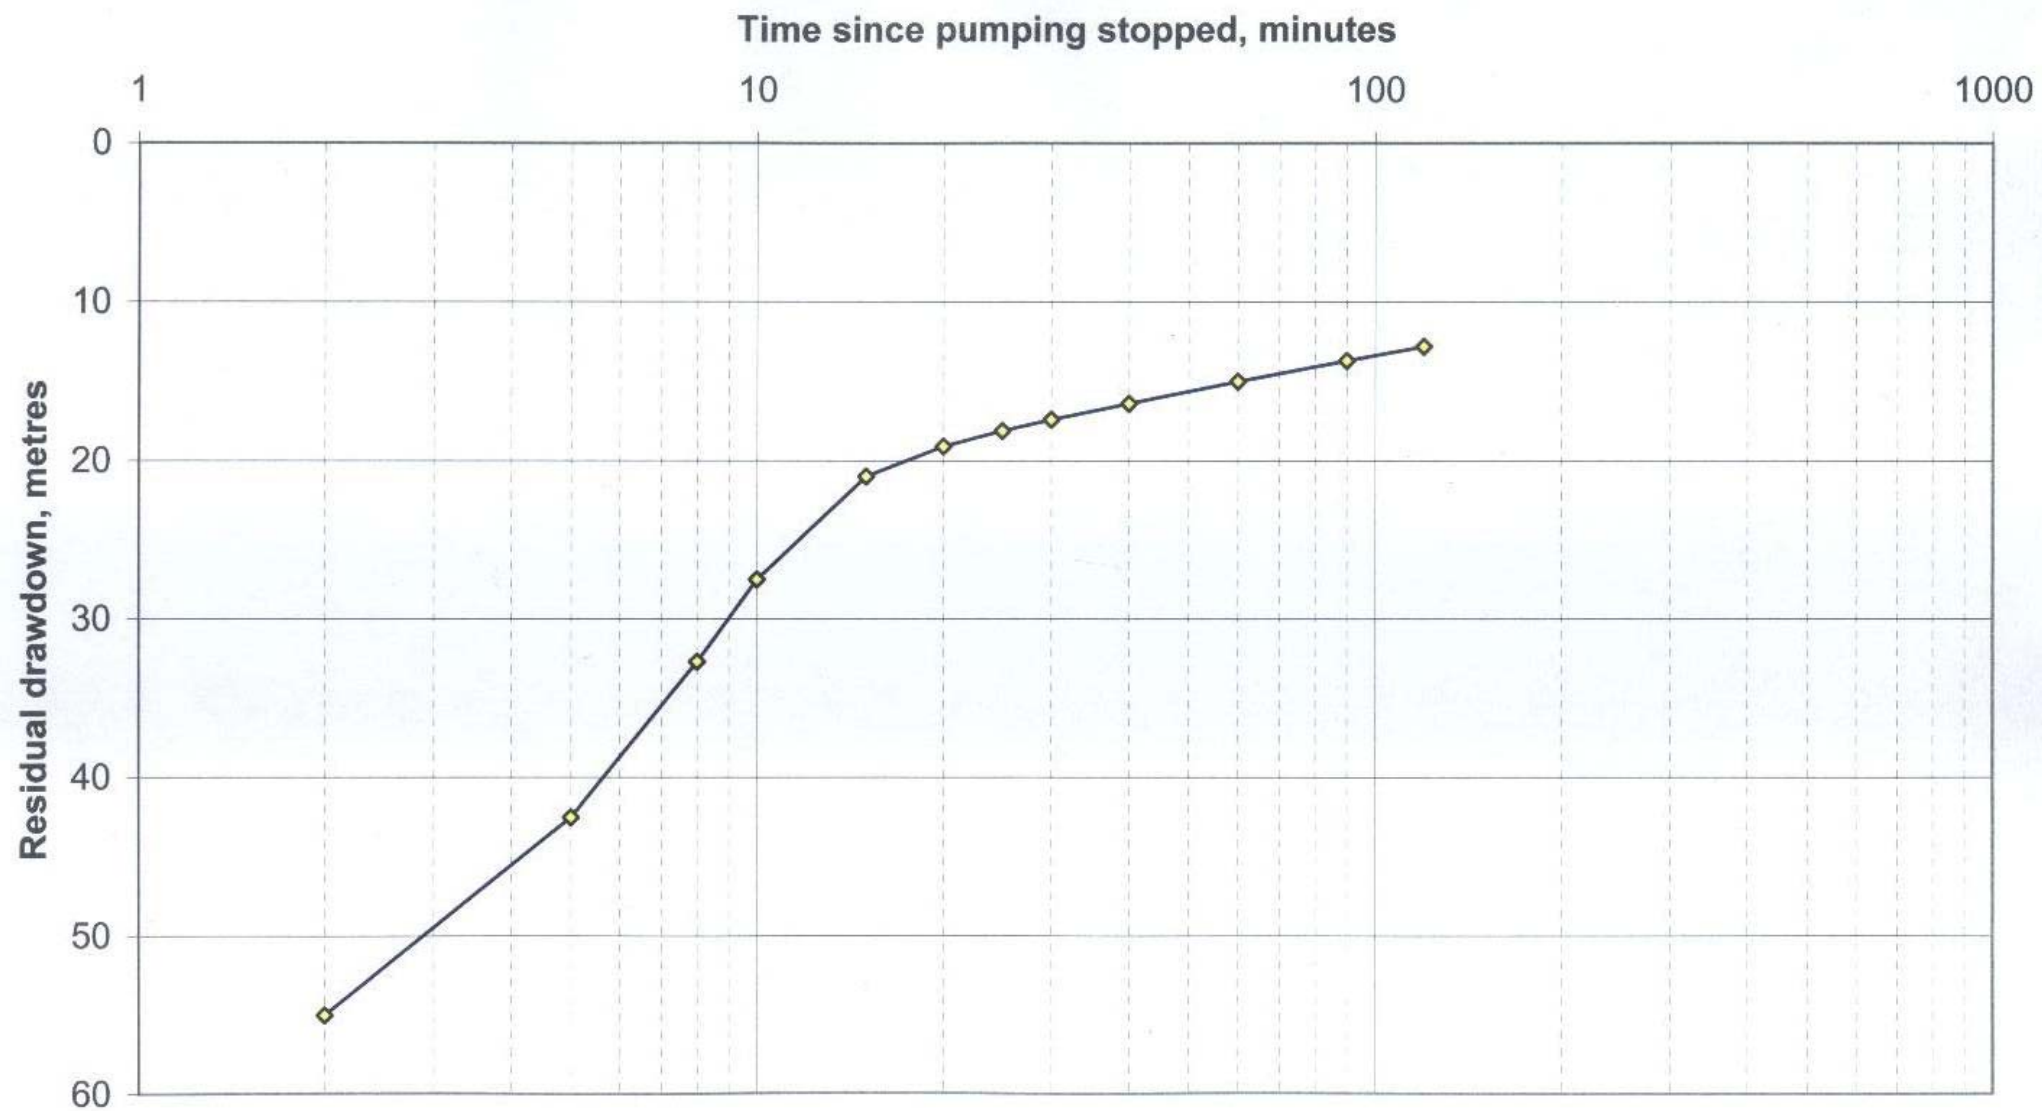
# Ballinspittle, Pumping Test 26/5/92

## Recovery Data

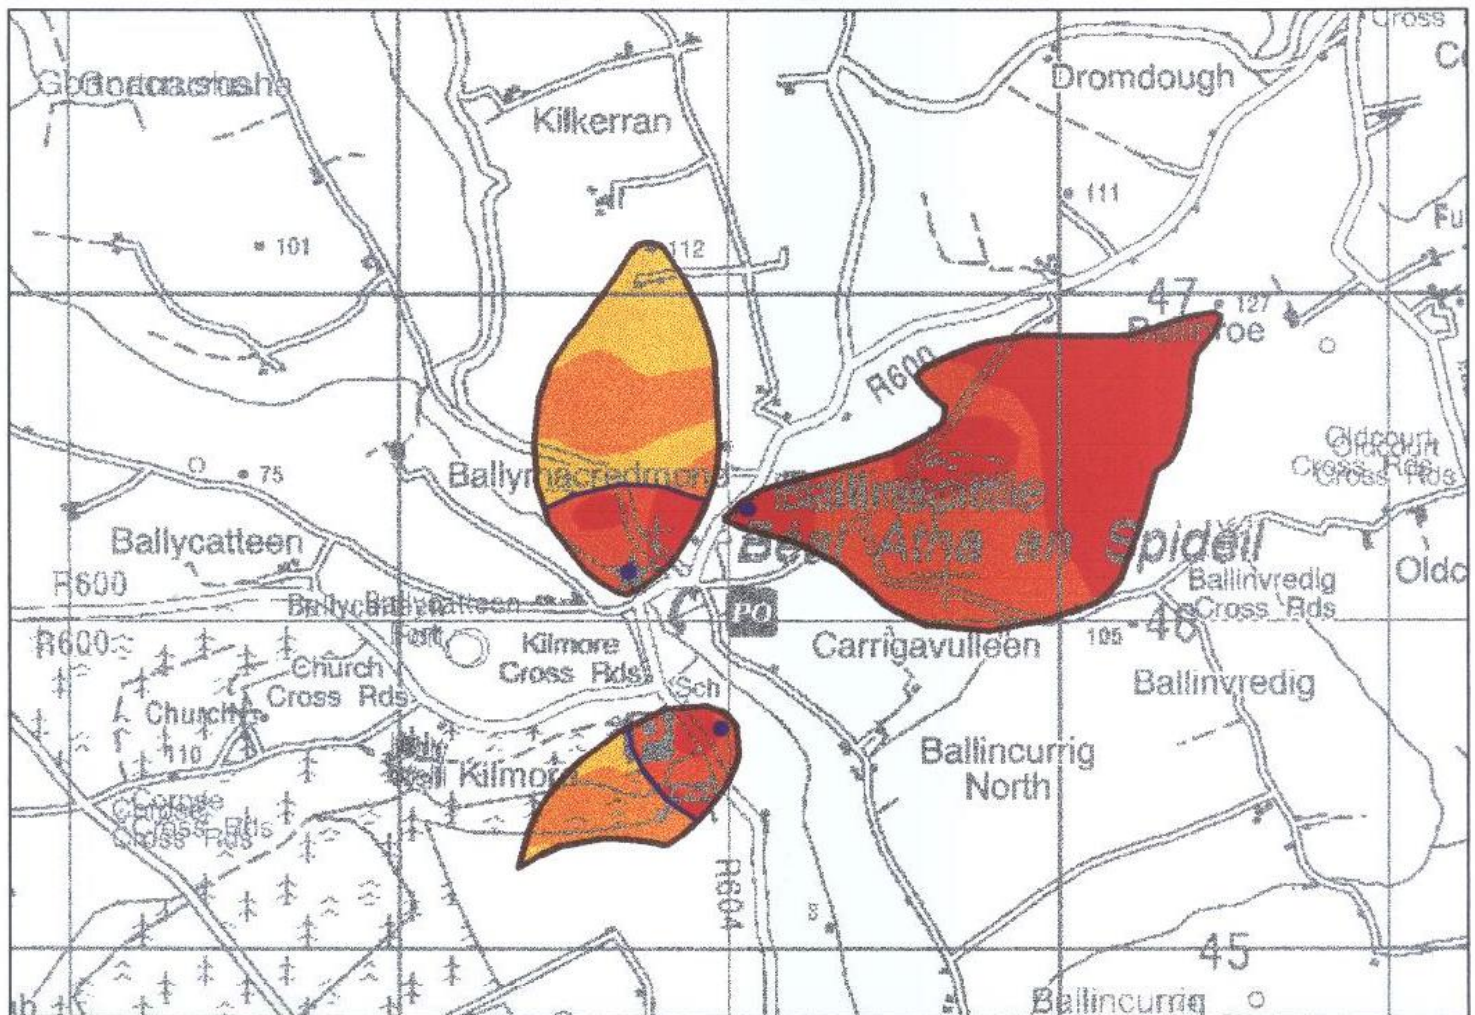
## Ballinspittle Water Supply Scheme

### Map 3. Source Protection Zones

Permeability values for the aquifer around this source were derived from pumping test data (see Section 8.2). This estimate of permeability (0.4 m/d) is an average over the effective 35 m depth of the aquifer. It is assumed that the upper few metres of bedrock will be more permeable, particularly as groundwater will have flowed over time towards the valley creating weathered, fissured zones in these upper levels. Therefore, for the purpose of protecting an inner zone, a high permeability (representative of the zone of greatest and fastest flow) must be taken into account to give maximum protection to the borehole. Therefore, a permeability of 1 m/d was used to estimate the 100 day time of travel zone distance to the well. Using an effective porosity value of 0.02 and a groundwater gradient of 0.06, the 100 day time of travel distance to the well is estimated at 300 m (see Map 3).
