# **CORK - COUNTY GEOLOGICAL SITE REPORT**

NAME OF SITE Other names used for site IGH THEME TOWNLAND(S) NEAREST TOWN/VILLAGE SIX INCH MAP NUMBER ITM CO-ORDINATES 1:50,000 O.S. SHEET NUMBER GIS CODE Coom Mine

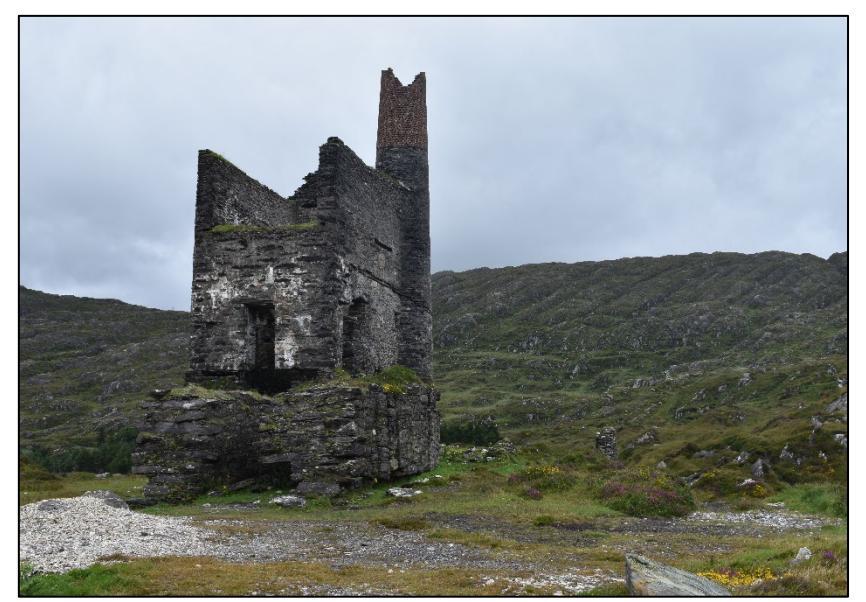
Coom engine house, view from south. The bob wall is visible and overlooks the engine shaft (out of shot, to the left), known as Bewley's Shaft.

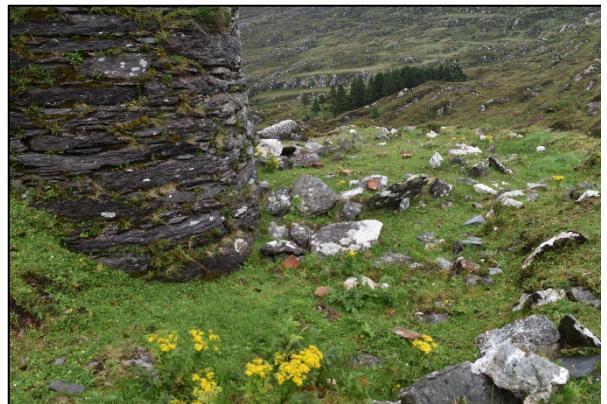
Base of Coom engine house chimney, showing accumulation of bricks that have fallen from chimney.

Coom engine house in 2008 – note greater height of chimney compared to recent photo (above). Steel support apparent in 2008 (red circle) now absent.

The site is readily accessible on foot by the gravel road leading from Caminches Mine. The engine house is now in a serious state of disrepair, with significant loss of brickwork from the chimney, and the disappearance of metal supports from its base raise questions about its overall stability. The site is part of the original Allihies Copper Mine Trail, as testified to by a metal signboard beside the road below the engine house, and is described on the Copper Mine Museum map and website. It does not require further promotion.

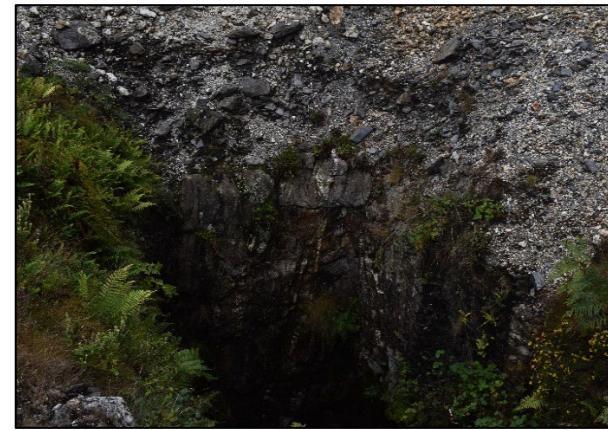
Coom engine house (Bewley's) shaft.

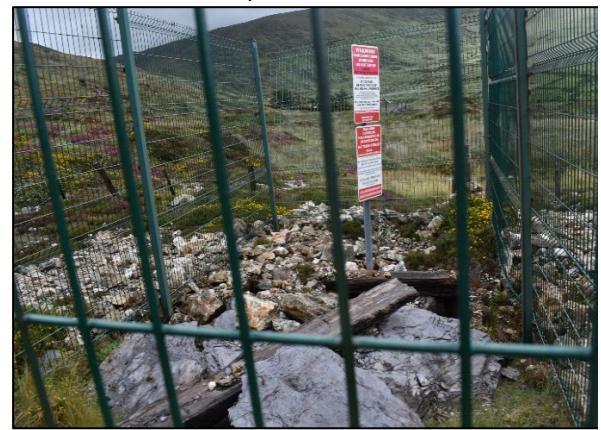
Whinze shaft southeast of the engine house and engine house shaft.
