GALWAY - COUNTY GEOLOGICAL SITE REPORT

Croaghill Turlough

IGH1 Karst, IGH16 Hydrogeology Croaghill, Parkbaun, Carrowneany, Brierfort Williamstown 1, 6 559400E 770650N (centre of feature) GSI BEDROCK 1:100,000 SHEET NO. 11

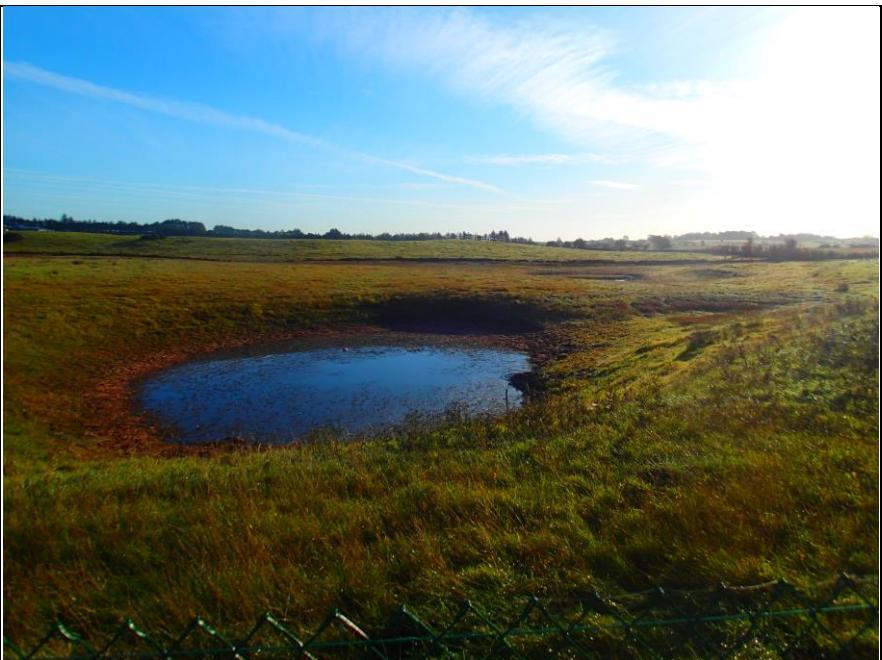
One of the deep, enclosed depressions at the northwestern end of the turlough feature.

Croaghill Turlough is a 'wet' turlough, parts of which stay flooded well into July. The topography of the surrounding, impounding hills is dominated by deposits of till (glacial sediment), with some glaciofluvial sands and gravels at the northwest, and an esker just outside the site boundary at the west. The floor of the feature is notably undulating, which means that the vegetation of the basin floor has a complex pattern. A number of marked, deep, karstic, enclosed depressions (dolines) are seen at the northwestern and western ends of the turlough basin.

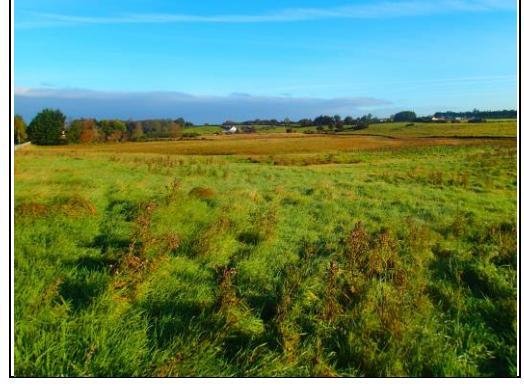
A line of enclosed depressions at the western end of the main turlough basin.

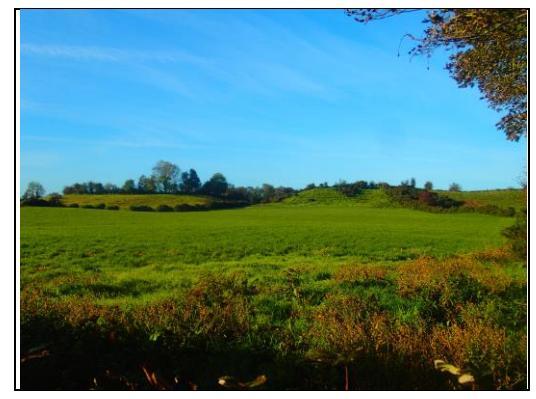
The esker at the western edge of the feature.

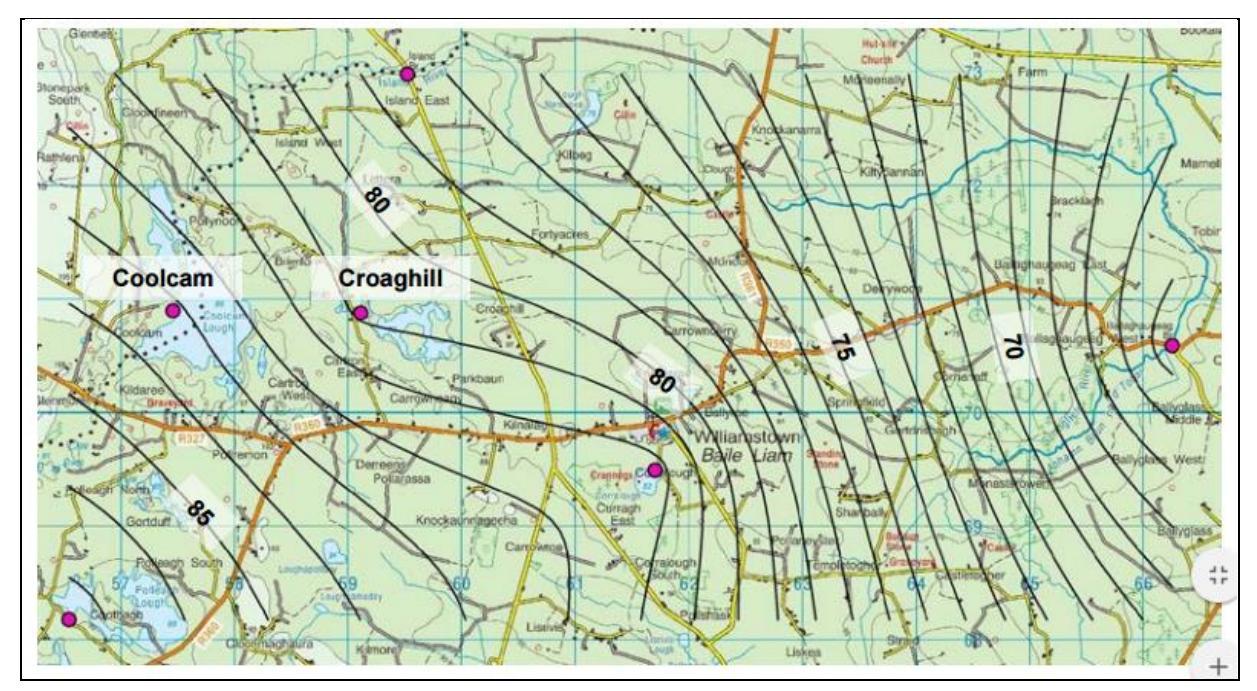
Water table map for area around Coolcam and Croaghill turloughs, from a report 'Turloughs Hydrology, Ecology and Conservation' by a multi-disciplinary team from the Departments of Botany, Zoology, Geology, Civil Structural and Environmental Engineering, and the Centre for the Environment, at Trinity College Dublin, for the National Parks & Wildlife Services. Department of Arts, Heritage and the Gaeltacht, Dublin.

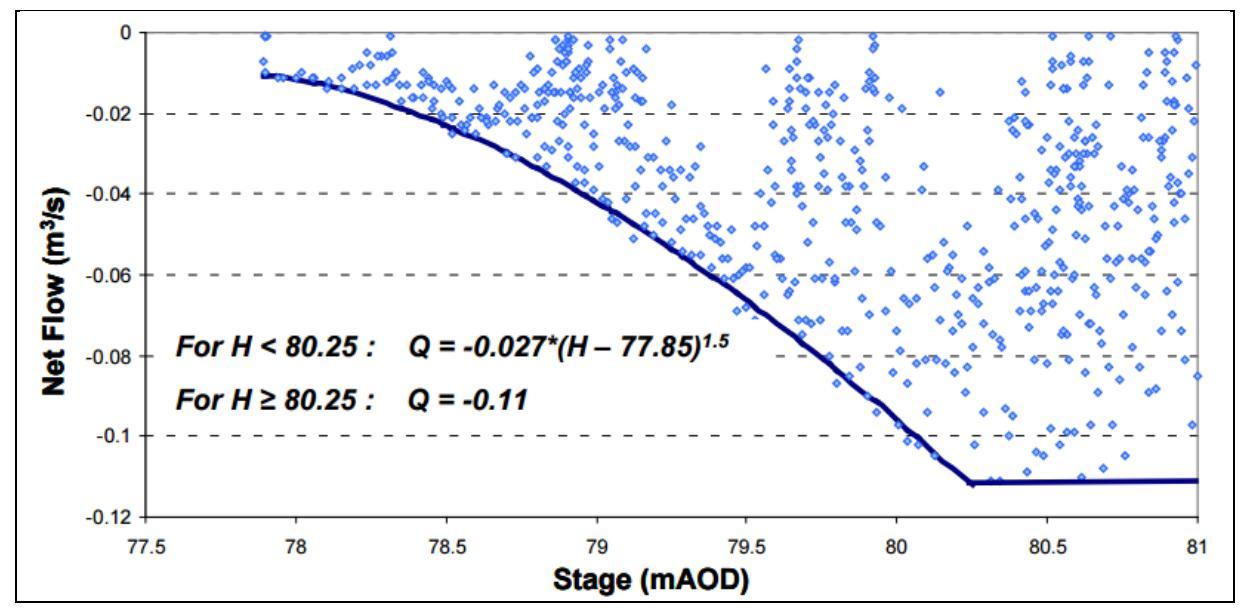
Stage-discharge curve of Croaghill Turlough, from the same report. This curve shows that the turlough empties more rapidly the 'fuller' it is, but takes a longer time to empty when the water level reaches low flood levels.

The wetness of the turlough has led to the accumulation of deep peat, and a 3 m depth is recorded. The turlough has been monitored over the last ten years by the Department of Environmental Engineering in Trinity College Dublin, which has shown that during flood a maximum water depth of 4.4 m is found in the centre of the turlough basin, and the feature has an average daily inflow when filling of 0.496 m^3/s (496 litres per second).
