REDCROSS WATER SUPPLY

GROUNDWATER SOURCE PROTECTION REPORT

Revised March 2003

Prepared by Louise Woods & Geoff Wright, Groundwater Section, Geological Survey of Ireland, Beggars Bush, Haddington Road, Dublin 4.

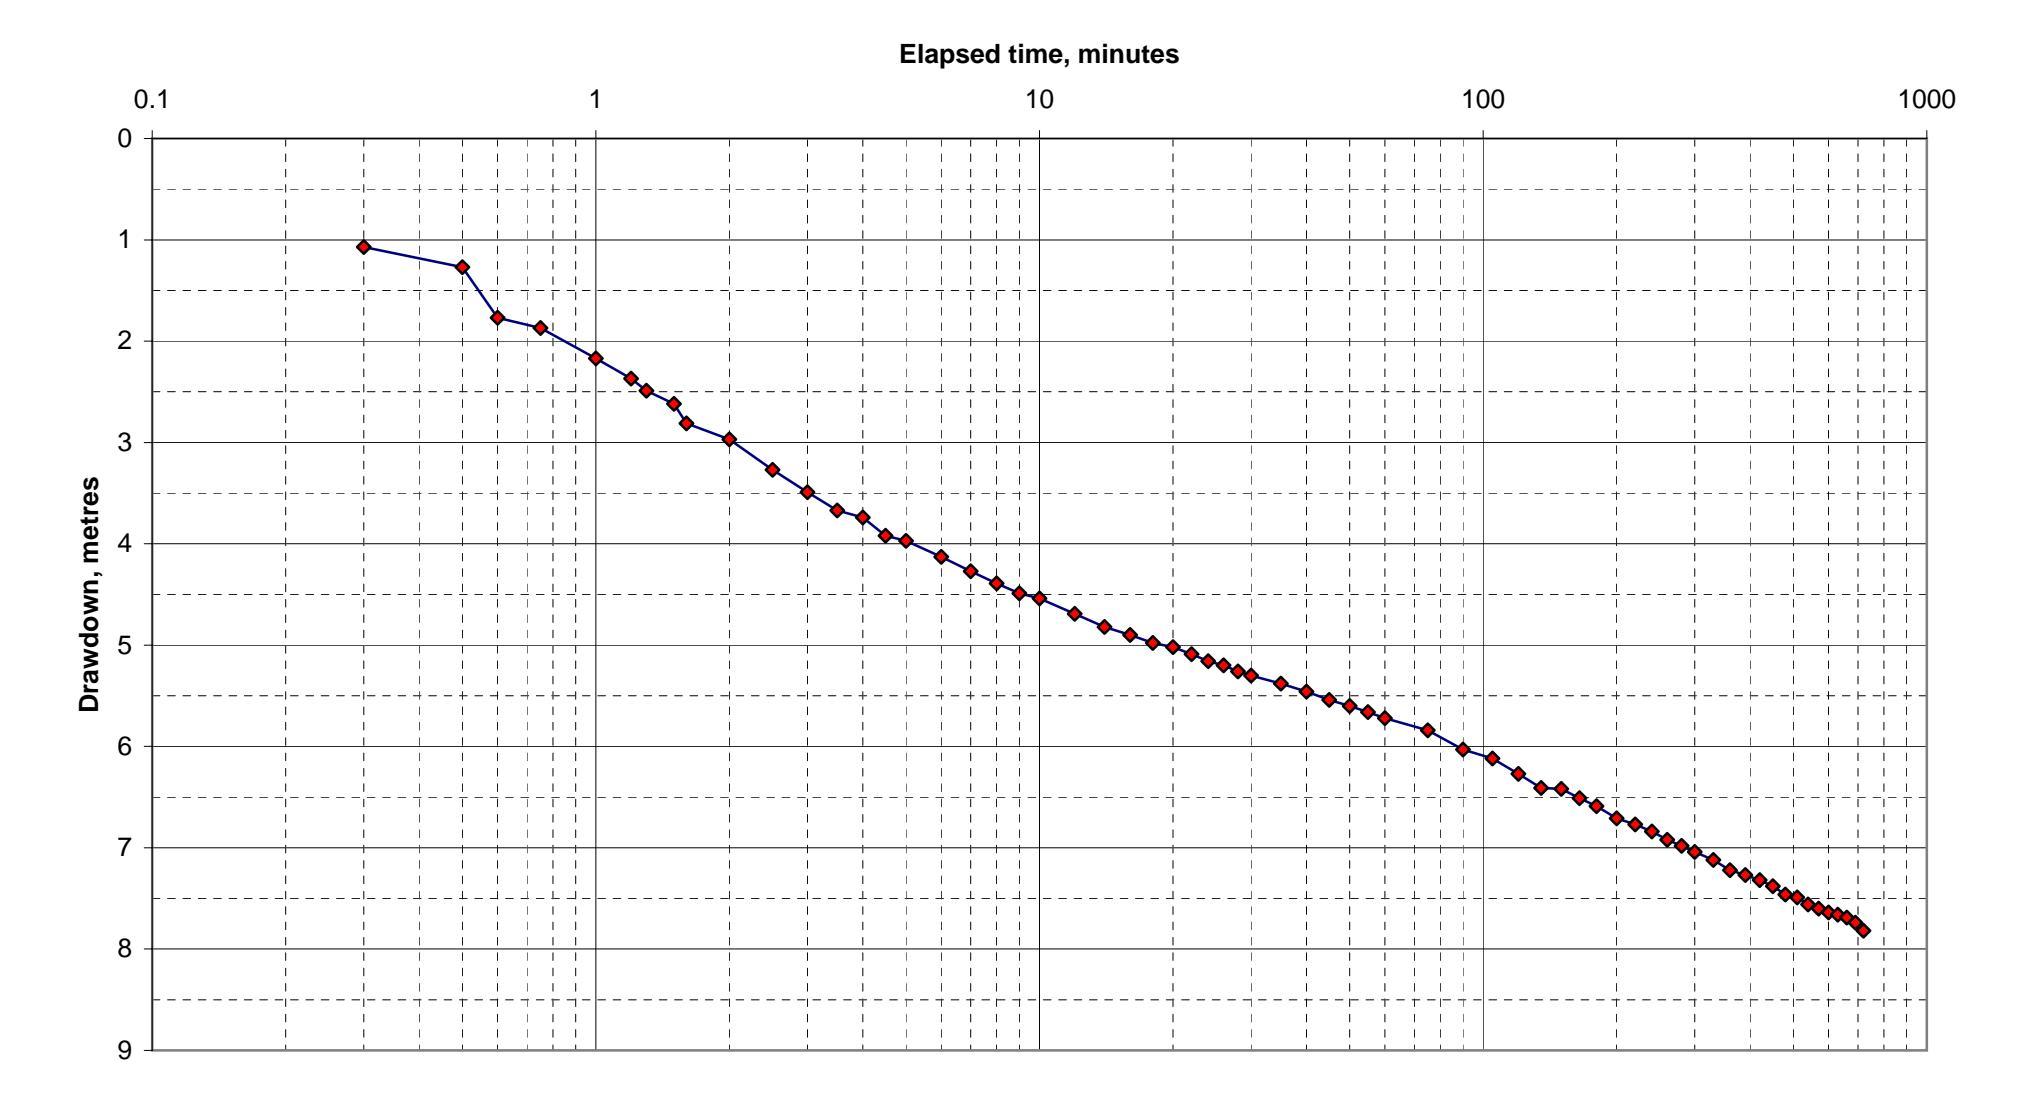
Redcross Pumping Test, PW1, 1 May 1997

Redcross PW1, Pumping Test, 1 May 1997, Drawdown data

The underlying aquifer at Redcross is composed of fractured and weathered shales. Analysis of the 12 hour pumping test provided an apparent transmissivity of about $32 \text{ m}^2/\text{d}$. The specific capacity calculated in PW No.1 (extrapolated to 1 week) was around $35 \text{ m}^3/\text{d/m}$.

During the pumping test the drawdown increased gradually over the 12 hours, and a steady state pumping water level was not attained. A longer test would be required to obtain a steady state pumping water level. The well is currently pumping at its maximum capacity.

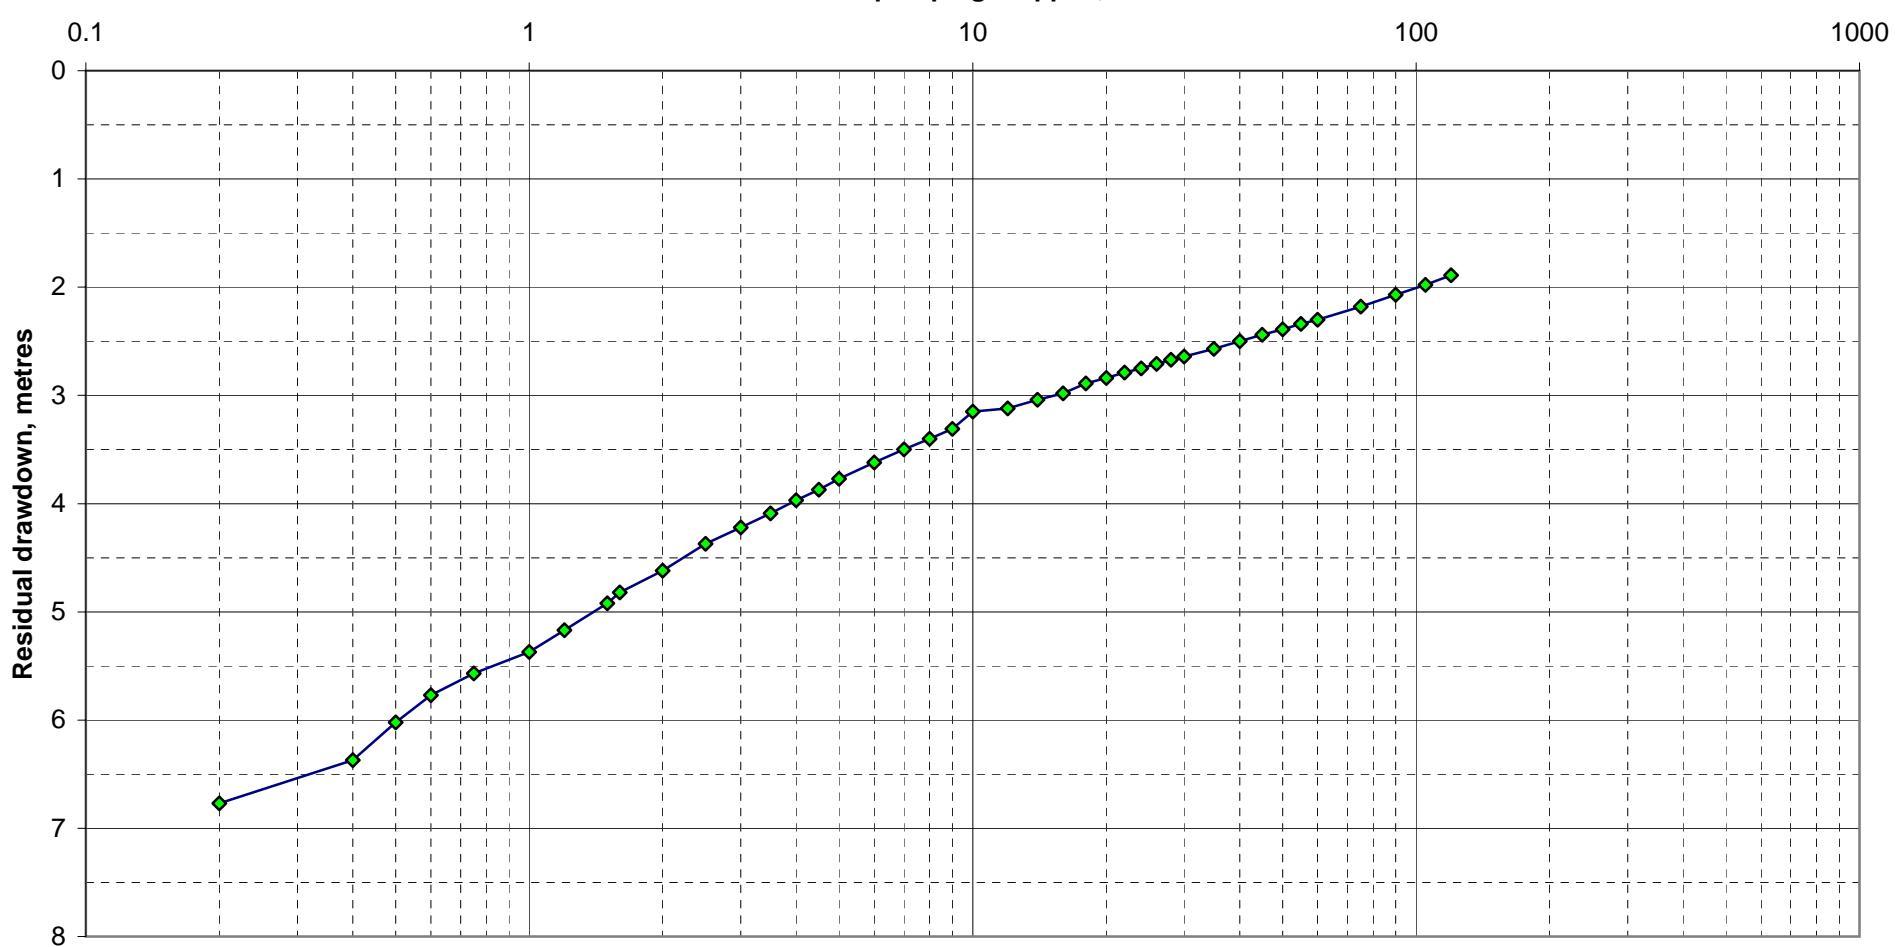
Redcross Pumping Test, 1 May 1997, Recovery data

Redcross PW1, Pumping Test, 1 May 1997, Recovery Data

Time since pumping stopped, minutes

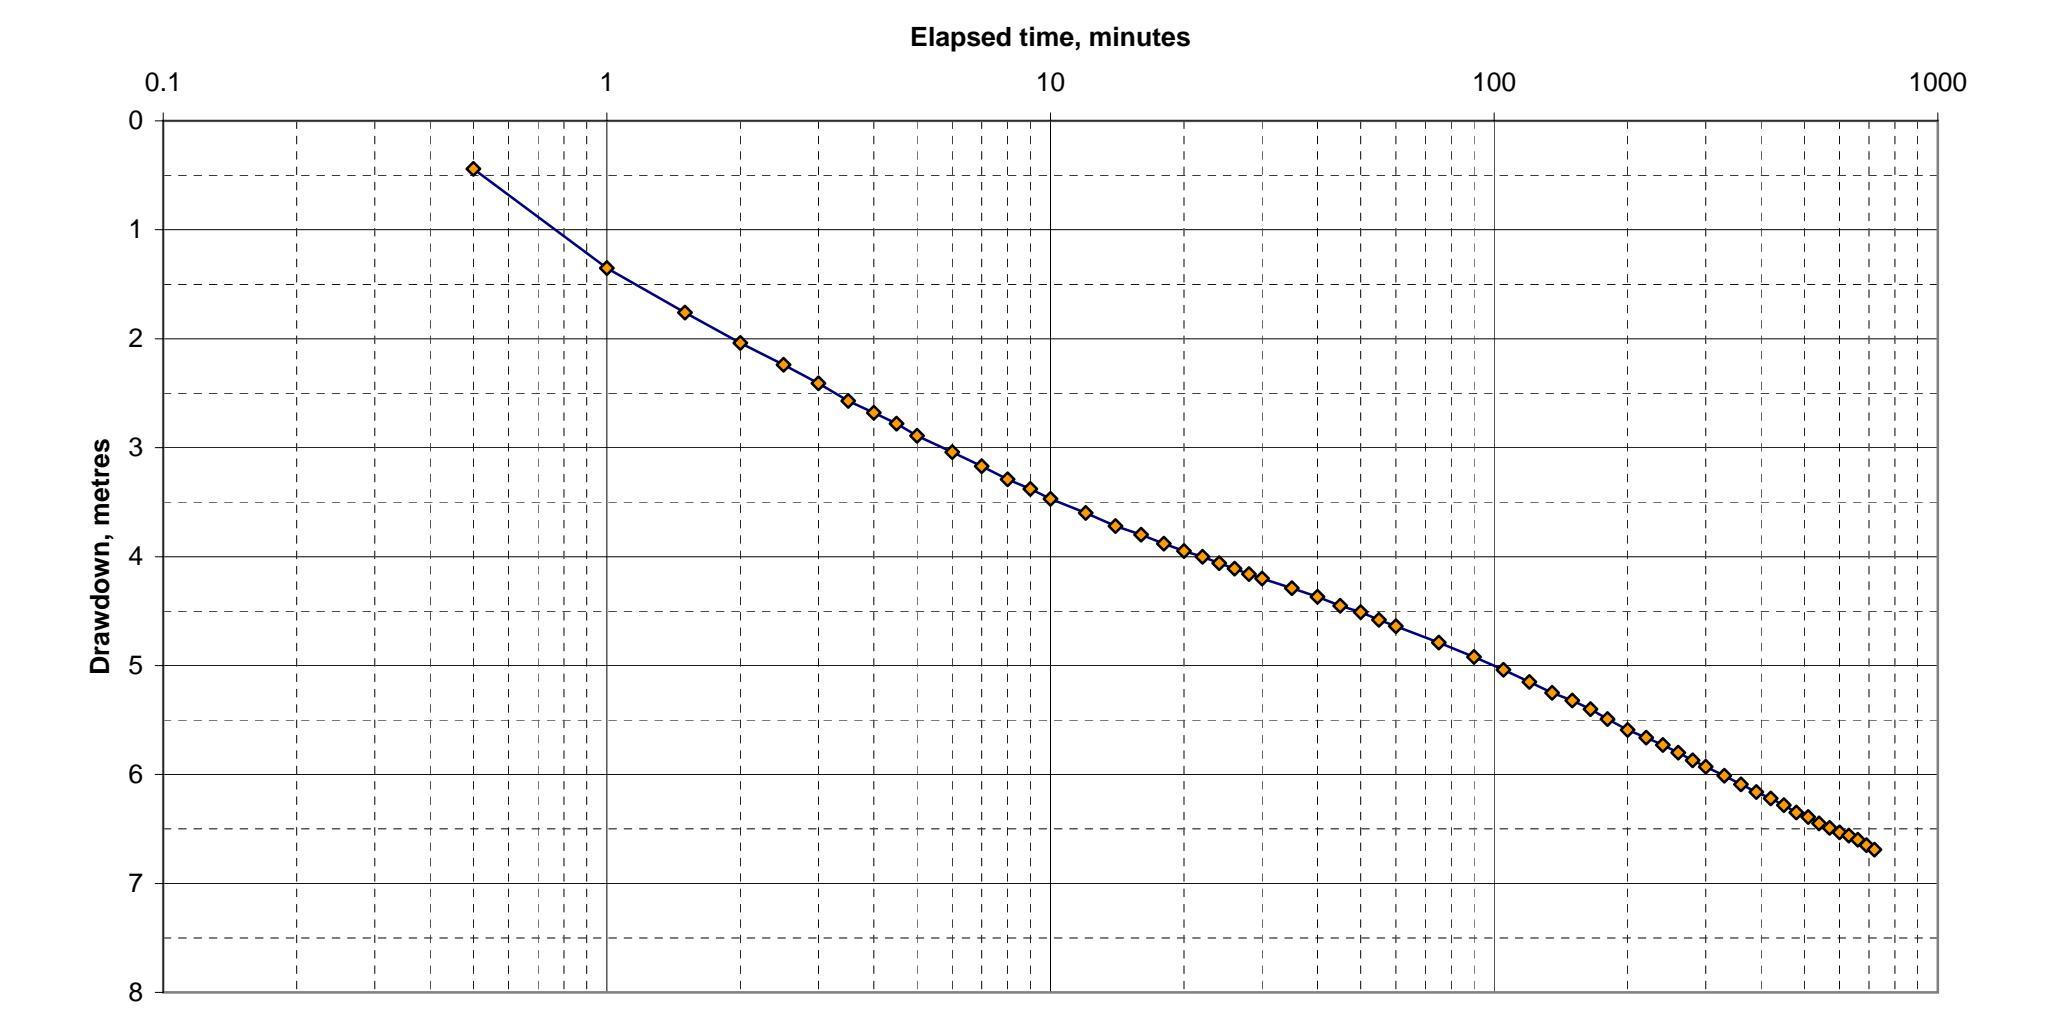
Redcross Pumping Test, 1 May 1997, OW1 Drawdown data

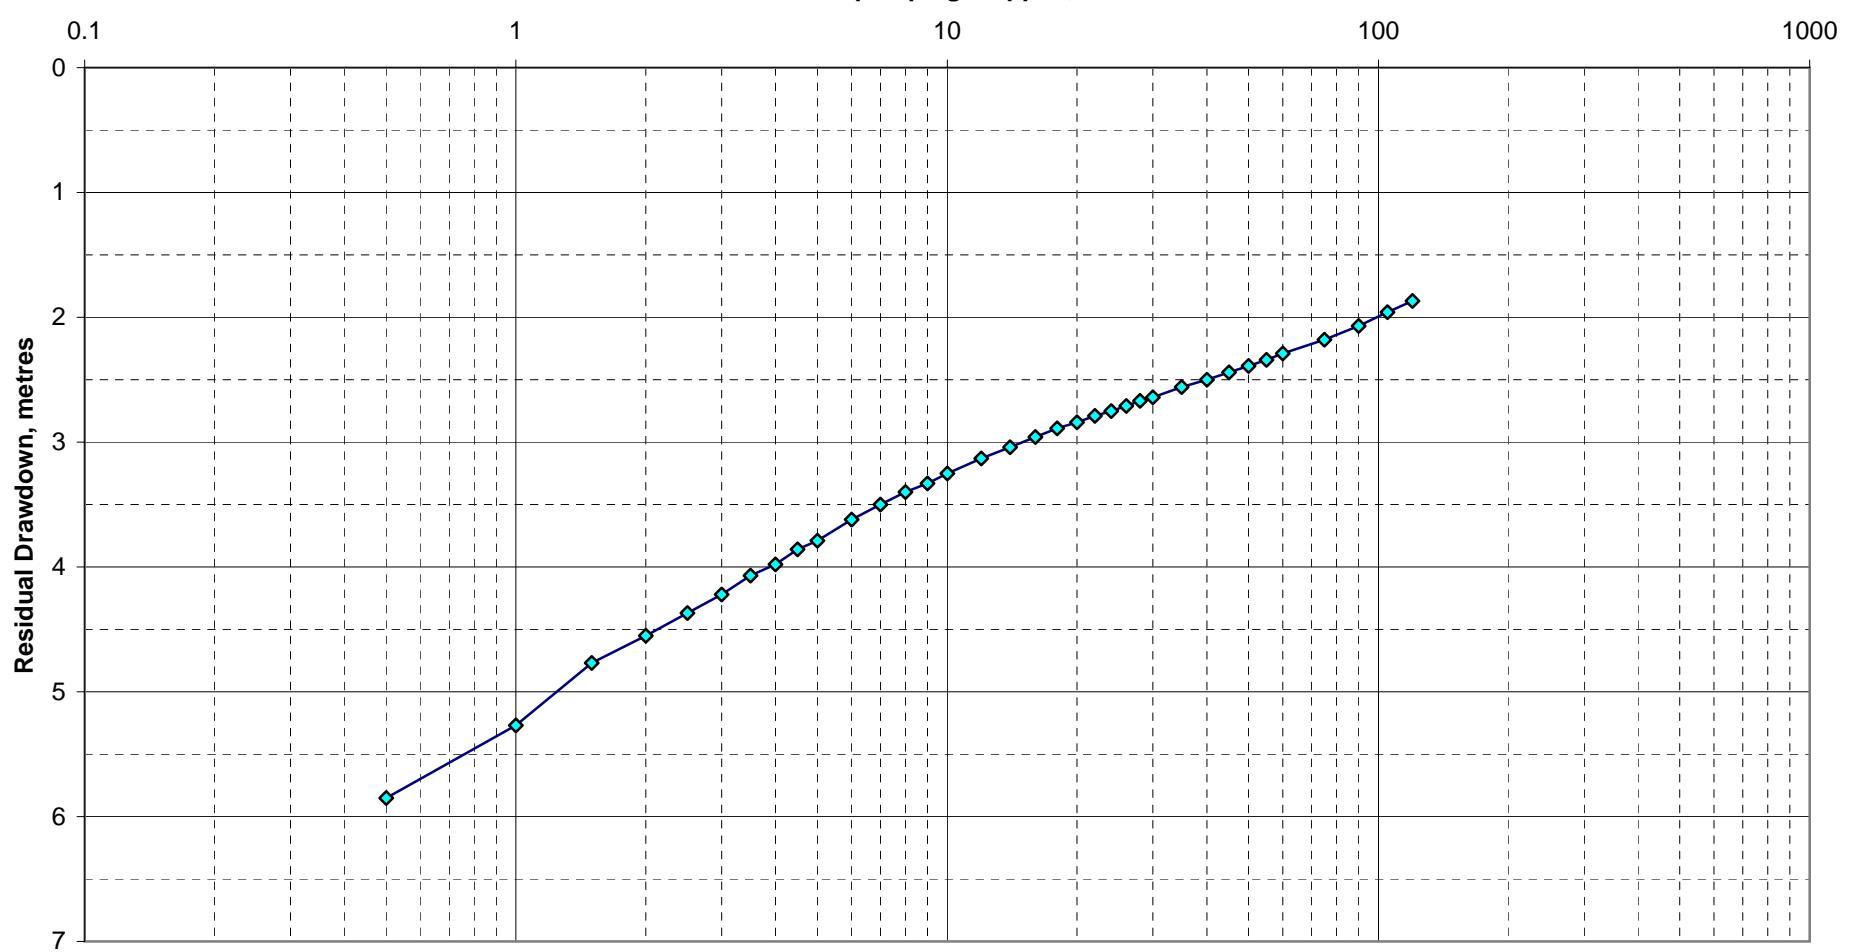
Redcross Pumping Test, 1 May 1997, OW1 Recovery data

Time since pumping stopped, minutes

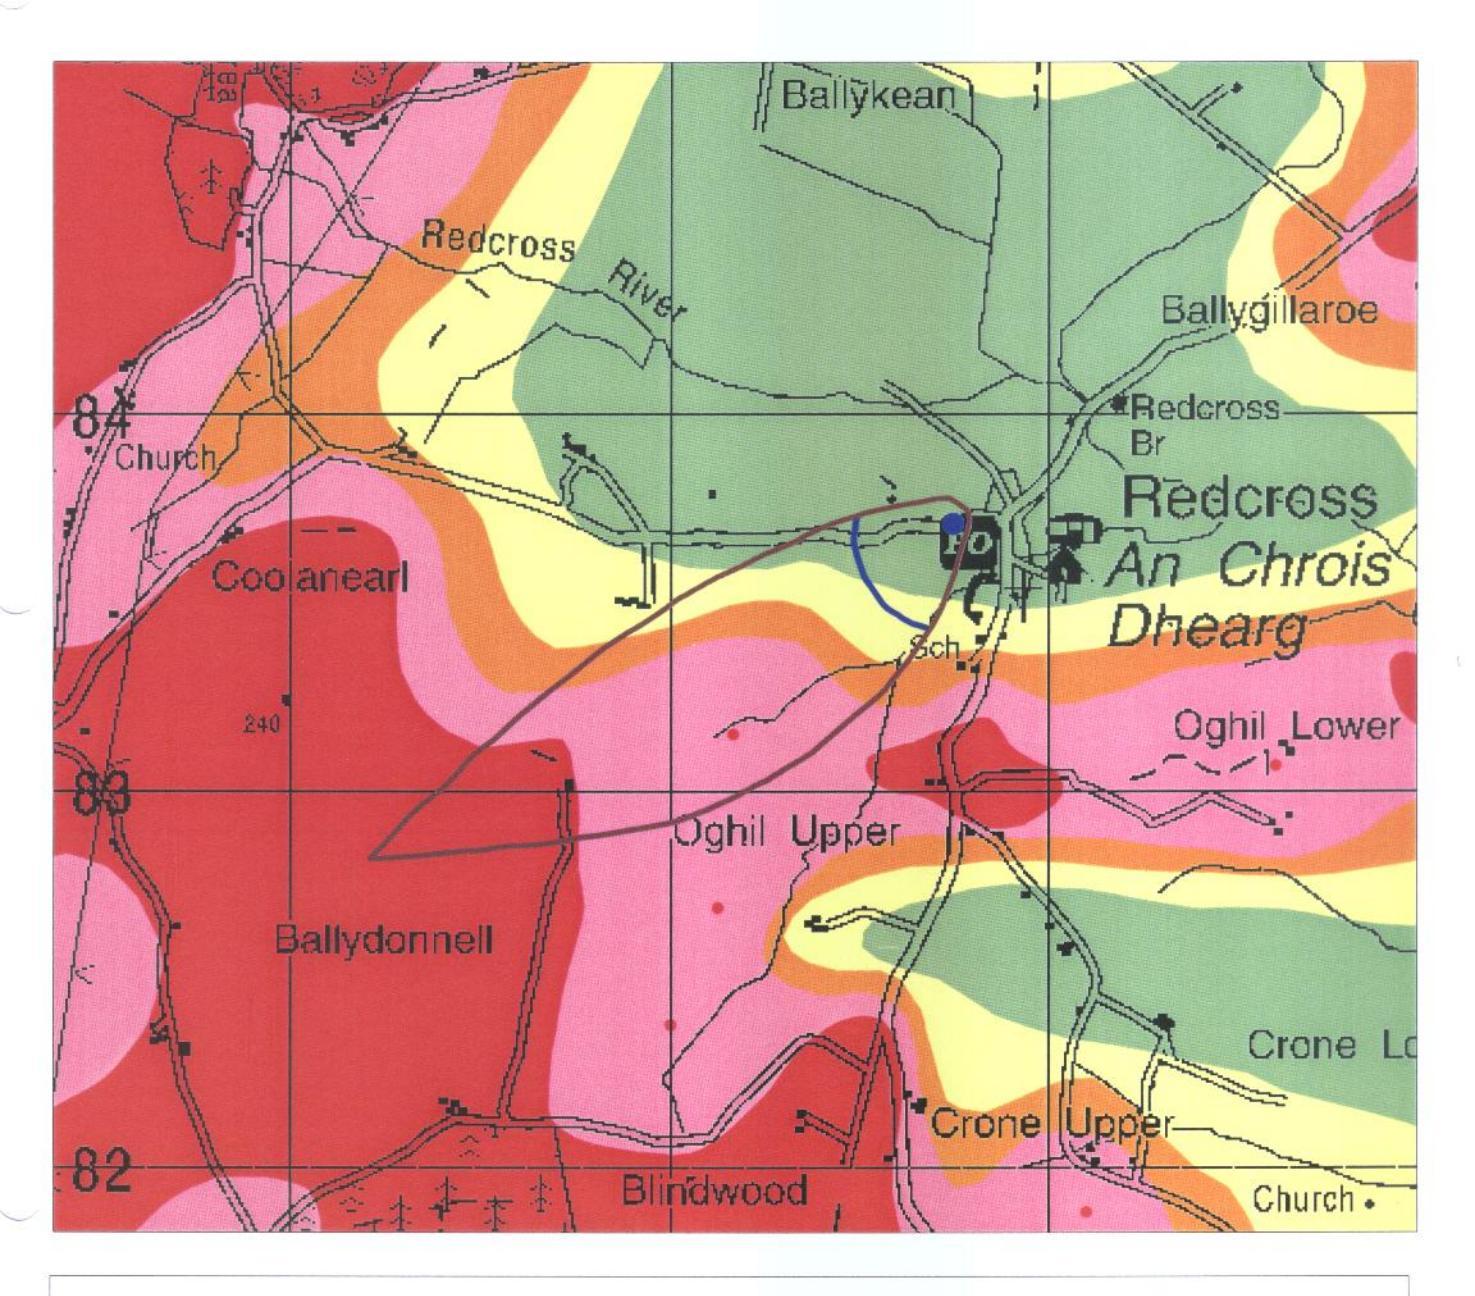
Fig. 2. Groundwater Vulnerability

The map shows the vulnerability of the first groundwater encountered (in either sand/gravel aquifers or in bedrock) to contaminants released at depths of 1-2 m below the ground surface. Where contaminants are released at significantly different depths, there will be a need to determine groundwater vulnerability using site-specific data. The characteristics of individual contaminants have not been taken into account.

Along the Redcross River valley the subsoils are generally thicker, over 10 metres. The depth to rock contouring for the Groundwater Vulnerability map (Figure 2) is based on very limited data points and may need refining as further depth to bedrock records become available.

The catchment area for the Redcross source encompasses the full range of vulnerability classes from low to extreme. The subsoils near the pumping well are quite thick (over 10 metres) and of low permeability (clayey till) although further from the well there is thin clayey till which provides little protection from pollution.

Areas where rock is less than 3 m below surface occur to the south of Redcross village around Oghil and westwards around Ballydonnell. Under the GSI vulnerability mapping guidelines, these areas are mapped as having an 'extreme' vulnerability. The 3 metre depth to bedrock contours were sketched in using aerial photographs and the available data points. The surrounding area is classified as 'highly vulnerable' due to the shallow cover, despite the low permeability of the subsoil. An area of 'moderate' vulnerability is found where the subsoils range from 5 to 10 metres in thickness. The remainder of the surrounding area is classified as having 'low' vulnerability. The vulnerability zones are shown on Figure 2.

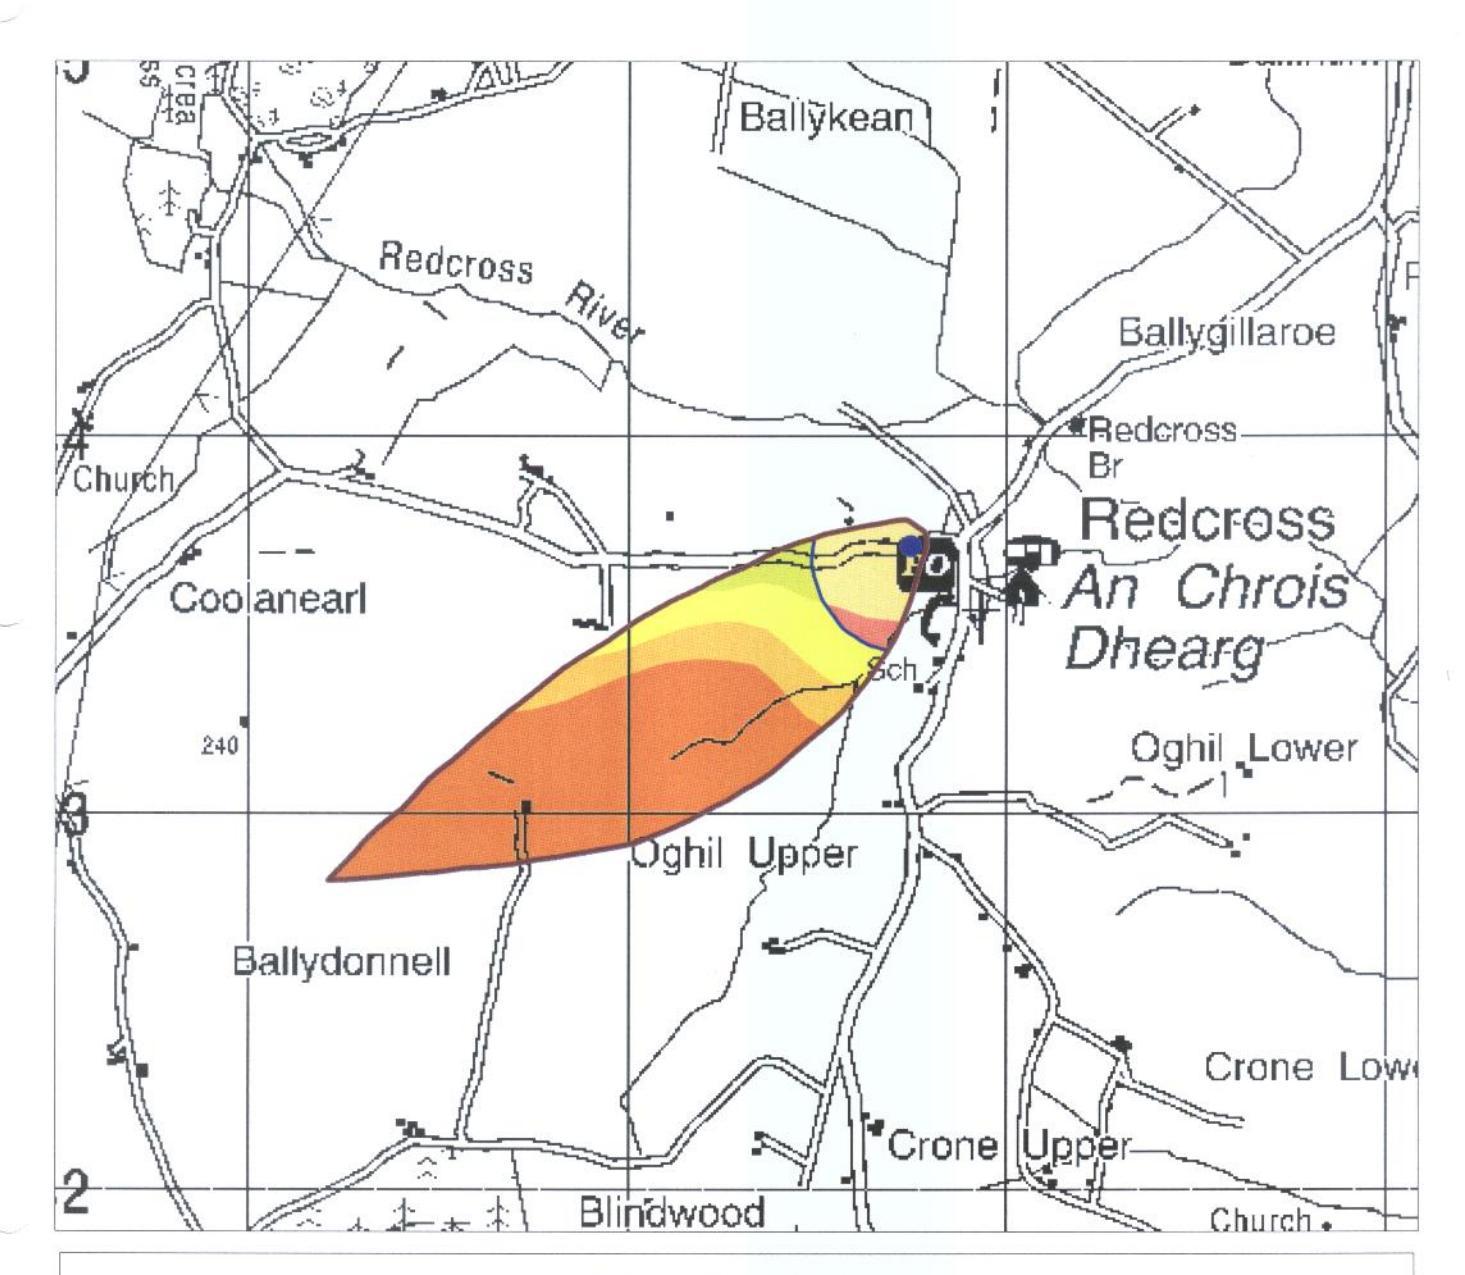
Fig. 3. Source Protection Zones

VULNERABILITY	SOURCE PROTECTION ZONES					
RATING	Inn	er (SI)	Outer (SO)			
Extreme (E)	not present	SI/E		SO/E		
High (H)	not present	SI/H		SO/H		
Moderate (M)		SI/M		SO/M		
Low (L)		SI/L		SO/L

This **Source Protection Zone map** is designed for general information and strategic planning usage. The boundaries are based on the available evidence and local details have been generalised to fit the map scale. Evaluation of specific sites and circumstances will normally require further and more detailed assessements and will frequently require site investigations to determine the risk to groundwater.

Using the following aquifer coefficients: permeability (k) = 5 m/d, porosity = 0.03, and the hydraulic gradient (i) = 0.02, the 100 day time of travel distance to the well is estimated to be approximately 330 metres (Figure 3).

The Outer Protection Area includes the remainder of the catchment area to the source, i.e. the zone of contribution (ZOC), and is defined as the area required to support an abstraction from long-term recharge. The ZOC at Redcross is derived from hydrogeological mapping techniques and is controlled primarily by the required recharge area and the groundwater flow direction. The size of the ZOC as shown in Figure 3 is based largely on the Recharge Equation. Assuming an annual recharge of 450 mm, the area required to supply the pumping rate of $350 \text{ m}^3/\text{d}$ is estimated at 0.3 km^2 . The null point or down-gradient boundary of the ZOC (the distance down-gradient after which water is not contributing to the well) is no more than 50 metres. A buffer (safety margin) is included in the final zone of contribution by incorporating a $10-20^\circ$ error margin for the estimated groundwater flow direction and this provides a very conservative ZOC for the Redcross PW No. 1. The actual area of the ZOC in Figure 3 is approximately 0.5 km^2 .

Combining the Source Protection Areas with the vulnerability ratings produces five Groundwater Protection Zones for the Redcross source. These are listed here in order of decreasing degree of protection required and are shown in Figure 7:

- Inner Protection Area /Low (SI/L)
- Outer Protection Area / Extreme (SO/E)
- Outer Protection Area / High (SO/H)
- Outer Protection Area / Moderate (SO/M)
- Outer Protection Area / Low (SO/L)
