# **GALWAY - COUNTY GEOLOGICAL SITE REPORT**

NAME OF SITE Other names used for site IGH THEME TOWNLAND(S) NEAREST TOWN/VILLAGE SIX INCH MAP NUMBER ITM CO-ORDINATES 1:50,000 O.S. SHEET No. 46 **Ballyglunin Cave**

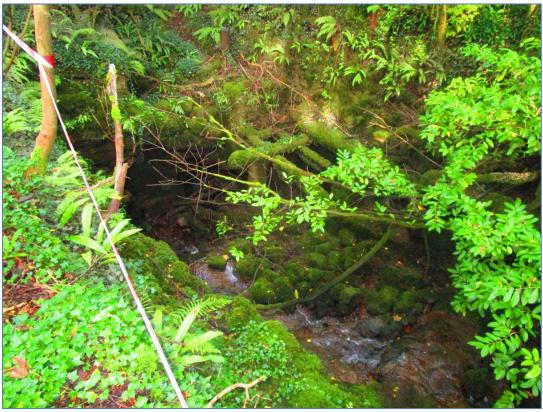
The sinking stream in the entrance collapse of Ballyglunin Cave.

The cave consists of a complex network of passages carrying a water flow which was diverted off the Abbert River. There are the remains of a water powered turbine structure which had been installed in the entrance depression which was probably a natural collapse into the cave. The passages are a complex mix of different heights and widths, some dry and some carrying water.

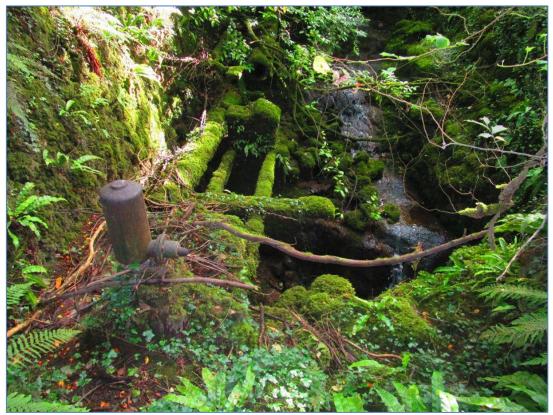
The remains of a turbine structure above the sinking stream entrance to Ballyglunin Cave.
