## TIPPERARY - COUNTY GEOLOGICAL SITE REPORT

<b>NAME OF SITE</b>	<b>Ballytarsna M8 Road Cut</b>		
Other names used for site			
<b>IGH THEME</b>	<b>IGH8 Lower Carboniferous</b>		
<b>TOWNLAND(S)</b>	<b>Ballytarsna (Hackett), Grangemore</b>		
<b>NEAREST TOWN/VILLAGE</b>	<b>Cashel</b>		
<b>SIX INCH MAP NUMBER</b>	<b>53</b>		
<b>ITM CO-ORDINATES</b>	<b>611300E 646760N</b>		
<b>1:50,000 O.S. SHEET NUMBER</b>	<b>66</b>	<b>GSI BEDROCK 1:100,000 SHEET NO.</b>	<b>18</b>

A road cutting through limestone bedrock on the M8 motorway between Junction 6 Horse and Jockey and Junction 7 Cashel North.

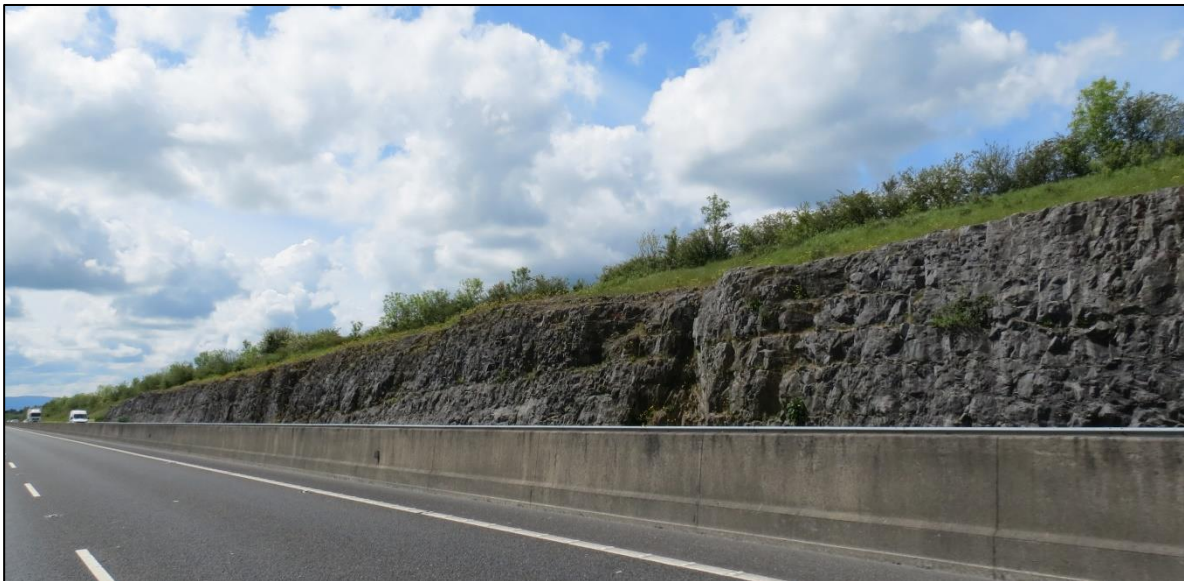
Durrow Formation exposed on west side of M8 road cutting.

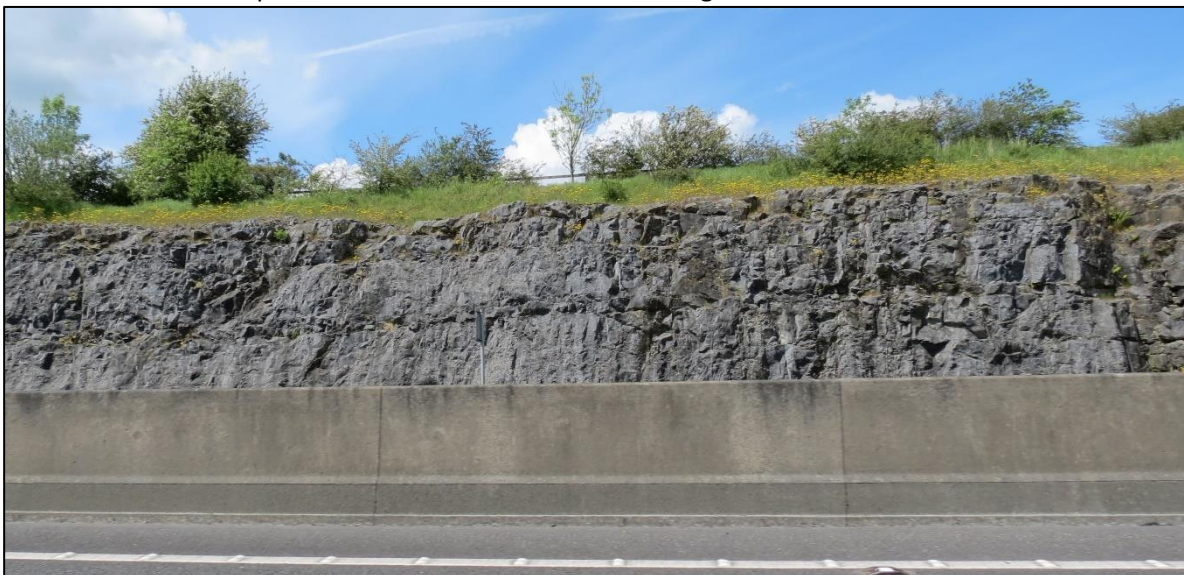
Thick bedded Durrow Formation lithologies exposed on west side of M8 road cutting.
