TIPPERARY - COUNTY GEOLOGICAL SITE REPORT

NAME OF SITE	Earlshill (Slieve Ardagh coalfield)		
Other names used for site			
IGH THEME	IGH15 Economic Geology		
TOWNLAND(S)	Earlshill		
NEAREST TOWN/VILLAGE	Ballingarry		
SIX INCH MAP NUMBER	48		
ITM CO-ORDINATES	626080E 650760N		
1:50,000 O.S. SHEET NUMBER	67	GSI BEDROCK 1:100,000 SHEET NO.	18

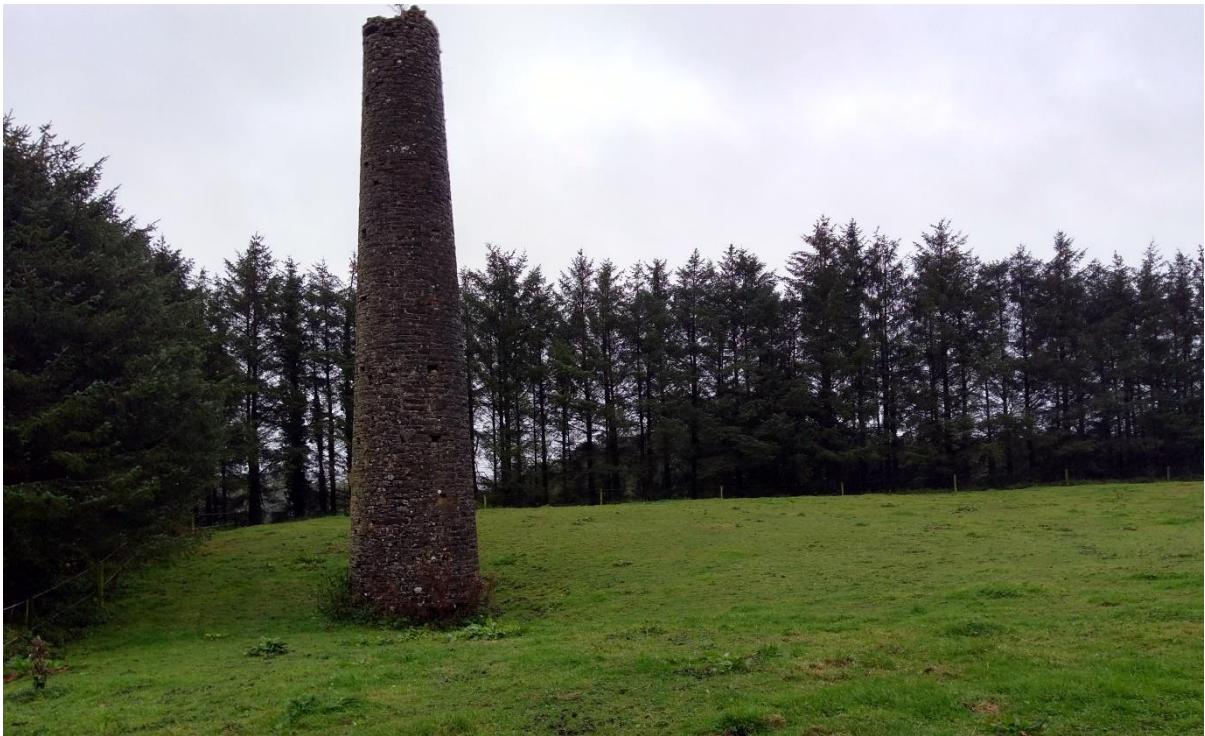
The site includes three large “banks” or heaps of waste and several well-preserved mine buildings. Two of the waste heaps are flattened and overgrown by gorse, trees and rough grass. The third, on the site of the engine house and chimney, has been reclaimed to pasture. The engine house is now gone but the round chimney remains: cracks are showing on the walls and numerous blocks have fallen from the top where birds appear to be nesting. A hollow beside the chimney is presumably what remains of the engine shaft.

Engine house chimney, Earlshill

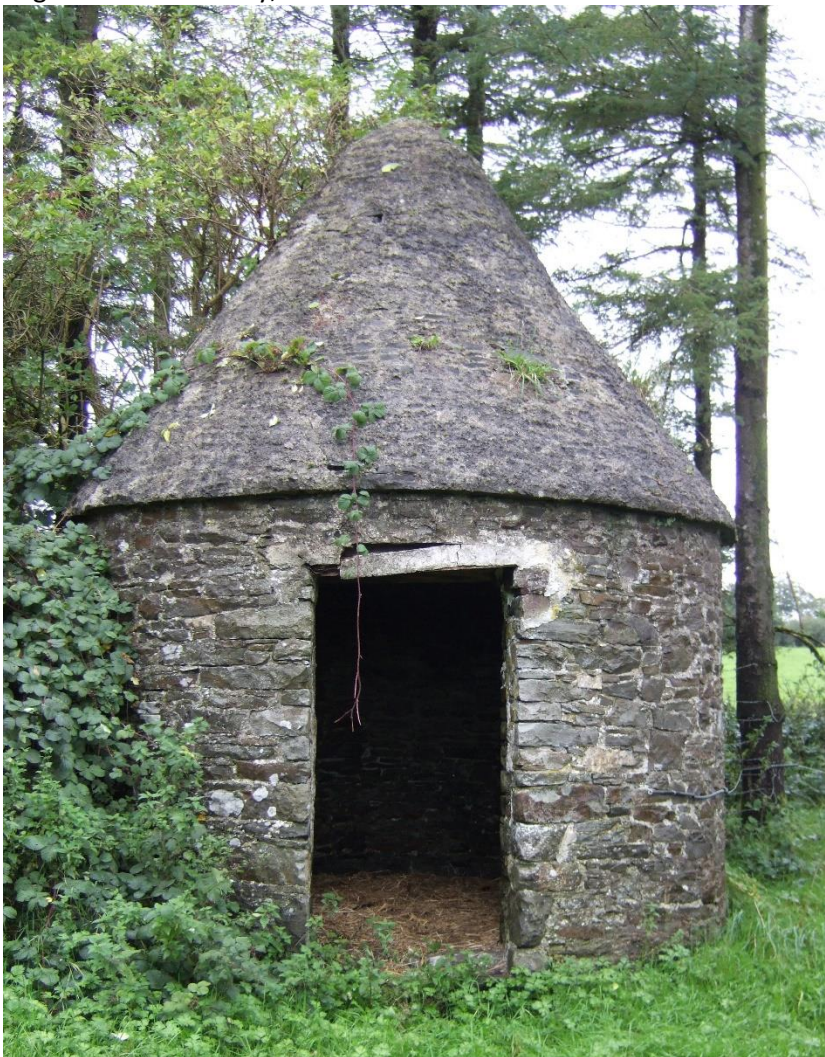
Along the entrance road to the west the old mine manager’s house and offices are abandoned but still standing. To the rear of the house, in what is now a farmyard, a round building with pitched conical roof is a powder house or magazine. The roof is intact and the building dry. The door lintel is broken and requires repair.

Powder house (magazine), Earlshill

The powder house is a unique building in the context of Irish coalfields or indeed Irish mine sites in general. It has been in disrepair for many years and requires conservation. It is sited within a farmyard on private land but the landowner is apparently well disposed towards efforts to preserve the heritage amenity of the site. The engine house chimney also requires conservation. The powder house is an iconic building that could be one of the centrepieces of a heritage trail in Slieve Ardagh. The existence of the Old School Mining Museum in Commons, run by knowledgeable and committed volunteers, should be the basis for any mine heritage or geotourism initiatives in the district.
