TIPPERARY - COUNTY GEOLOGICAL SITE REPORT

NAME OF SITE	Toberadora
Other names used for site	Toberadorah, <i>Tiobraid Fheorainn</i>
IGH THEME	IGH1 Karst, IGH16 Hydrogeology
TOWNLAND(S)	Toberadora
NEAREST TOWN/VILLAGE	Holycross
SIX INCH MAP NUMBER	53
ITM CO-ORDINATES	607850E 649692N
1:50,000 O.S. SHEET NUMBER 66	GSI BEDROCK 1:100,000 SHEET NO. 18

Toberadora is a roadside spring site, regarded as a sacred well, along the road between Holycross and Cashel.

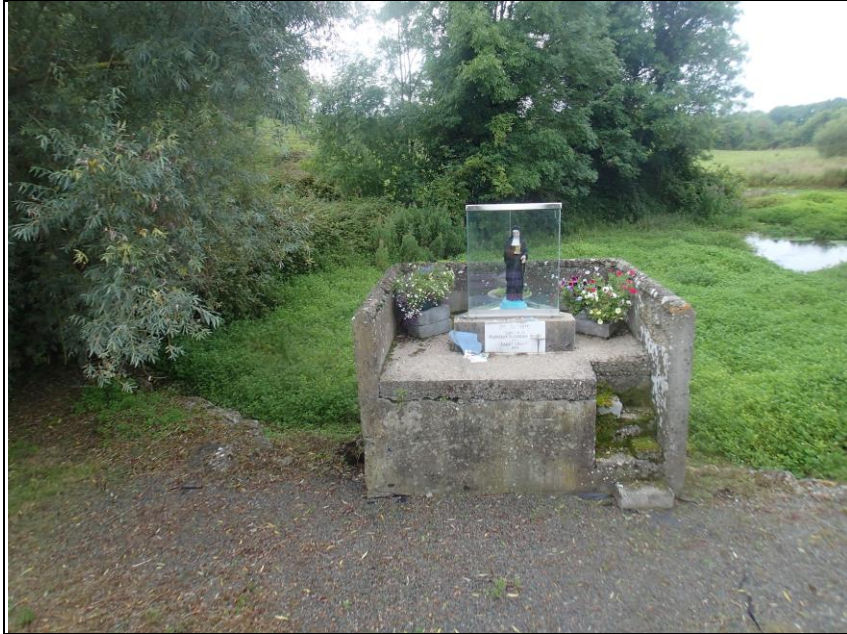
The spring emerging at Toberadora.

Though emerging from impure limestones, which crop out at the spring emergence, much of the area immediately east (and up-gradient of) the spring is underlain by karstified, pure bedded limestones. At such karstic spring localities, groundwater will either emerge from the bedrock directly, as at Toberadora, or will filter through some depth of glacial till deposits. In the area east of Toberadora the limestone aquifer is probably highly karstified, given the size of the spring emergence here.

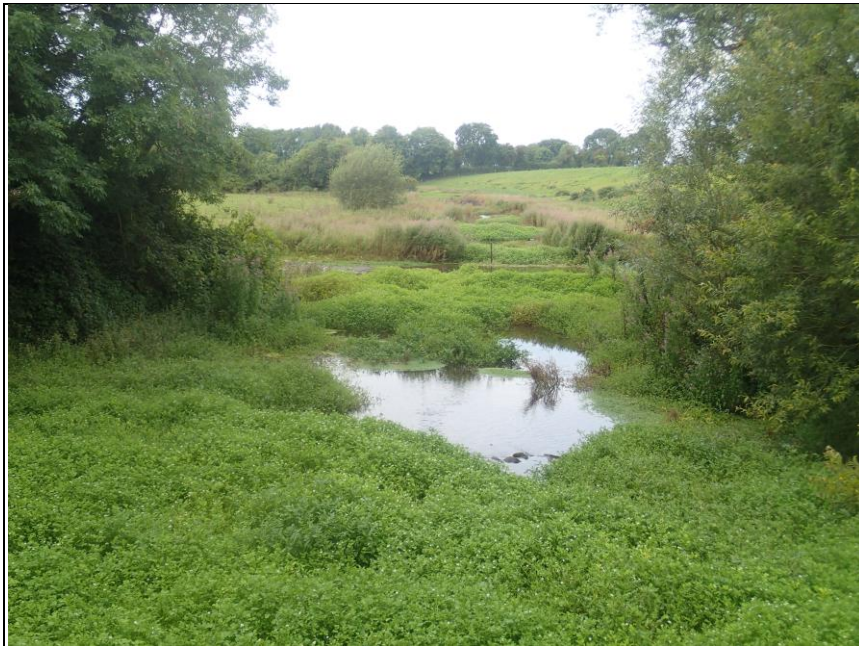
View of the Toberadora Stream, flowing out westwards from the spring.

The limestone across a wide area in mid- and south Tipperary comprises well bedded, well-jointed, pale, clean, coarse grained bedrock, with occasional thin shales. A large spring at Toberadora, set in a roadside compound, forms the head of the Toberadora Stream, which flows westwards towards the River Suir,

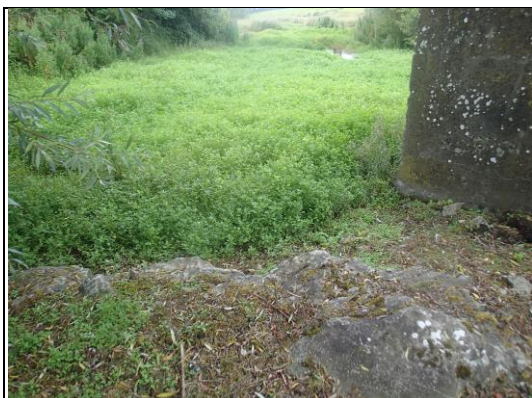
Limestone bedrock outcrop at the head of the spring.

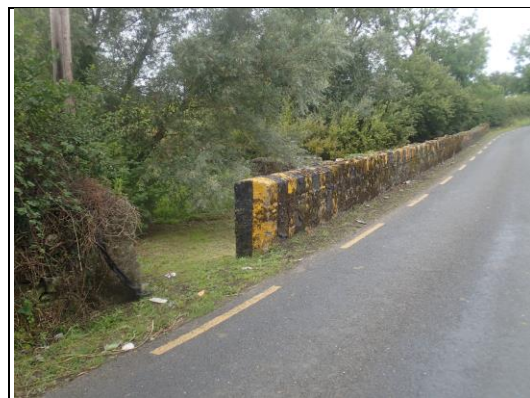
The small roadside compound housing the spring.

The site has its own compound, but the spring is open to the elements. Being a water source vulnerable to contamination the general promotion of the locality should be regarded with sensitivity. General education about the vulnerability of karst groundwater supplies to pollution from septic tanks and agricultural slurry spills and bad spreading practices is advisable, and a signboard illustrating the hydrogeology of the feature, how it arises, and the potential risks to contamination owing to its nature, would be beneficial.
